**From:** Lewark, Chris  
**Sent:** Thursday, January 14, 2021 2:22 PM  
**To:** blake.yazel <blake.yazel@lonestarsv.com>  
**Subject:** REMA charger inlet cable update

# TSB – Rema Charge Inlet Quality Issue

January 14<sup>th</sup>, 2020

**From:** Ziehm, Dan <dan.ziehm@dana.com>  
**Sent:** Friday, January 15, 2021 7:29 AM  
**To:** Bob Kern; Wayne Wilson; Crystal Childress  
**Subject:** TSB for Rema Inlet Issue  
**Attachments:** TSB\_REMA\_Inlet\_issue\_PACCAR\_14\_01\_2020.pdf

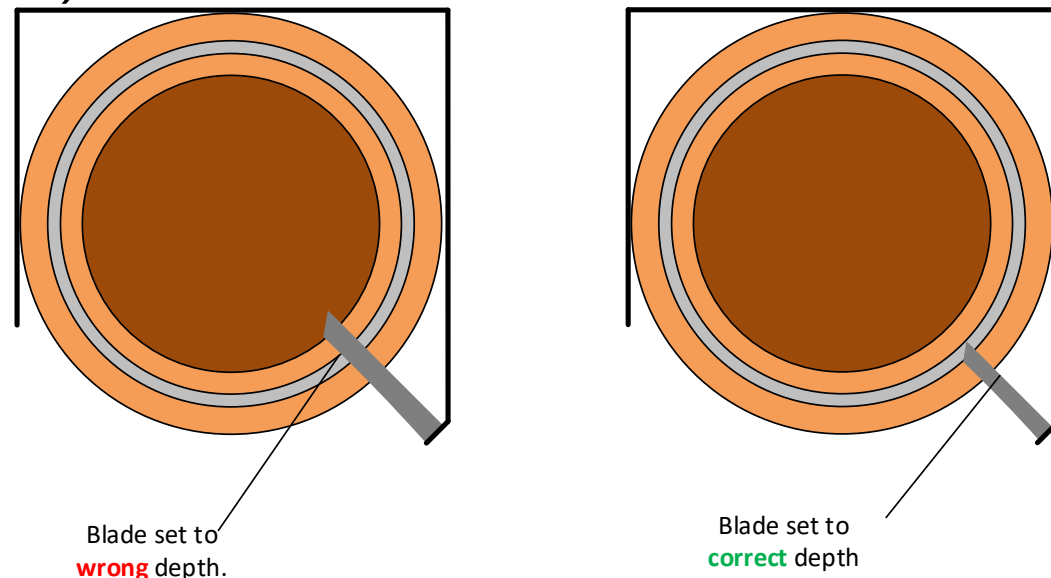
During manufacturing by Rema, two layers (1+2) of the cable are removed near the charge inlet and covered in shrink tube. Due to the tooling used, there is a high-risk of cutting through the inner layers (3+4).

Fig 2 – Cros sectional view of wire + cutting tool

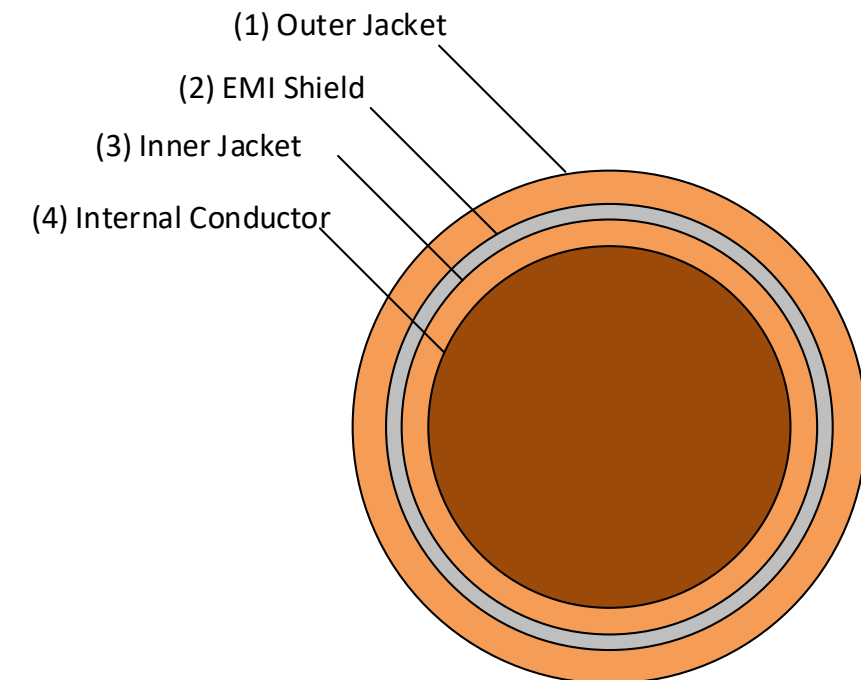
A manufacturing quality issue was identified with the Rema AC/DC Charge Inlet (P/N 9602094 (1741-002-01)). The supplier identified a manufacturing issue by which improper tooling and inadequate inspection of their assembly may lead to exposed and cut HV wiring jacket and conductors within the charge inlet assembly; and, inadequate adhesion of a piece of shrink tubing may expose a portion of the shield.

Fig 1 – Cross Sectional view of shielded cable

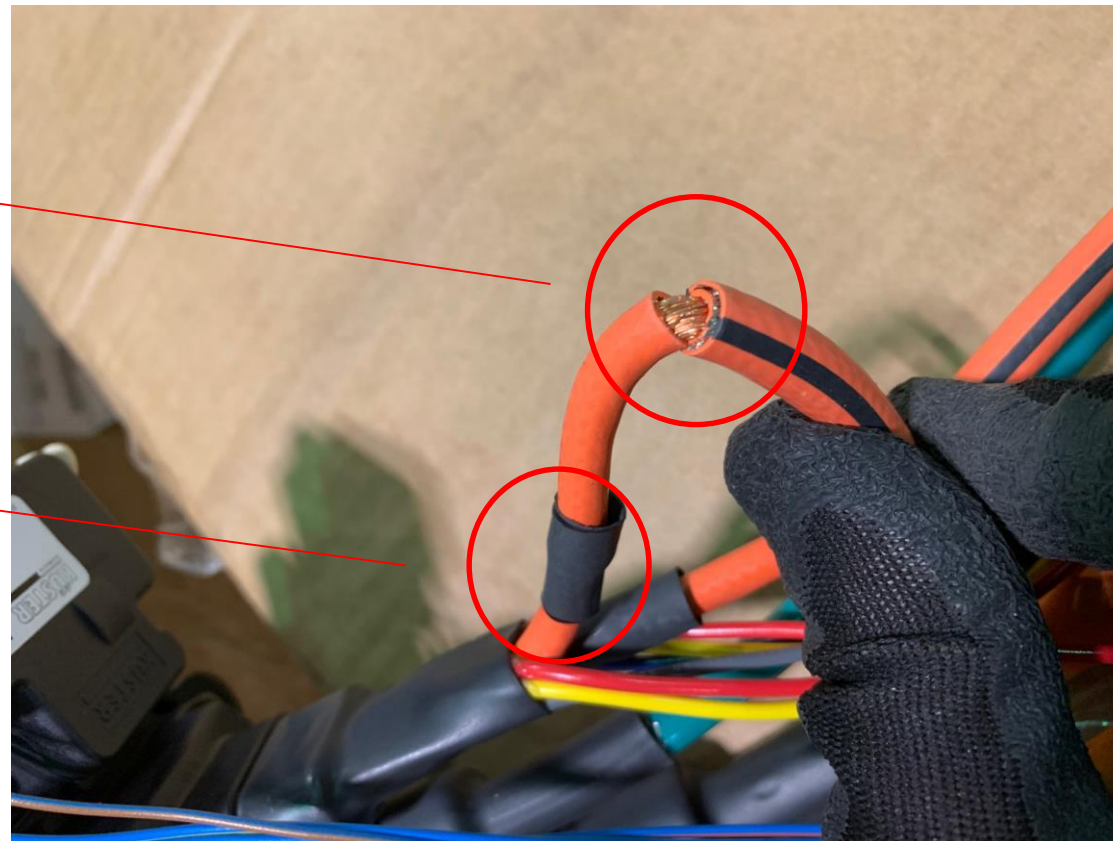
Fig 3 – Inner conductor + Inner Jacket cut

- (1) Risk of contact between the AC or DC high-voltage and the shield, which may cause a loss of isolation on the vehicle and/or energize the chassis
- (2) Risk of reduced cross-sectional area of the internal conductor, which may result in overloading and heat build-up in the conductor during AC or DC charging.
- (3) Risk of environmental contaminants entering conductor and causing corrosion inside the wire assembly, inhibiting charge function or increase wire internal resistance.

Due to the nature of the issue, please **refrain from charging**, or **connecting to any charging infrastructure**, both AC and DC, the BEV vehicles identified below, until inspected by Dana personnel.

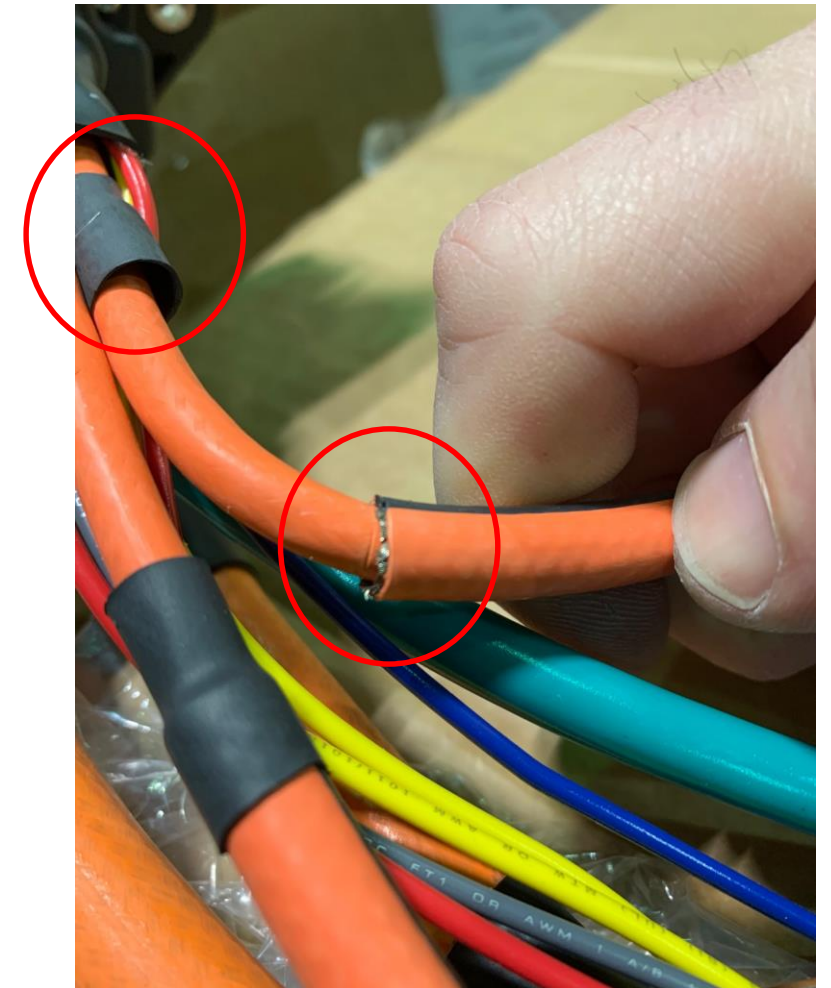
The issue was discovered due to shrink tubing that was not adhering to the cable assembly.

Cut inner jacket without exposed conductor

Shrink tubing not adhering to cable

Fig 4 – Inner Jacket cut, conductor not exposed

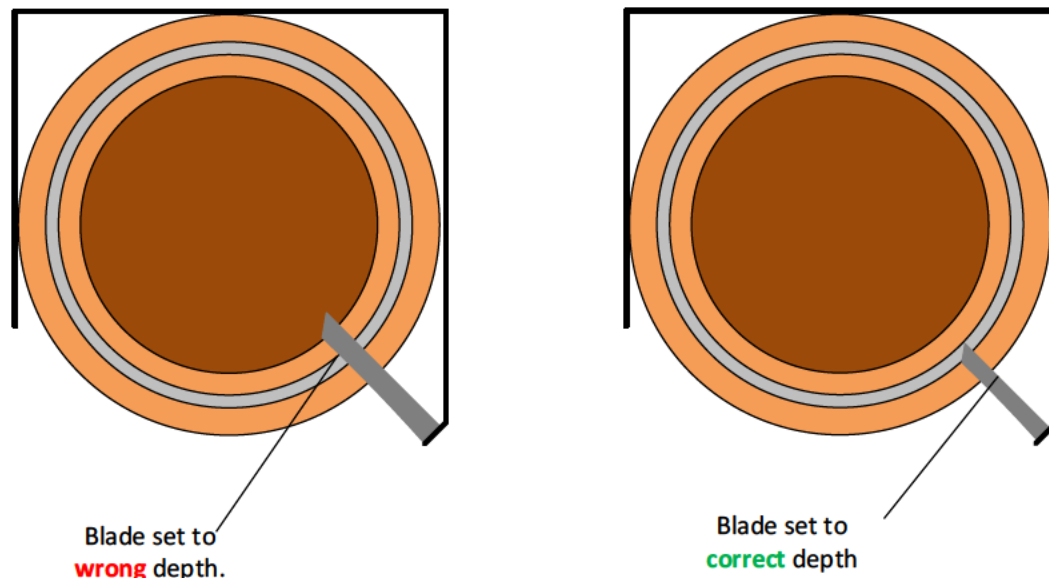
During manufacturing by Rema, two layers (1+2) of the cable are removed near the charge inlet and covered in shrink tube. Due to the tooling used, there is a high-risk of cutting through the inner layers of the cable, exposing the conductor (3+4).

Fig 2 – Cross sectional view of wire + cutting tool

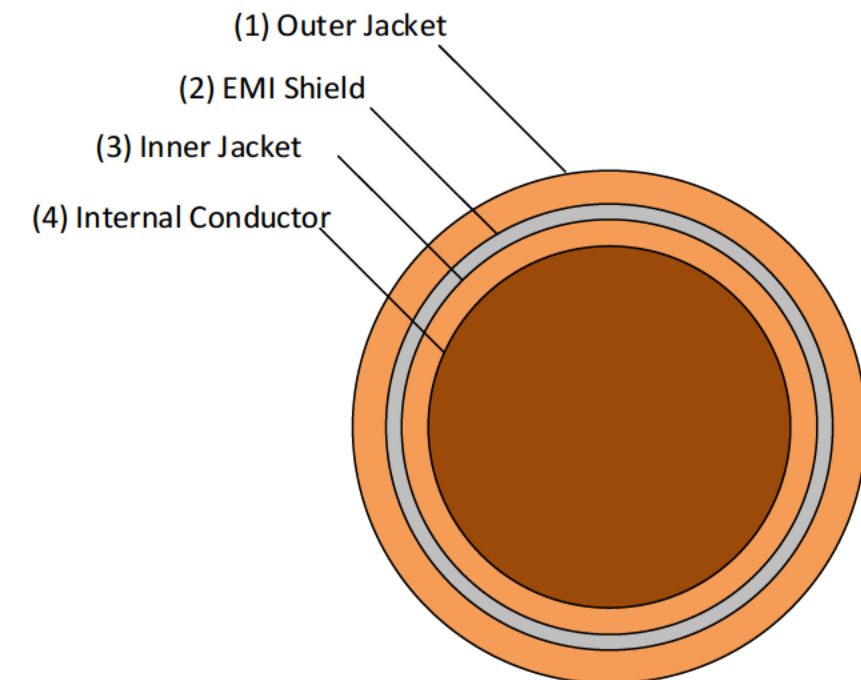
A manufacturing quality issue was identified with the Rema AC/DC Charge Inlet (P/N 9602062 (1741-008-00)). The supplier identified a manufacturing issue by which improper tooling and inadequate inspection of their assembly may lead to exposed and cut HV wiring jacket and conductors within the charge inlet assembly; and, inadequate adhesion of a piece of shrink tubing may expose a portion of the shield.

Fig 1 – Cross Sectional view of shielded cable

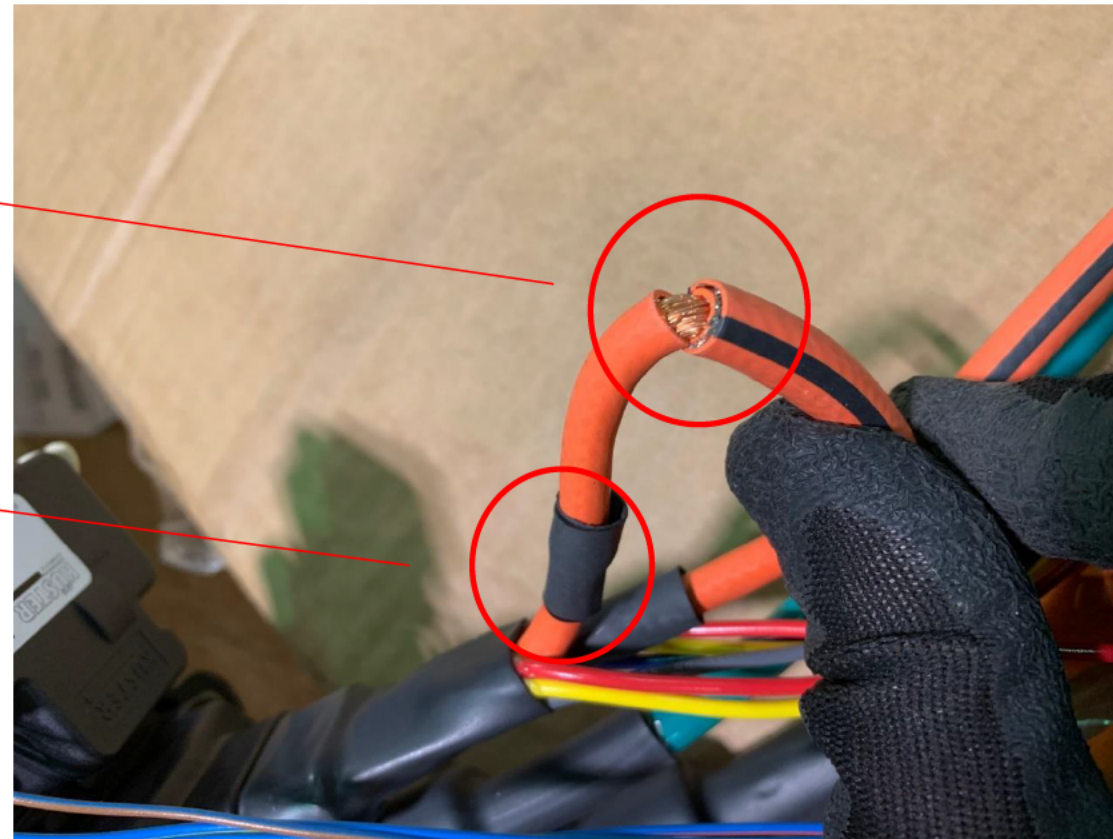
Fig 3 – Inner conductor + Inner Jacket cut

- (1) Risk of contact between the AC or DC high-voltage and the shield, which may cause a loss of isolation on the vehicle and/or energize the chassis.
- (2) Risk of reduced cross-sectional area of the internal conductor, which may result in overloading and heat build-up in the conductor during AC or DC charging.
- (3) Risk of environmental contaminants entering conductor and causing corrosion inside the wire assembly, inhibiting charge function or increase wire internal resistance.

Due to the nature of the issue, please **refrain from charging**, or **connecting to any charging infrastructure**, both AC and DC, the BEV vehicles identified below, until inspected by Dana personnel.

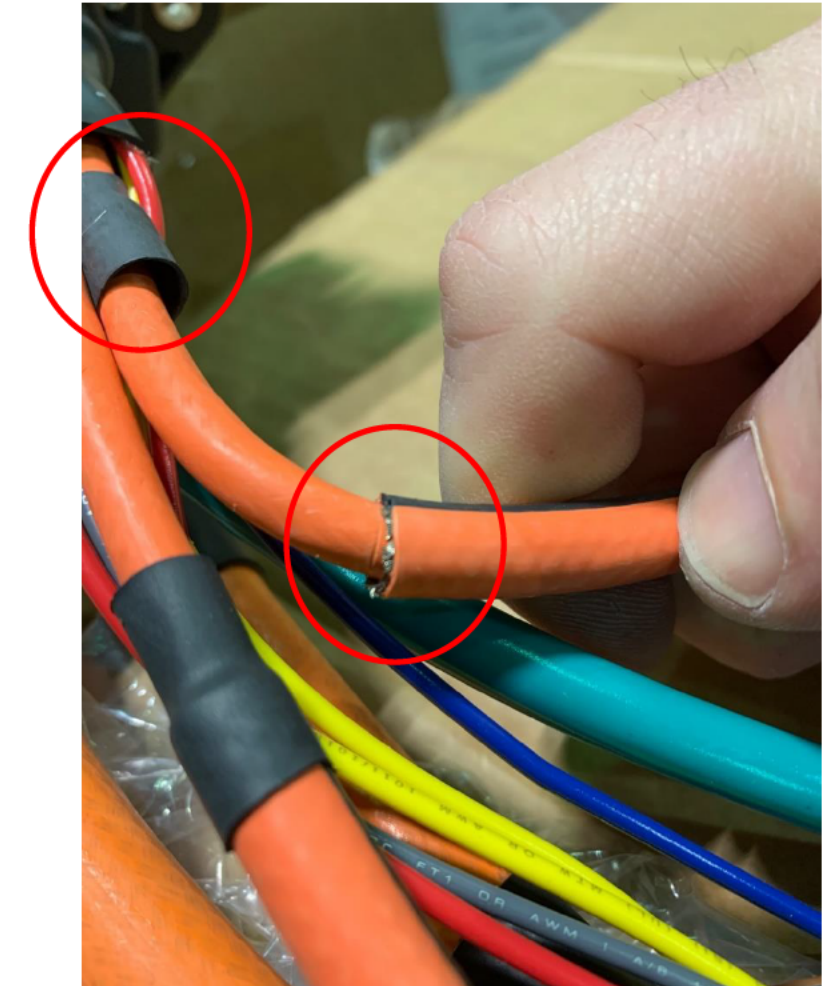
Cut inner jacket without exposed conductor

Shrink tubing not adhering to cable

Fig 4 – Inner Jacket cut, conductor not exposed
