SERVICE BULLETIN

APPLICABILITY: 2015-20MY Legacy and Outback
 2012-19MY Impreza
 2013-19MY Crosstrek
 2013-19MY Forester
 2015-20MY WRX and STI
 2019-20MY Ascent

NUMBER: 12-203-16R
DATE: 07/14/16
REVISED: 01/12/21

SUBJECT: Squeaking Sound from Front Seat Buckle

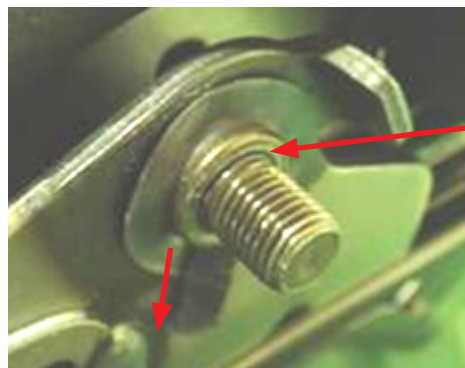
**Shouldered
Portion**

- Install the new spring wave washer onto the groove in the shouldered portion of the mounting bolt as shown below. The felt portion should be at about the 6:00 position (pointing down).

- **IMPORTANT: CAREFULLY** reinstall the seat belt buckle assembly onto the shouldered portion against the wave washer and hold it firmly in place while tightening the retaining nut.
- Torque the retaining nut to 38 Nm (28 ft. lbs.) and confirm the seat belt buckle assembly moves freely. If the buckle assembly feels like it is binding, make sure the spring wave washer and / or buckle assembly did not come off the shouldered portion of the mounting bolt while the retaining nut was being tightened. If the spring wave washer came off, it most likely was pinched and damaged, requiring replacement. **DO NOT** try to straighten / reuse it.
