Complaint - Oil Leak on Intake Side of Right Turbocharger: Replace Intake Pipe (210/20)

Vehicle Type: **911 Carrera (992) / 911 Carrera S (992) / 911 Carrera 4 (992) / 911 Carrera 4 S (992) / 911 Targa 4 (992) / 911 Targa 4S (992)**

Model Year: **As of 2020 up to 2021**

Concerns: **Intake pipe on turbocharger, right**

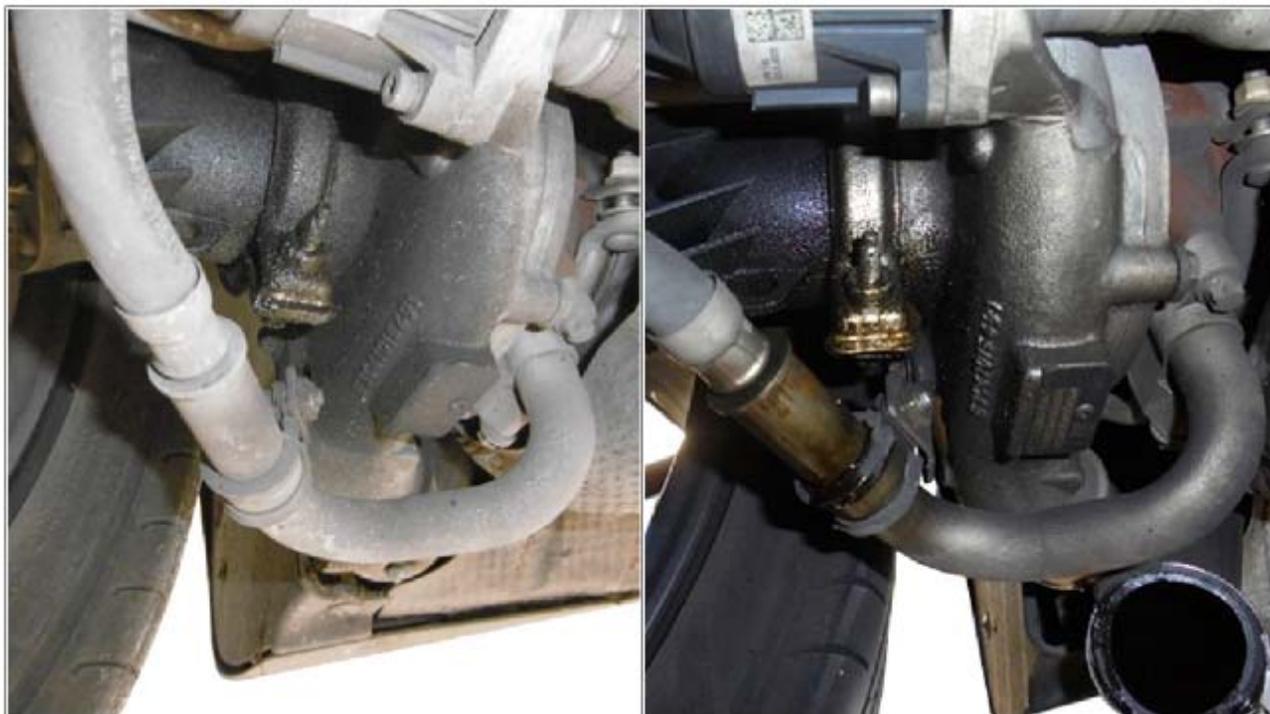
Information: The right turbocharger shows a leak on the intake side and there are traces of oil visible on the turbocharger and intake pipe housing.

Oil leak on right turbocharger

Action required: In the event of a customer complaint do **not** replace the turbocharger, but rather the intake pipe. Replacing the turbocharger or oil separator will not correct this problem.

Work Procedure: 1 Replace intake pipe, see ⇒ *Workshop Manual '212419 Removing and installing intake manifold'*
