SERVICE PROGRAM BULLETIN

APPLICABILITY: 2019MY Impreza **NUMBER:** WRF-20
SUBJECT: Air Conditioning Refrigerant Pipe Replacement **DATE:** 01/18/21

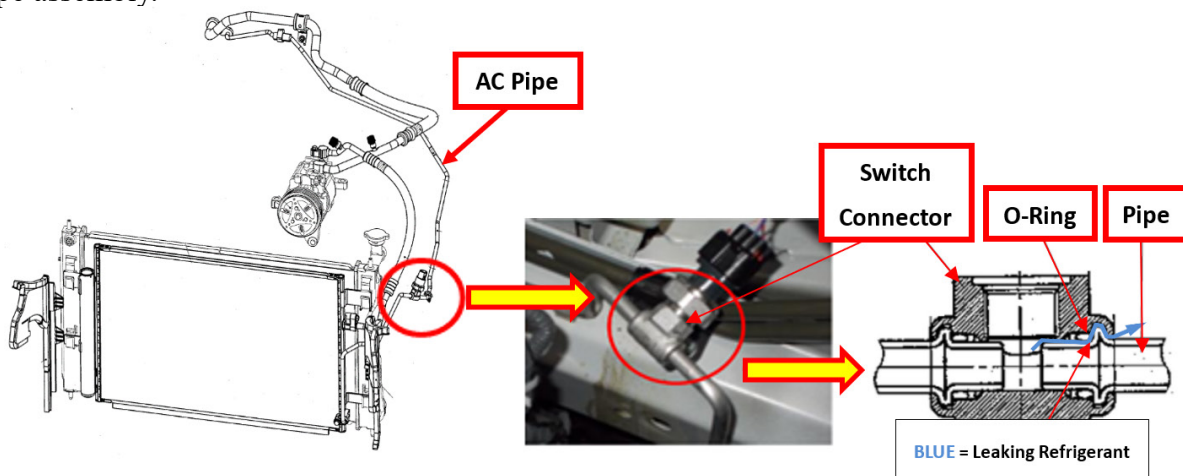
The sealing capability of the pressure switch connector on the metal high-pressure refrigerant pipe may have been compromised during manufacture resulting in a refrigerant leak and unsatisfactory cooling performance of the A/C system. The switch connector is a component of the high-pressure pipe assembly as shown in the illustrations below. This service program involves replacement of the pipe assembly.

The service procedures for replacing the A/C pressure pipe remain unchanged. Always refer to the applicable Service Manual and review the full requirements of the repair being performed. The Service Manual procedures contain information critical to performing an effective repair the first time, every time. This includes but is not limited to important SAFETY precautions, proper inspection criteria, necessary special tools, required processes and related one-time-use parts (e.g. the a/c system o-rings) needed for a complete and lasting repair.
