## TECHNICAL SERVICE BULLETIN Illuminated ABS Warning Indicator With DTC C0020 - Built On Or Before 29-Feb-2020

**20-2364**

11 January  
2021

<b>Ford</b> 2020 Explorer
2020 Police Interceptor Utility
<b>Lincoln</b> 2020 Aviator

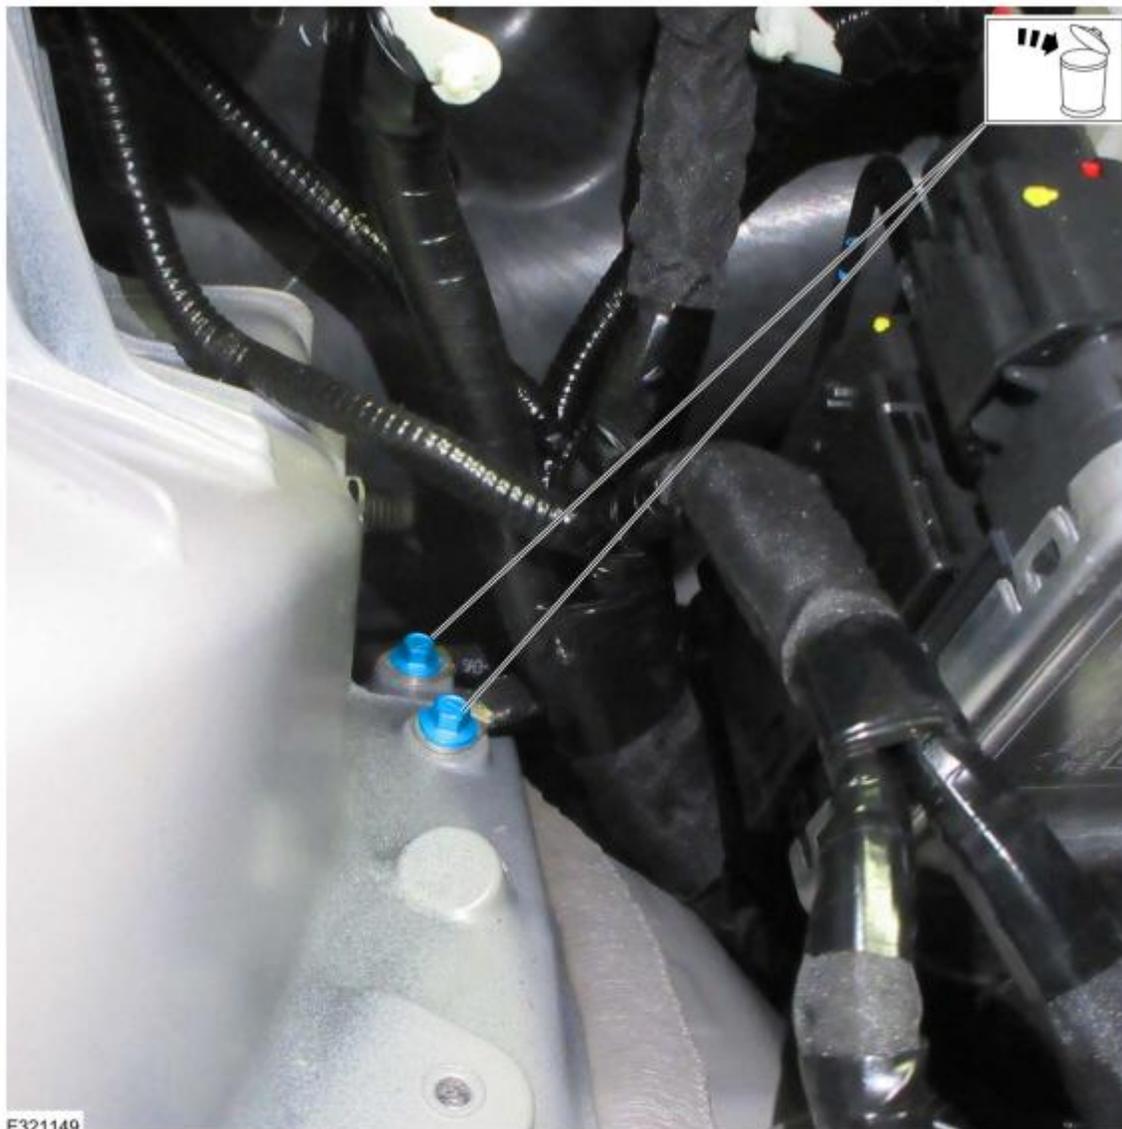
**Issue:** Some 2020 Explorer/Aviator/Police Interceptor Utility vehicles built on or before 29-Feb-2020 may exhibit an illuminated anti-lock brake system (ABS) warning indicator lamp with diagnostic trouble code (DTC) C0020 stored in the ABS module. It may not be necessary to replace the ABS module/hydraulic control unit (HCU) to resolve DTC C0020. This may be due to a poor ground connection and/or improper plating on the attachment bolts at G108. To correct the condition, follow the Service Procedure to replace and properly tighten the ground cable fasteners.

3. Remove and discard the fasteners for ground G108. Refer to Wiring Diagram, Cell 10-4. (Figure 2)

4. Make sure no shrink tube adhesive is interfering with the fastener clamping force or ground path through the fastener. Clean as necessary with a razor blade.

**NOTE: Do not remove any paint from the body as the ground path conduction is through the bolt threads.**

5. Tighten the new fasteners securing the ground cables to 12 Nm (106 lb-in).
6. Apply Motorcraft® Electrical Grease to the fastener and ground cable eyelet.
7. To install, reverse the removal procedure.
8. Clear DTCs from the ABS module.
