WLN5 - Reworking Screws on Front Side Member (Workshop Campaign)

Model Line: **718 (982)**

Model Year: **2021**

Concerns: **Screws on front side member**

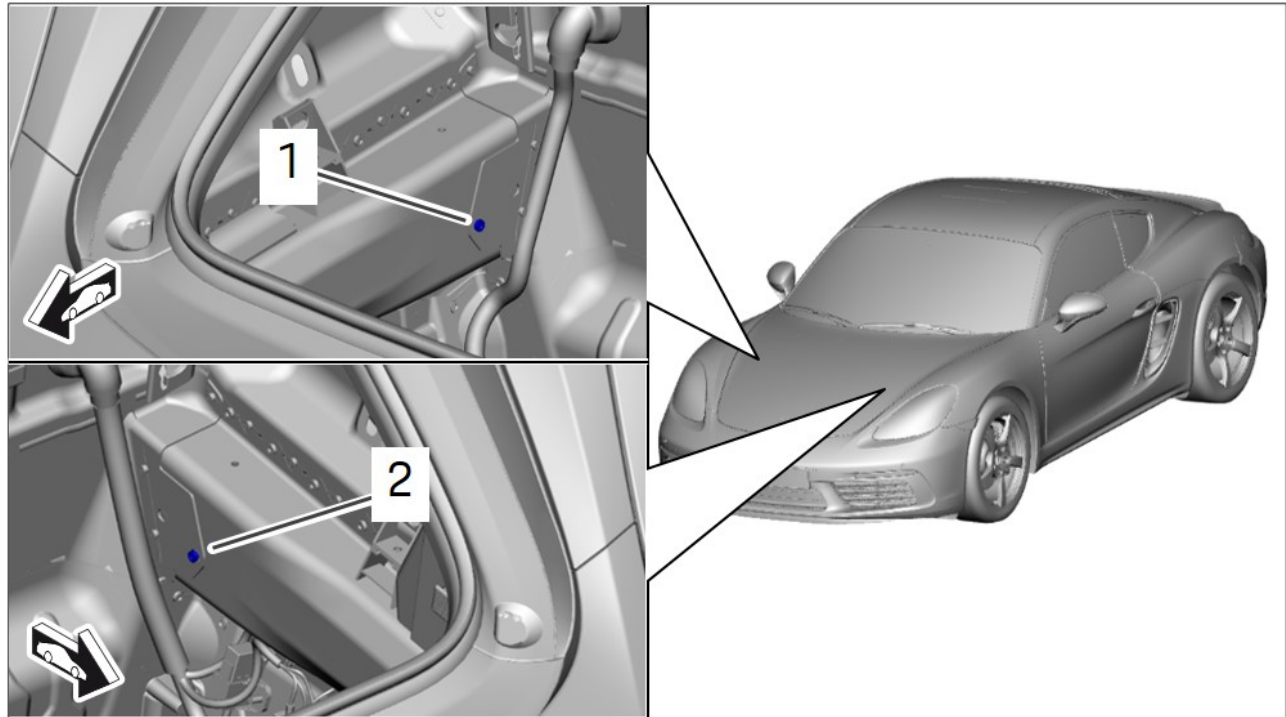
Installation position of screws on front side member

Information: **There is a possibility that a screw on the front side member was not tightened to the prescribed tightening torque on the affected vehicles.**

As a result, the screw can become loose while driving, resulting in noises from around the body front section.

- 1 – Screw on front side member, right (**tighten**)
 2 – Screw on front side member, left (**tighten**)

Action Required: Tighten fastening screws on the side member to the prescribed tightening torque.
