## Mack Anthem - Hood Latch Striker Rattle

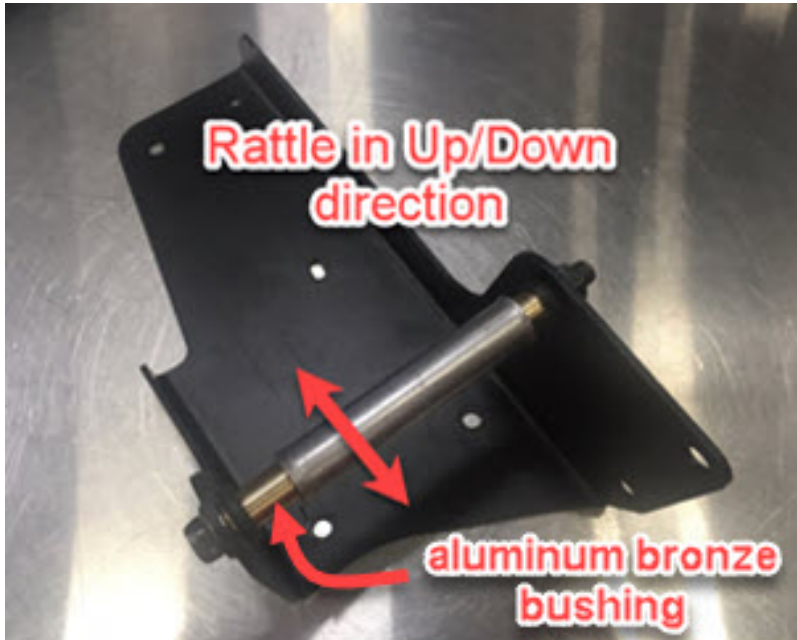
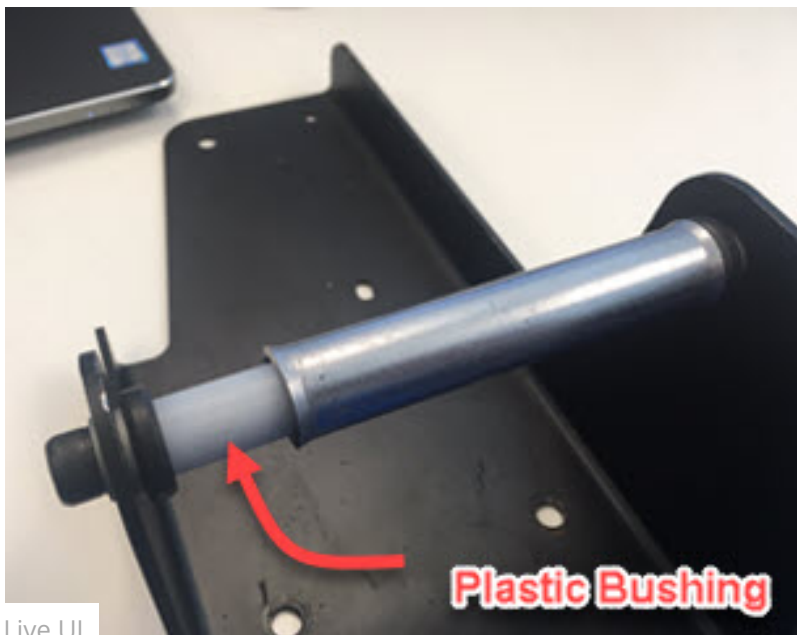
For Mack Anthem units with the hood striker rattle complaint, an updated hood latch striker design has been developed. The new design features a plastic bushing rather than the aluminum bronze bushing. To correct this issue replace both striker pins using kit P/N **23799066**. Latch assemblies manufactured after November 16th, 2020 will contain the updated striker pin.
