Diagnostic Trouble Codes (DTC) P0016-76 - Crankshaft Position - Camshaft Position Correlation - Turbo Compound (TC) - Model Year 2018 and Newer

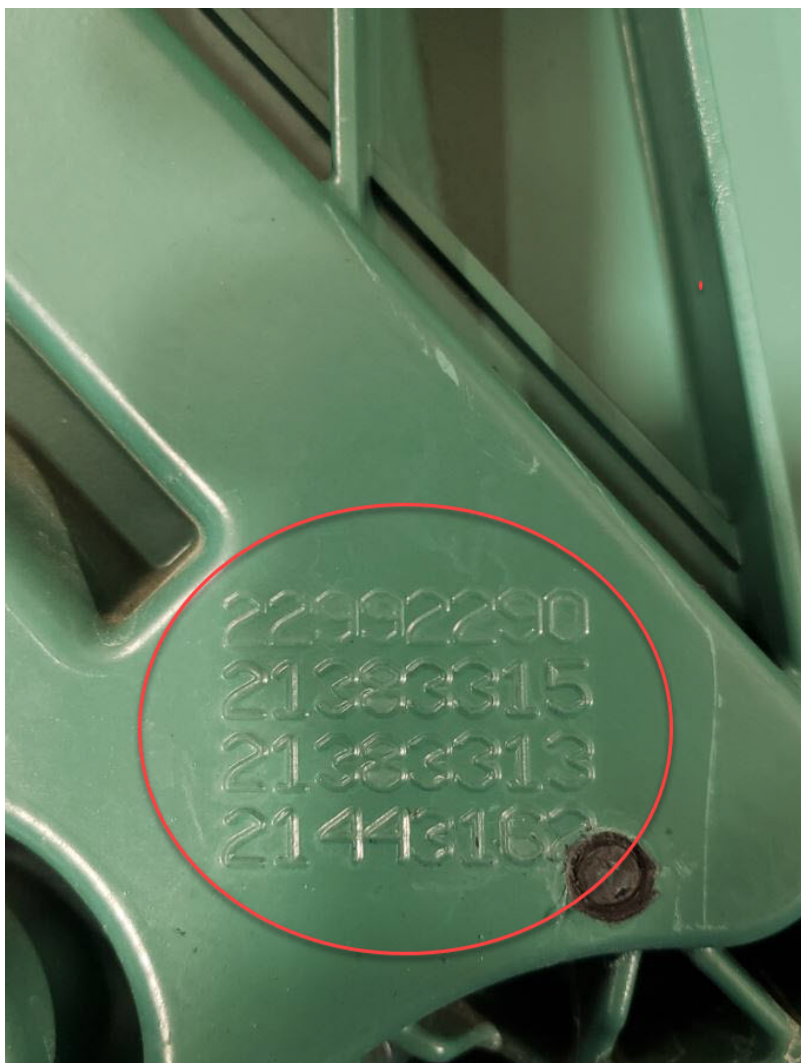
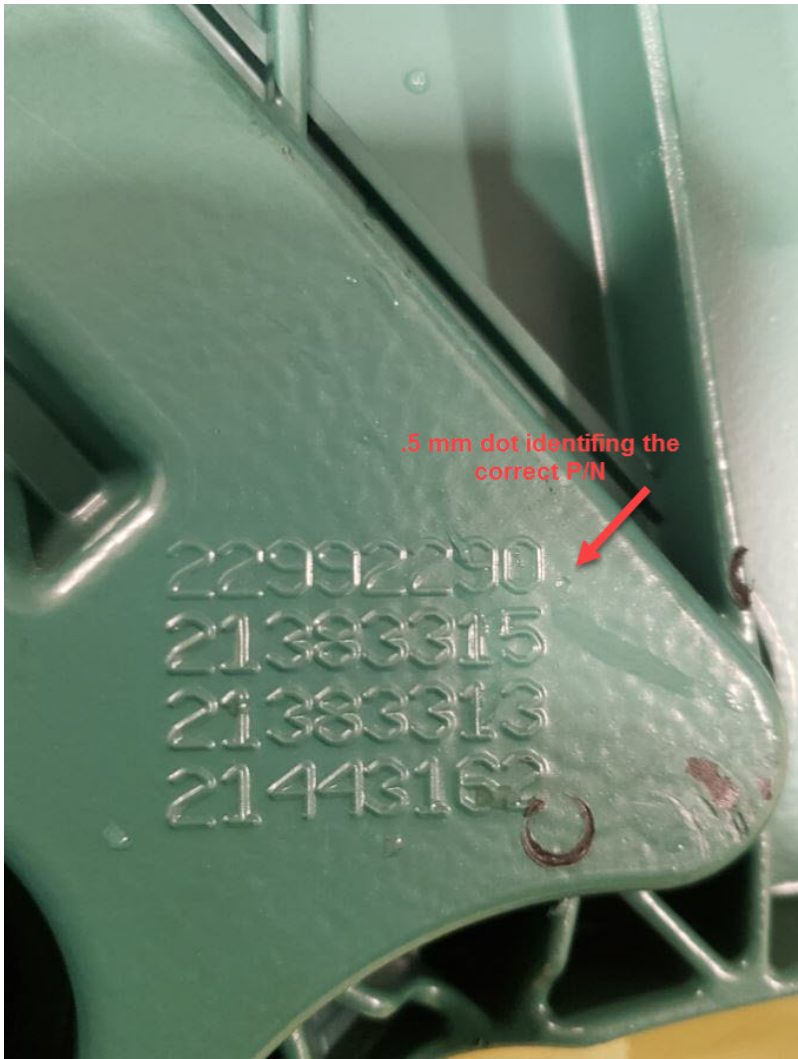
Each cover is stamped with the same 4 P/N's. The appropriate number of the four will be marked with a .5 mm dot beside the correct number.

If fault code P0016-76, Crankshaft Position - Camshaft Position Correlation, is active on a TC chassis please confirm the rear upper timing cover installed is the correct P/N for your particular engine.

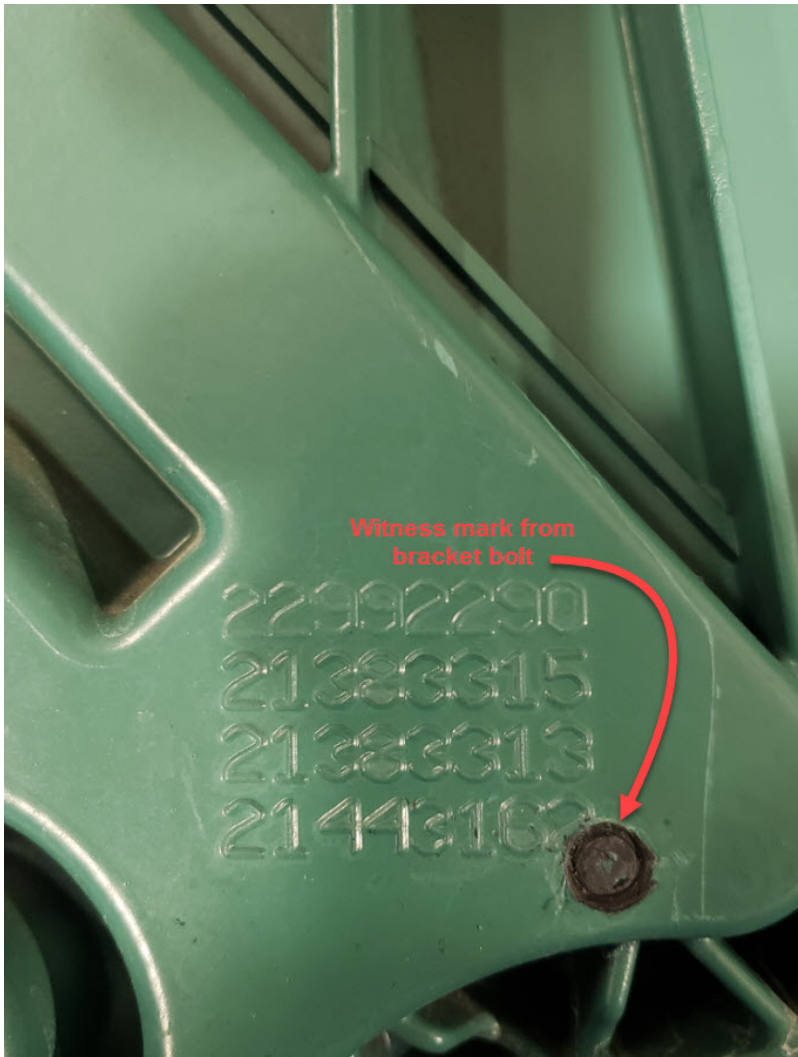
Looking for this dot can be difficult on the lower number due to a witness mark from a bracket bolt that runs into the cover when installed in frame.

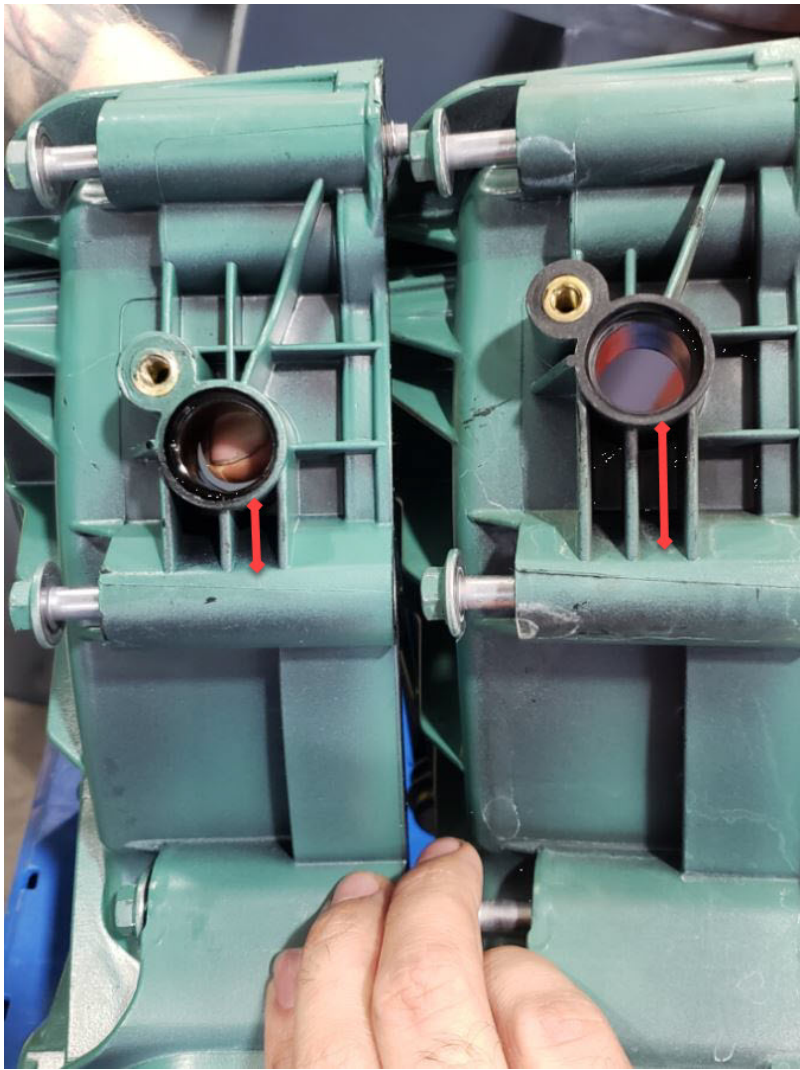
When the 2 covers are compared you can clearly see a difference in Cam sensor mounting holes.

NOTE: In this instance IMPACT calls out a 22121029 rear upper timing cover which, according to the drawing, references to 21443162 as indicated on the cover. On the cover from the original engine the “dot” is hidden by the bolt witness mark. When the 2 covers are compared you can clearly see a difference in Cam sensor mounting holes. The incorrect cover came with a dot beside reference # 22992290.
