# INSTRUCTION TO SERVICE

ITS59132		01/06/2021
<b>SECTION:</b>	580 - Wheelchair Lift	
<b>WRITTEN BY:</b>	Devin Draward	
<b>SUBJECT:</b>	FR2E/BR2E SWITCH ASSY. CAM SERVICE BULLETIN	
<b>ISSUE:</b>	Field reports have indicated that the switch cams need re-adjustment/tightening after a few cycles of the ramp.	
<b>SUMMARY:</b>	Perform a proactive check of switch assembly cams for proper torque.

**Subject:** SWITCH ASSY. CAM  
**Applicable Products:** FR2E/BR2E  
**Effectivity:** 12/08/20

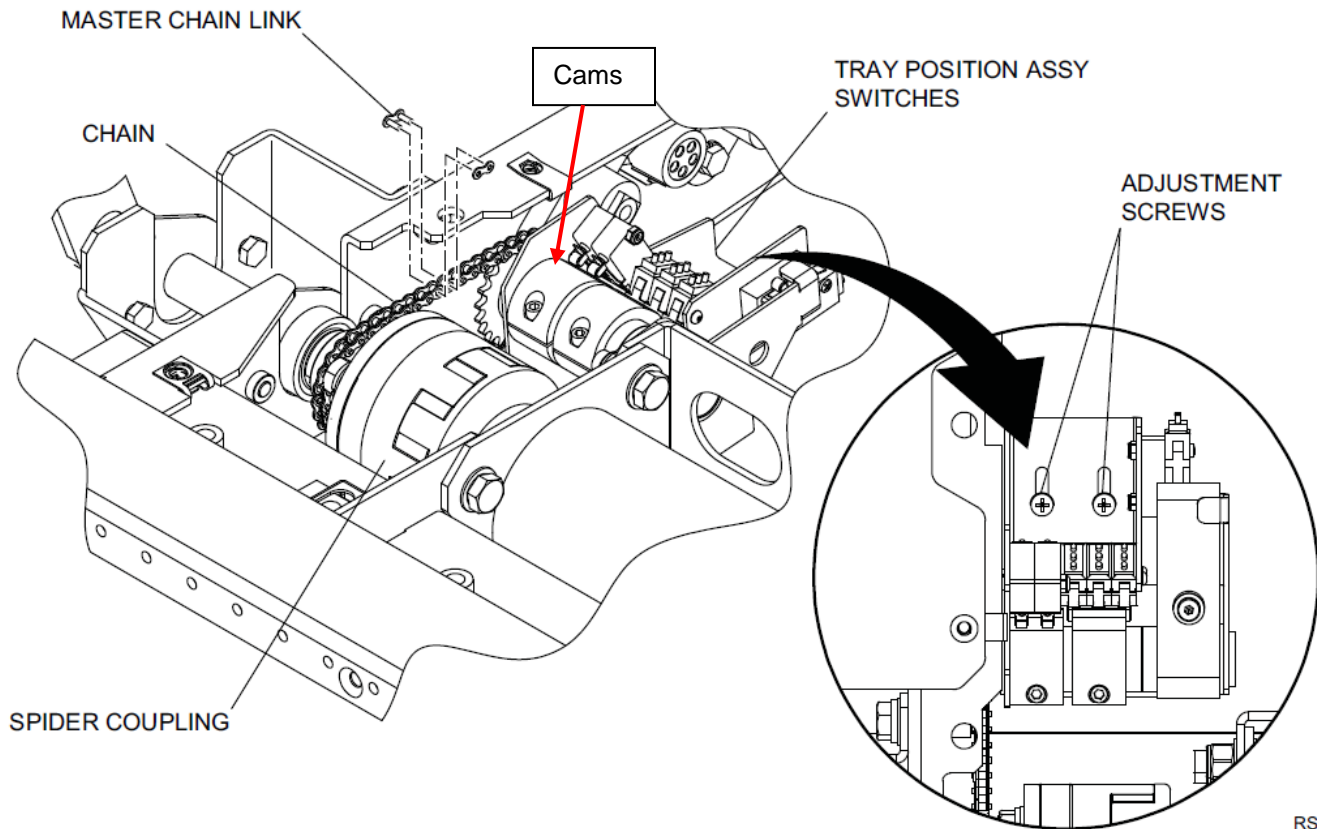
RSM0068500

Field reports have indicated that the switch cams need re-adjustment/tightening after a few cycles of the ramp. Inproper torque of the screw holding the cam in place may allow the screw to loosen over time.

1. Manually attempt to turn the position switch cams by hand.

2. If the cam is tight and cannot be moved by hand, no adjustment/tightening is needed.
3. If the cam is loose, minimal force will cause it to move from its at rest position and re-adjustment/tightening will be needed.
4. Re-adjust the cam position as necessary, and tighten the cam screw to 4in-lbs.
