# Technical Service Bulletin

## 15 Oil leak from the cylinder head - 2.9 and 3.0TFSI only

15 21 36 2053278/5 January 29, 2021. Supersedes Technical Service Bulletin Group 15 number 20-35 dated October 8, 2020 for reasons listed below.

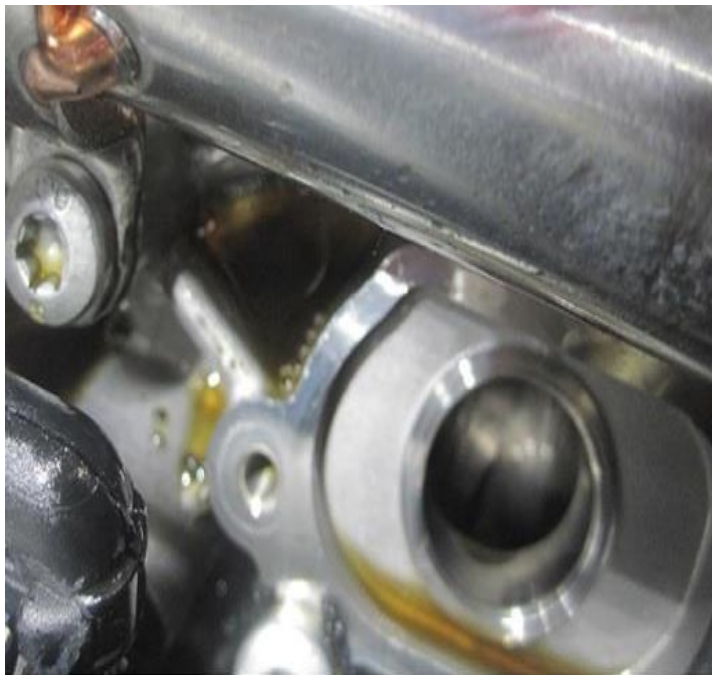
**A.** If there is a substantial quantity of oil below the Audi valvelift system actuator (illustration), the cause of the leak is the O ring of the Audi valvelift system actuator.

**Figure 2.** Oil in the Audi valve lift system.

Replace the Audi valvelift system actuator with an O ring, clean the engine compartment, and if necessary replace the noise insulation (if it is soaked in oil) (Figure 2).

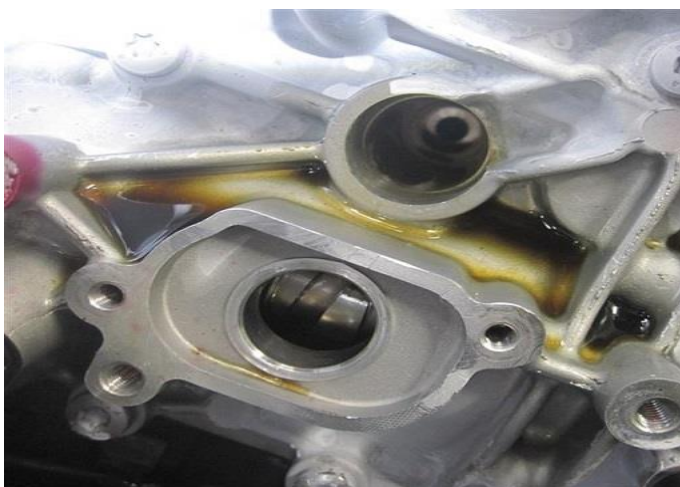
4. Remove the lower noise insulation.
5. Locate the affected cylinder. Oil should have gathered in the area of the injector (Figure 3) and the noise insulation should also be soaked in oil.

**Figure 3.** Locating the affected cylinder.

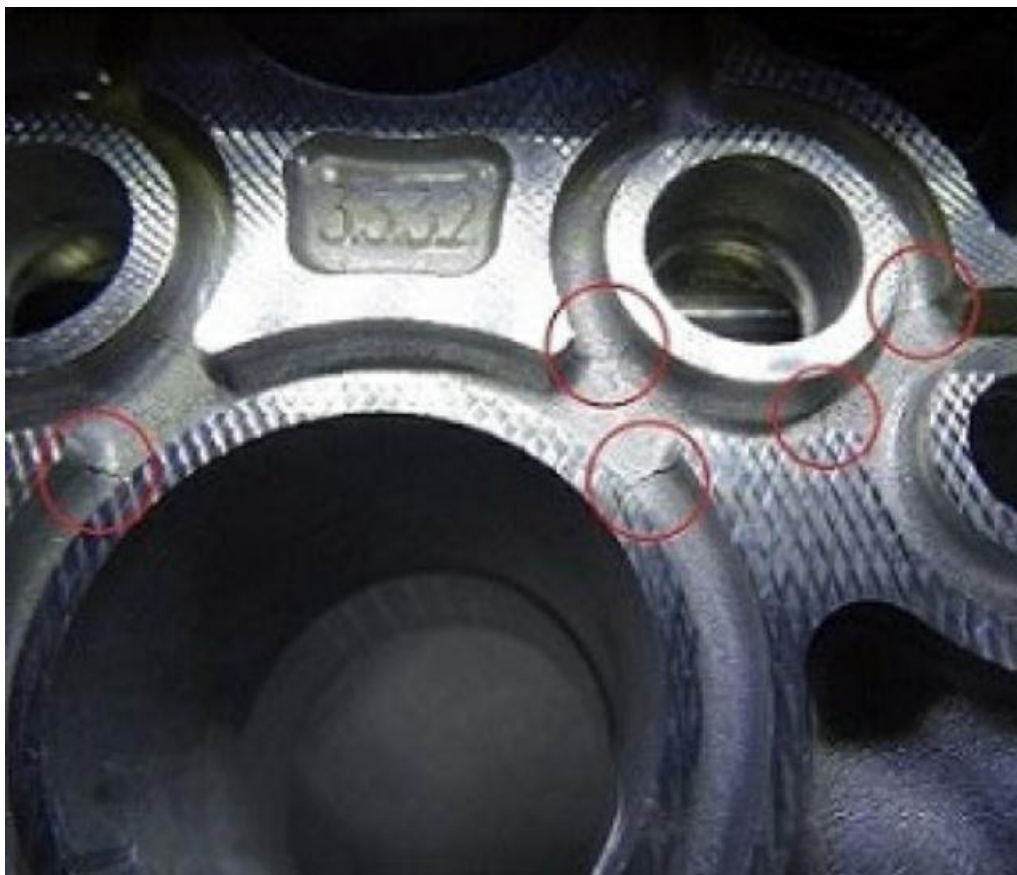
Metal shavings produced during manufacture in sealing groove between cylinder head cover and the cylinder head.

**Figure 5.** Before the repair.

7. Inspect the gasket groove in the cylinder head cover and remove any casting residues with a suitable tool. (Figure 5). The residues can be removed with a small flat screwdriver (Figure 6).

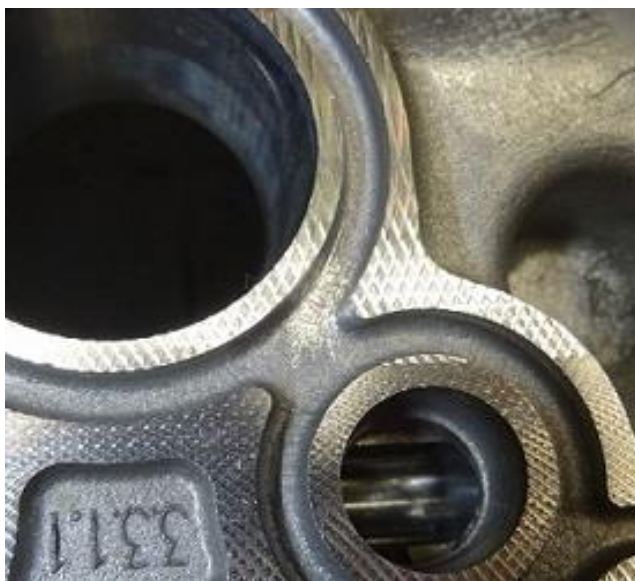
**Figure 6.** After the repair.

8. Install a new seal, re-assemble the camshaft cover, clean the engine compartment, and if necessary replace the noise insulation (if it is full of oil).
