Service Action – USA

Code: 67A9

Subject Radio Will Not Turn OFF

Release Date January 14, 2021

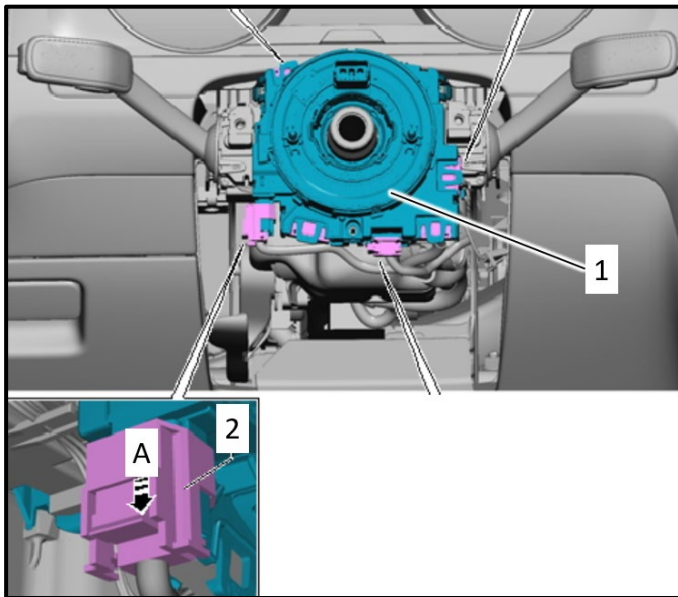
Disconnect connector from -J527- <1>:

- Pull out the connector lock in the direction of <arrow B> and press down.
- Disconnect the connector <2> from -J527- <1>.

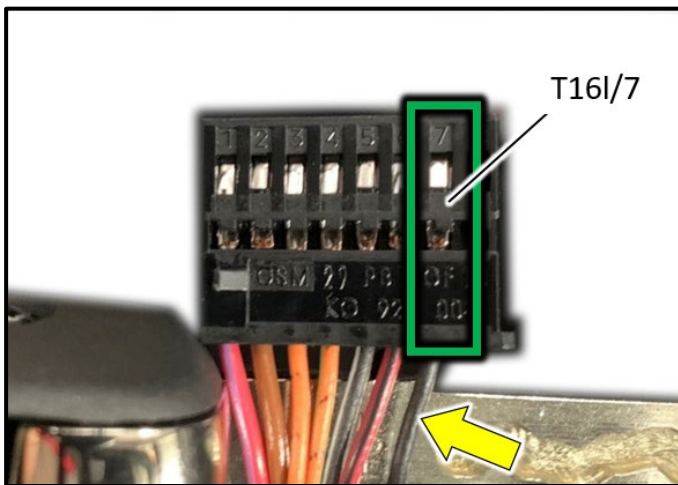
Inspect -J527- connector:

- Check position 7 of the T16I connector.
- If a black wire <arrow> is present in position T16I/7:
 - No further work is required.
 - Reassemble vehicle in the reverse order of removal.
 - Ensure -J527- connector is secured and locked.
 - Torque steering column trim screws to 2.5 Nm.
 - Proceed to Section C.
- If the black wire <arrow> is not present in position T16I/7, proceed to the next step.

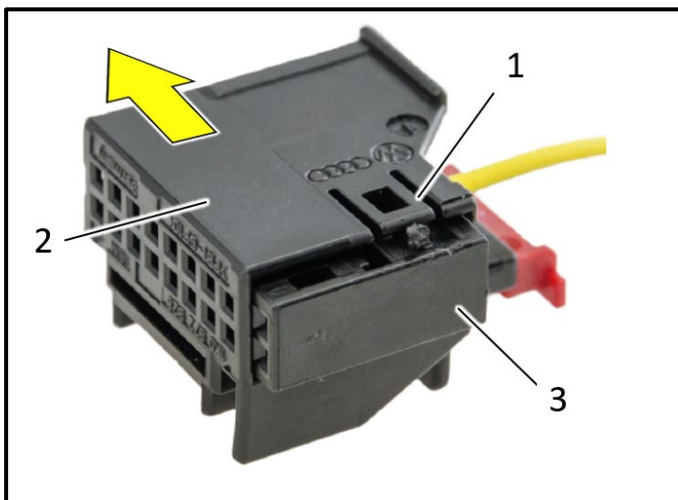
Remove connector cover:

- Release lock <1> with a small pick or screwdriver.
- Slide cover <2> off connector <3> in direction of <arrow>.

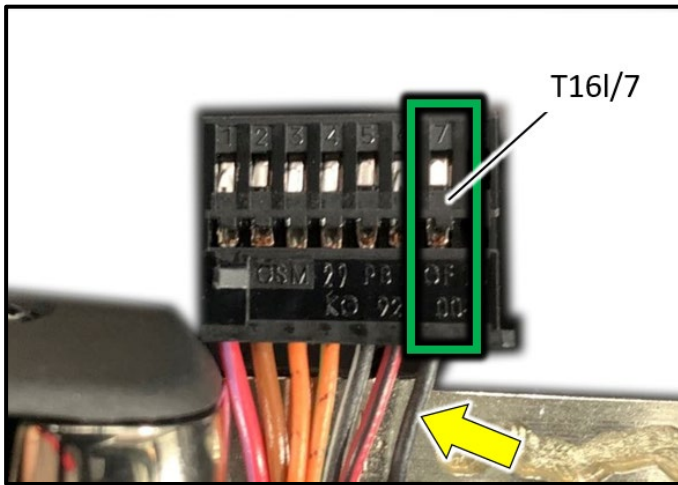
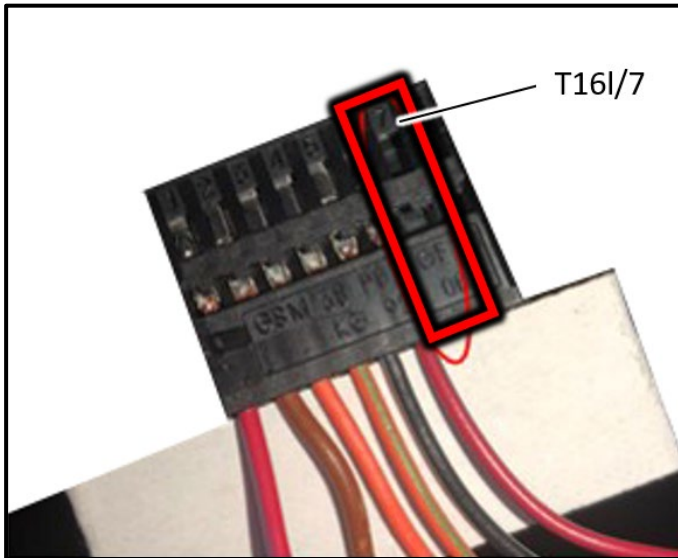
Rework T16l connector:

- If there is no wire present in position T16l/7:
 - The black wire would have been isolated back into the wiring harness and secured with black tape.
 - Locate the black wire in the steering column wiring harness.
 - Once the wire is located and freed up install the wire <arrow> back into the T16l connector.

Reassemble vehicle in the reverse order of removal:

- Install connector cover onto T16l connector.
- Ensure -J527- connector is secured and locked.
- Torque steering column trim screws to 2.5 Nm.
