# Technical Service Bulletin

## 91 Parking assistance provides false warnings

91 21 64 2024323/7 January 25, 2021. Supersedes Technical Service Bulletin Group 91 number 19-88 dated September 12, 2019 for reasons listed below.

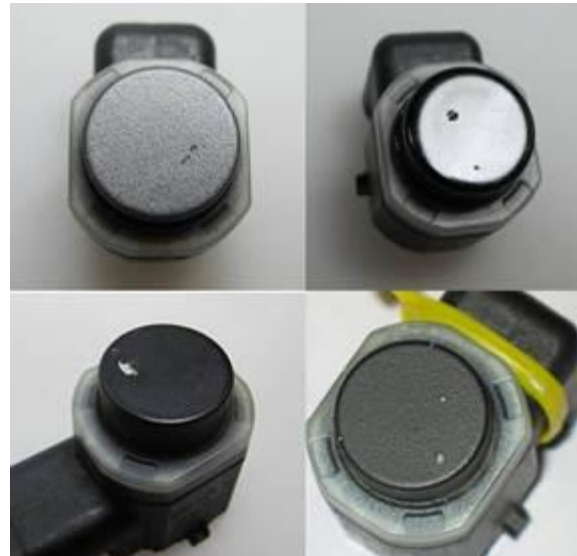
3. Check parking sensors (Figure 3) for obvious issues:

- Mechanical damage (stone chips, scratches).
- Dirt, ice, foreign bodies, and/or foil adhered to the sensor.
- Damage to the bumpers that may indicate an accident (or paint indicating a previous incident).

**Figure 3.** Stone chips causing sensor failure.

**Tip:** Exterior damage to the vehicle, including stone chips and scratches, is not covered by Audi Warranty. When painting sensors, the special painting instructions for parking sensors in the paint repair manual must be observed.

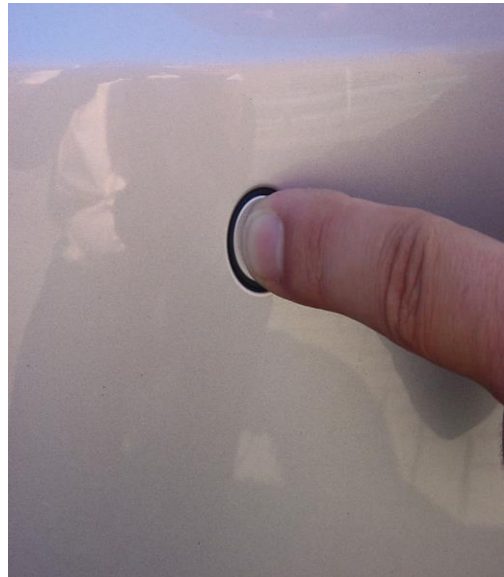
**Figure 4.** A pressure check on a parking aid sensor.

5. For 8 and 12 channel systems, check the installation of the front license plate holder for:
  - Protrusion. The license plate and holder must fit on flat.
  - Bent corners. Any bent-open corners may cause false readings.
  - Correct fit. Oversized license plate holders or frames can obstruct parking aid sensors.
6. Pressure check for a tight fit and correct attachment of the parking sensors (Figure 4). If the sensor is not snug or feels loose, remove the bumper and reinstall the sensor.

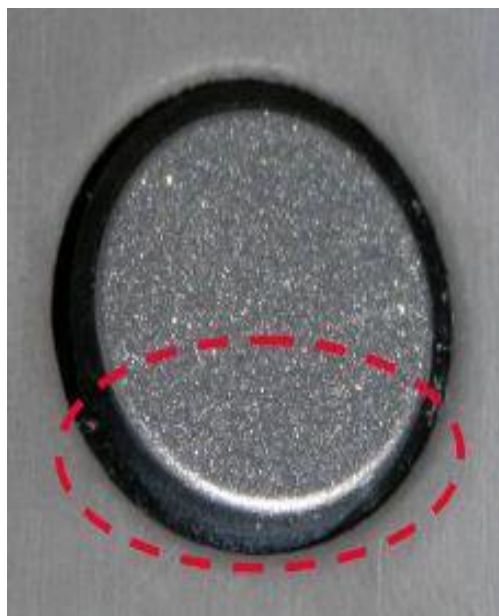
**Figure 6.** An incorrectly seated decoupling ring (bulging).

7. Check that the decoupling ring is correctly seated (Figures 5 - 7). If the ring is folded or bulging, remove the bumper and reinstall the sensor.

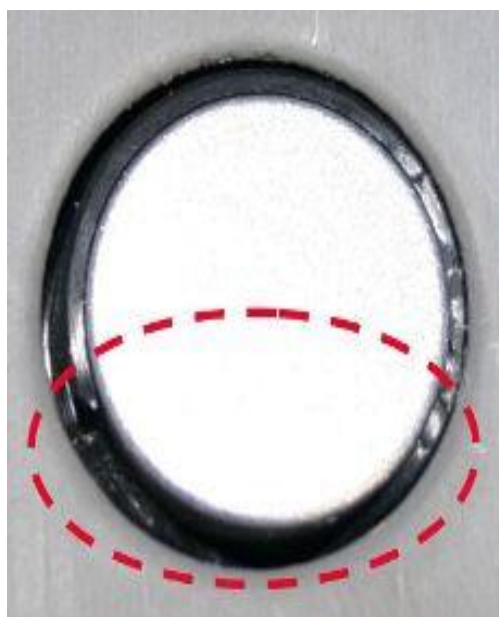
**Figure 7.** An incorrectly seated decoupling ring (folded).

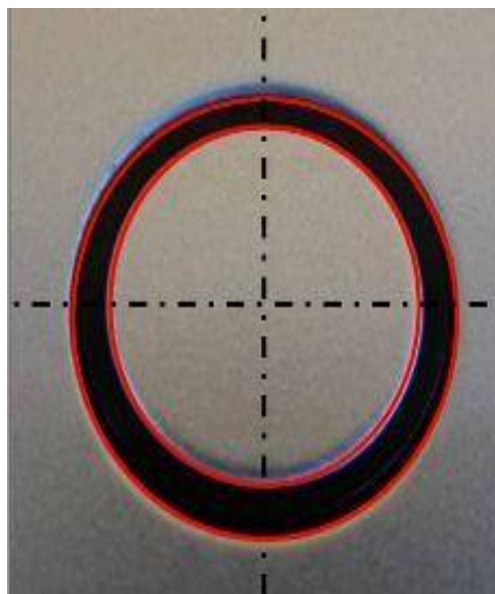
**Figure 9.** An off-center parking aid sensor.

8. Verify that the sensor is centered inside of the mounting hole (Figures 8 - 9). If the sensor is mounted off-center, remove the bumper and reinstall the sensor.

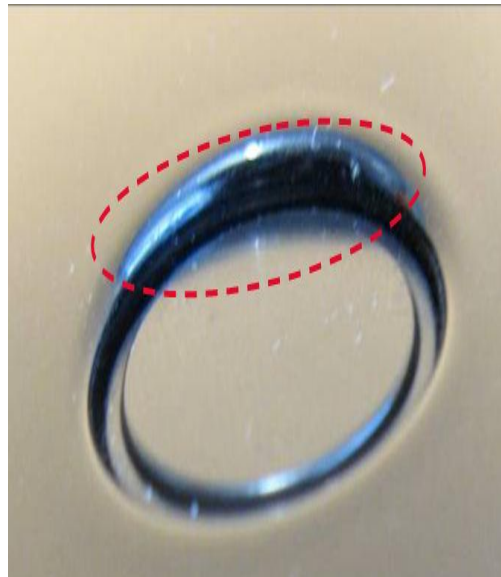
**Figure 11.** A recessed parking aid sensor.

9. Ensure the sensor sits flush with the bumper (Figures 10 - 11). If the sensor is recessed or bulging, remove the bumper and reinstall the sensor.

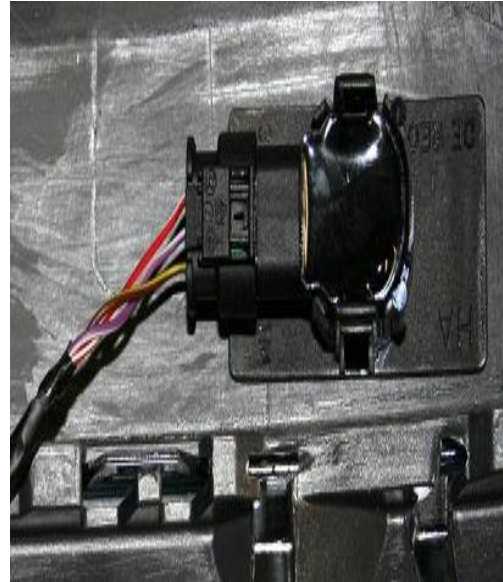
12. Check the cables in the bumper for damage and sufficient length (Figures 12 - 13). Cables that are too short can cause damage to the harness.
- If the cable is damaged, repair the cable using VAS Repair Kit 1978.
  - If the cable is too tight, correct the routing by moving the support clip so the cable is no longer under tension.

**Figure 13.** A sensor cable with insufficient length.

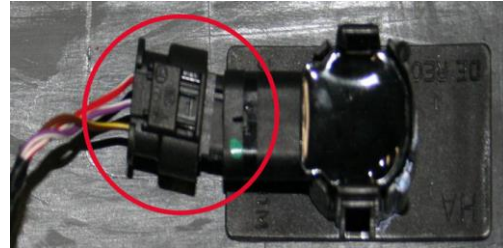
**Figure 15.** A parking aid sensor connector that is not seated correctly.

13. Check the connectors on the parking sensors and the socket box for correct installation (Figures 14 - 15). If the connectors are not installed properly, reinstall.
