60-19-04 - Sunroof Water Leak - Reduced Adhesion Causing Loose Seal (U.S. Only)

Release date: 1/28/2021

Applicable Vehicles					
Model(s)	Year	Eng. Code	Trans. Code	VIN Range From	VIN Range To
Tiguan LWB	2018-2020	All	All	AX_JM000001	AX_LM079699

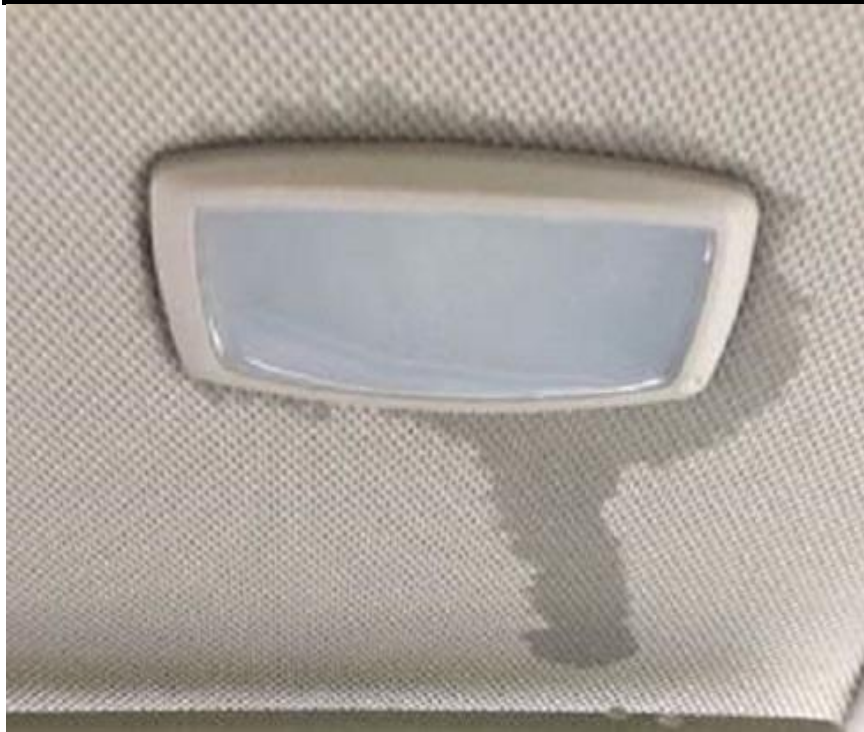
Front headliner area is wet around the vanity light(s), sunroof, and overhead console area due to water entering via the sunroof.

Figure 1: Example of water leak coming from the front vanity light.

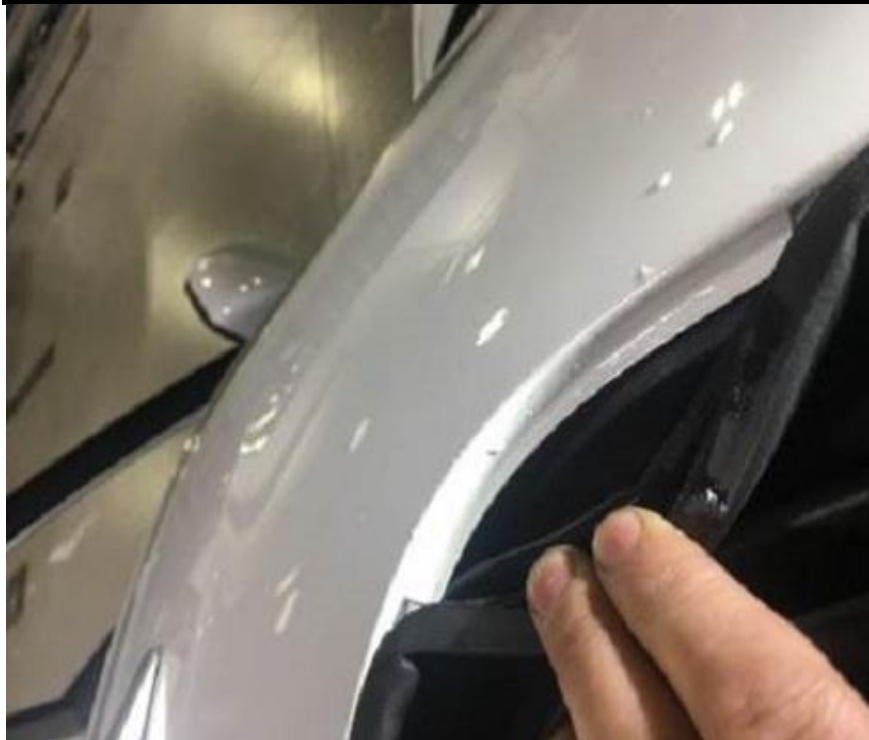
Water leak is due to poor adhesion of the sunroof body side seal to the body.

Figure 2: Example of the sunroof body side seal not having proper adhesion to the body.

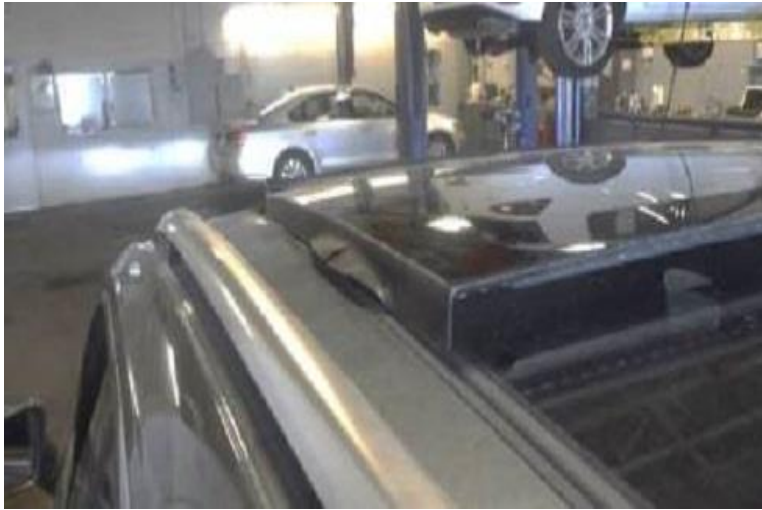
- Visually ensure sunroof panel molded seal and body side seal have no deformation.

Figure 3: Example of the sunroof panel molded seal warped/deformation.

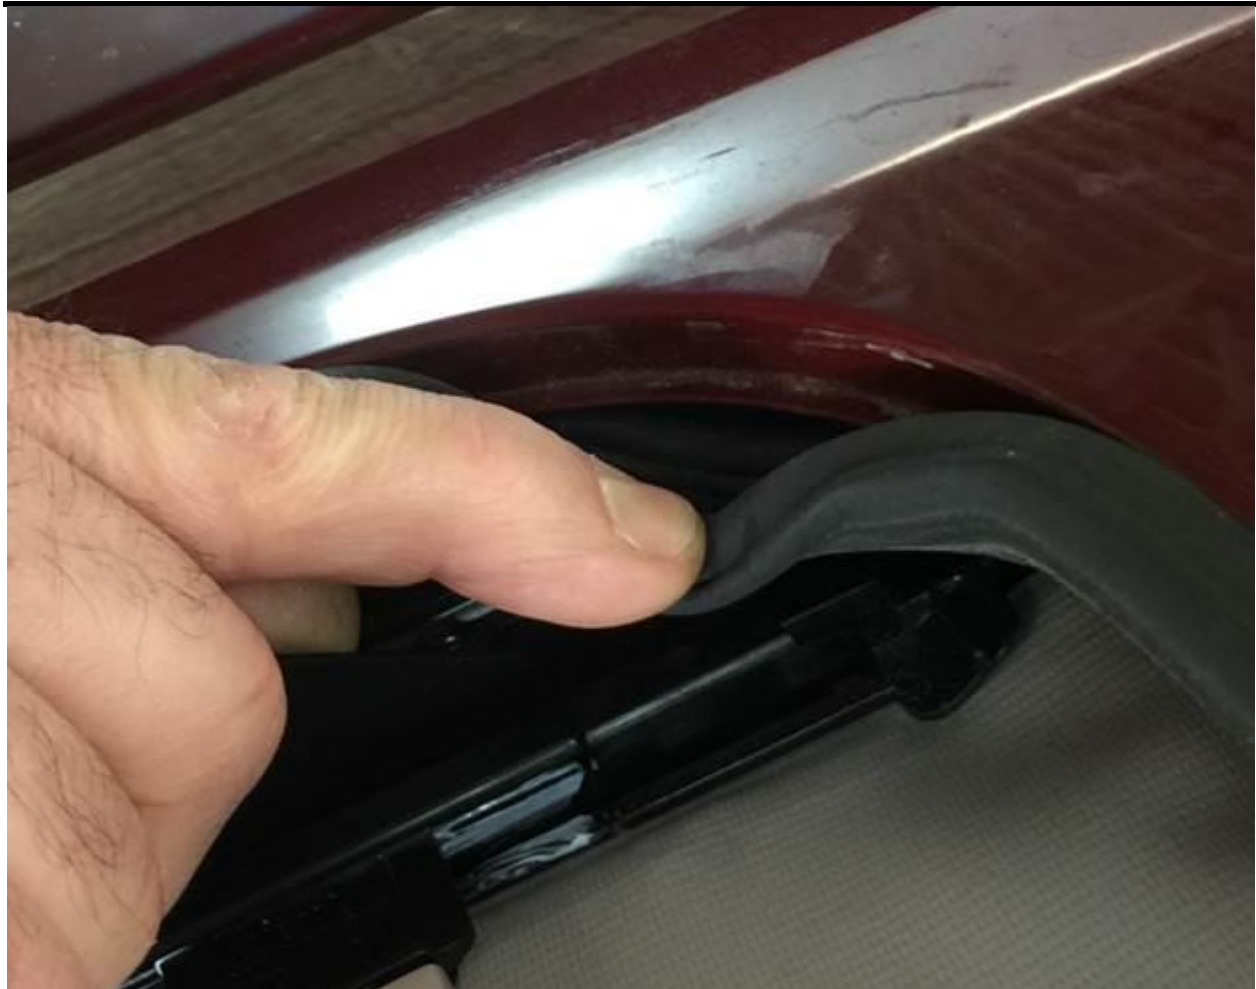
Figure 4: Example of a adhesion issue photo for uploading into WISE.

Take photos of the seal and body sections that were not adhered to the body and upload to WISE for a valid warranty claim.
