Service Action

Code: 40Q9

Subject	Suspension Strut Mounting Bolt (Passenger Side)																			
Release Date	January 28, 2021																			
Affected Vehicles

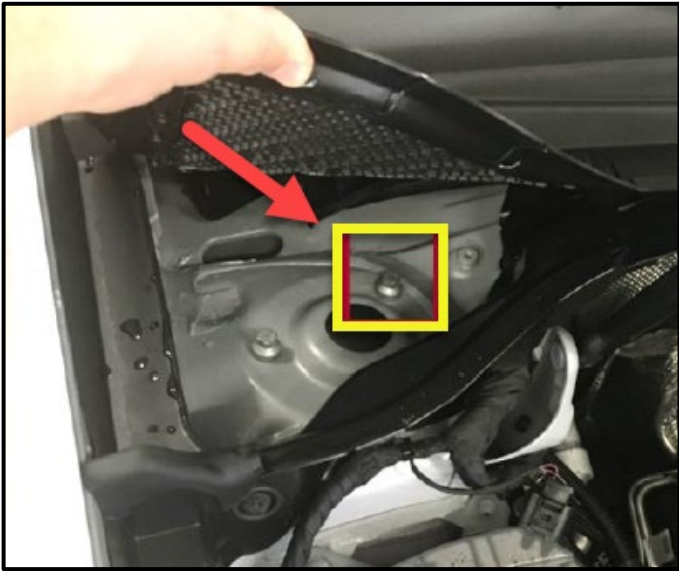
- Inspect strut mounting bolt on passenger side.
 - Replace bolt and rework PVC sealant, if necessary.

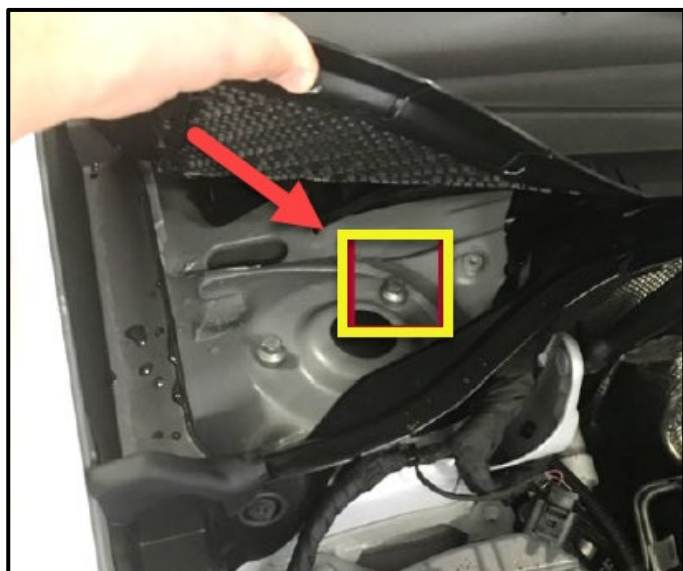
- Pull back plenum cover hood seal on the passenger side of the engine compartment.
- Carefully lift the plenum cover on the passenger side.
- Inspect the bolt highlighted <arrow>.

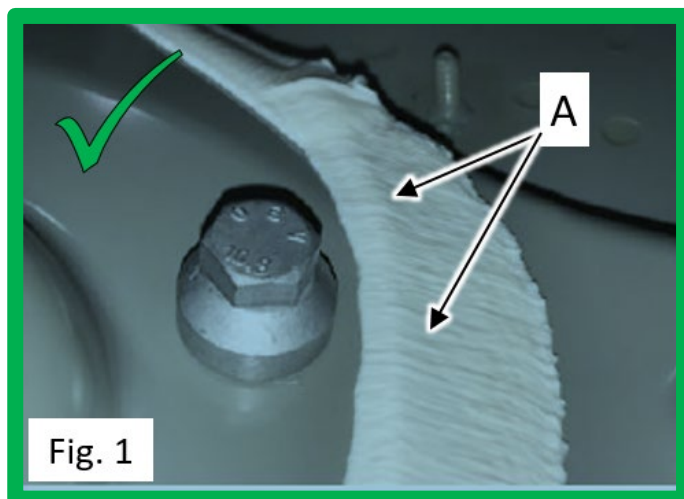
Fig. 1

- Inspect the PVC sealant <arrows> around the bolt.
- If the PVC sealant does not interfere with the bolt <arrows A> (fig. 1):
 - No further work is required.
 - Proceed to Section C.
- If the PVC sealant interferes with the bolt <arrows B> (fig. 2):
 - Remove the bolt.
 - Remove PVC sealant from entire contact area under bolt head so that the contact area for the new bolt is clean.
 - Install a new bolt and torque to 20 Nm + 90°.
