Service Action

Code: 93H6

Charge Level Indicator

January 20, 2021

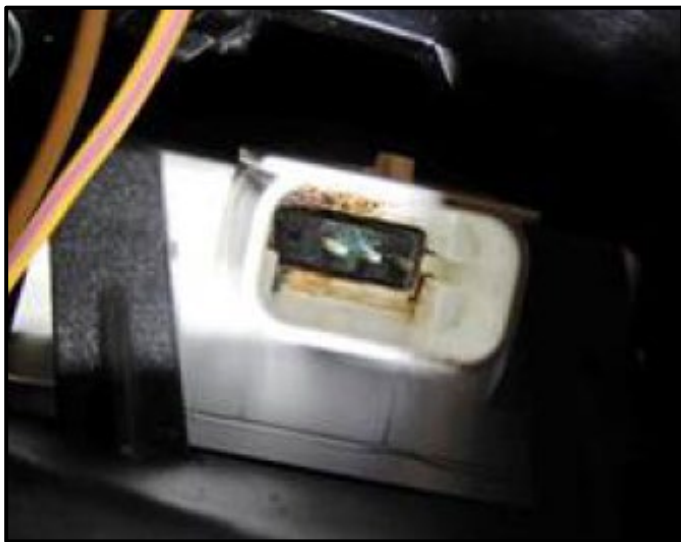
Inspect connector for damage:

- Inspect the connector on the charge door unit <2> and the wiring harness <1> for signs of moisture, corrosion or water intrusion.
- Use an inspection mirror to check connector <2>.
- If no damage is found:
 - The connector must be sealed.
 - Proceed to Section C.
- If there are signs of moisture, corrosion or water intrusion:
 - The charge door unit must be replaced.
 - Proceed to Section D.

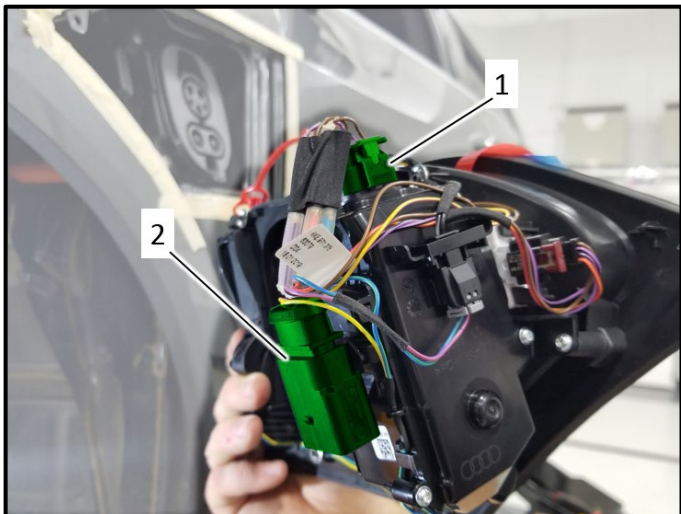
- If the lever <1> is in the incorrect position (pointed outward), the lever will not operate correctly and could break.
