Service Action

Code: 94M9

Subject	Rear Lid Auxiliary Tail Lamp																			
Release Date	January 20, 2021																			
Affected Vehicles

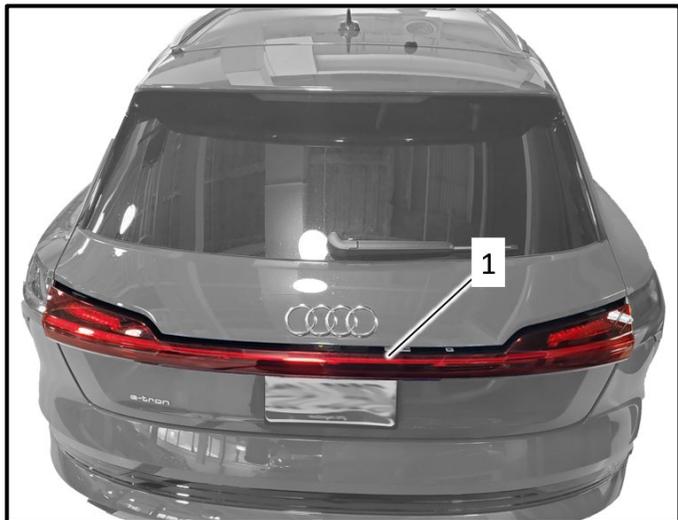
Repair Overview

What is the issue? The rear lid auxiliary tail lamp may flicker due to an internal electronics problem (increased resistance). As a result, the rear lid auxiliary tail lamp may sporadically fail to function. This issue does not affect the function of the other rear lamps on the vehicle.

- Replace rear lid auxiliary tail lamp <1>.
