Service Action

Code: 94M9

Subject	Rear Lid Auxiliary Tail Lamp				
Release Date	January 20, 2021				
Affected Vehicles	Country	Beginning Model Year	Ending Model Year	Vehicle	Vehicle Count
	USA	2019	2021	E-TRON QUATTRO	7,471
	CAN	2019	2021	E-TRON QUATTRO	768
	<p><i>Check Campaigns/Actions screen in Elsa on the day of repair to verify that a VIN qualifies for repair under this action. Elsa is the <u>only</u> valid campaign inquiry & verification source.</i></p> <ul style="list-style-type: none"> ✓ <i>Campaign status must show "open."</i> ✓ <i>If Elsa shows other open action(s), inform your customer so that the work can also be completed at the same time the vehicle is in the workshop for this campaign.</i> 				
Problem Description	The rear lid auxiliary tail lamp may flicker due to an internal electronics problem (increased resistance). As a result, the rear lid auxiliary tail lamp may sporadically fail to function. This issue does not affect the function of the other rear lamps on the vehicle.

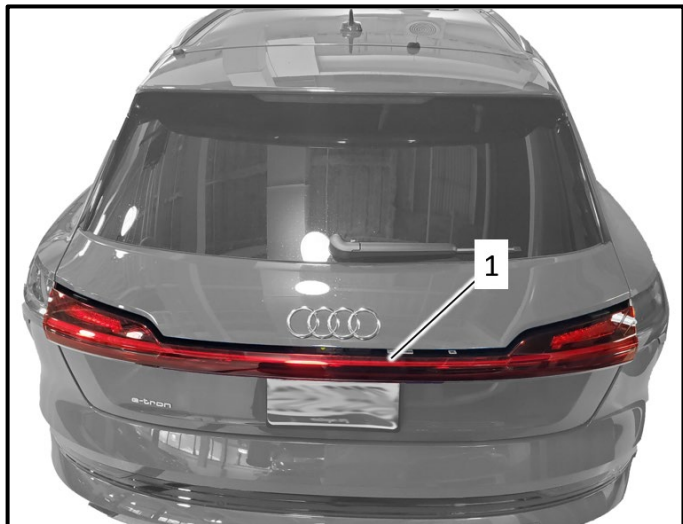
Repair Overview

What is the issue? The rear lid auxiliary tail lamp may flicker due to an internal electronics problem (increased resistance). As a result, the rear lid auxiliary tail lamp may sporadically fail to function. This issue does not affect the function of the other rear lamps on the vehicle.

- Replace rear lid auxiliary tail lamp <1>.
