ABS trailer code 520216 31 P4 New Cascadia Jul 2, 2020 9:36 PM

We have been receiving multiple ABS complaints on newer P4 new Cascadia's for trailer ABS. The re-occurring code that every truck is having is 520216 31, ESC function is reduced (trailer ABS not OK) condition exists. Wabco info is short and sweet, saying faulty ABS functionality. Trucks have ranged from 19k, 41k miles etc and upwards. Operators that pull multiple/different trailers have come in, not specific to a truck with same route/trailer. Two trucks in question, also present with the 629-11 code, are really new P4's too, (19,805 miles) and these two units happen to have a seven way cord that does not ground to the cab back wall. Instead routes under the headache rack, under the left side cab and grounds to a frame stud. Ground load tests from the seven way cord end have always been successful, and no other problems like dirty frame connections. This 520216 does not effect truck ABS but the display does not tell the driver that, they perceive that they have a truck ABS problem instead, often times dropping the current trailer and bringing to the shop.

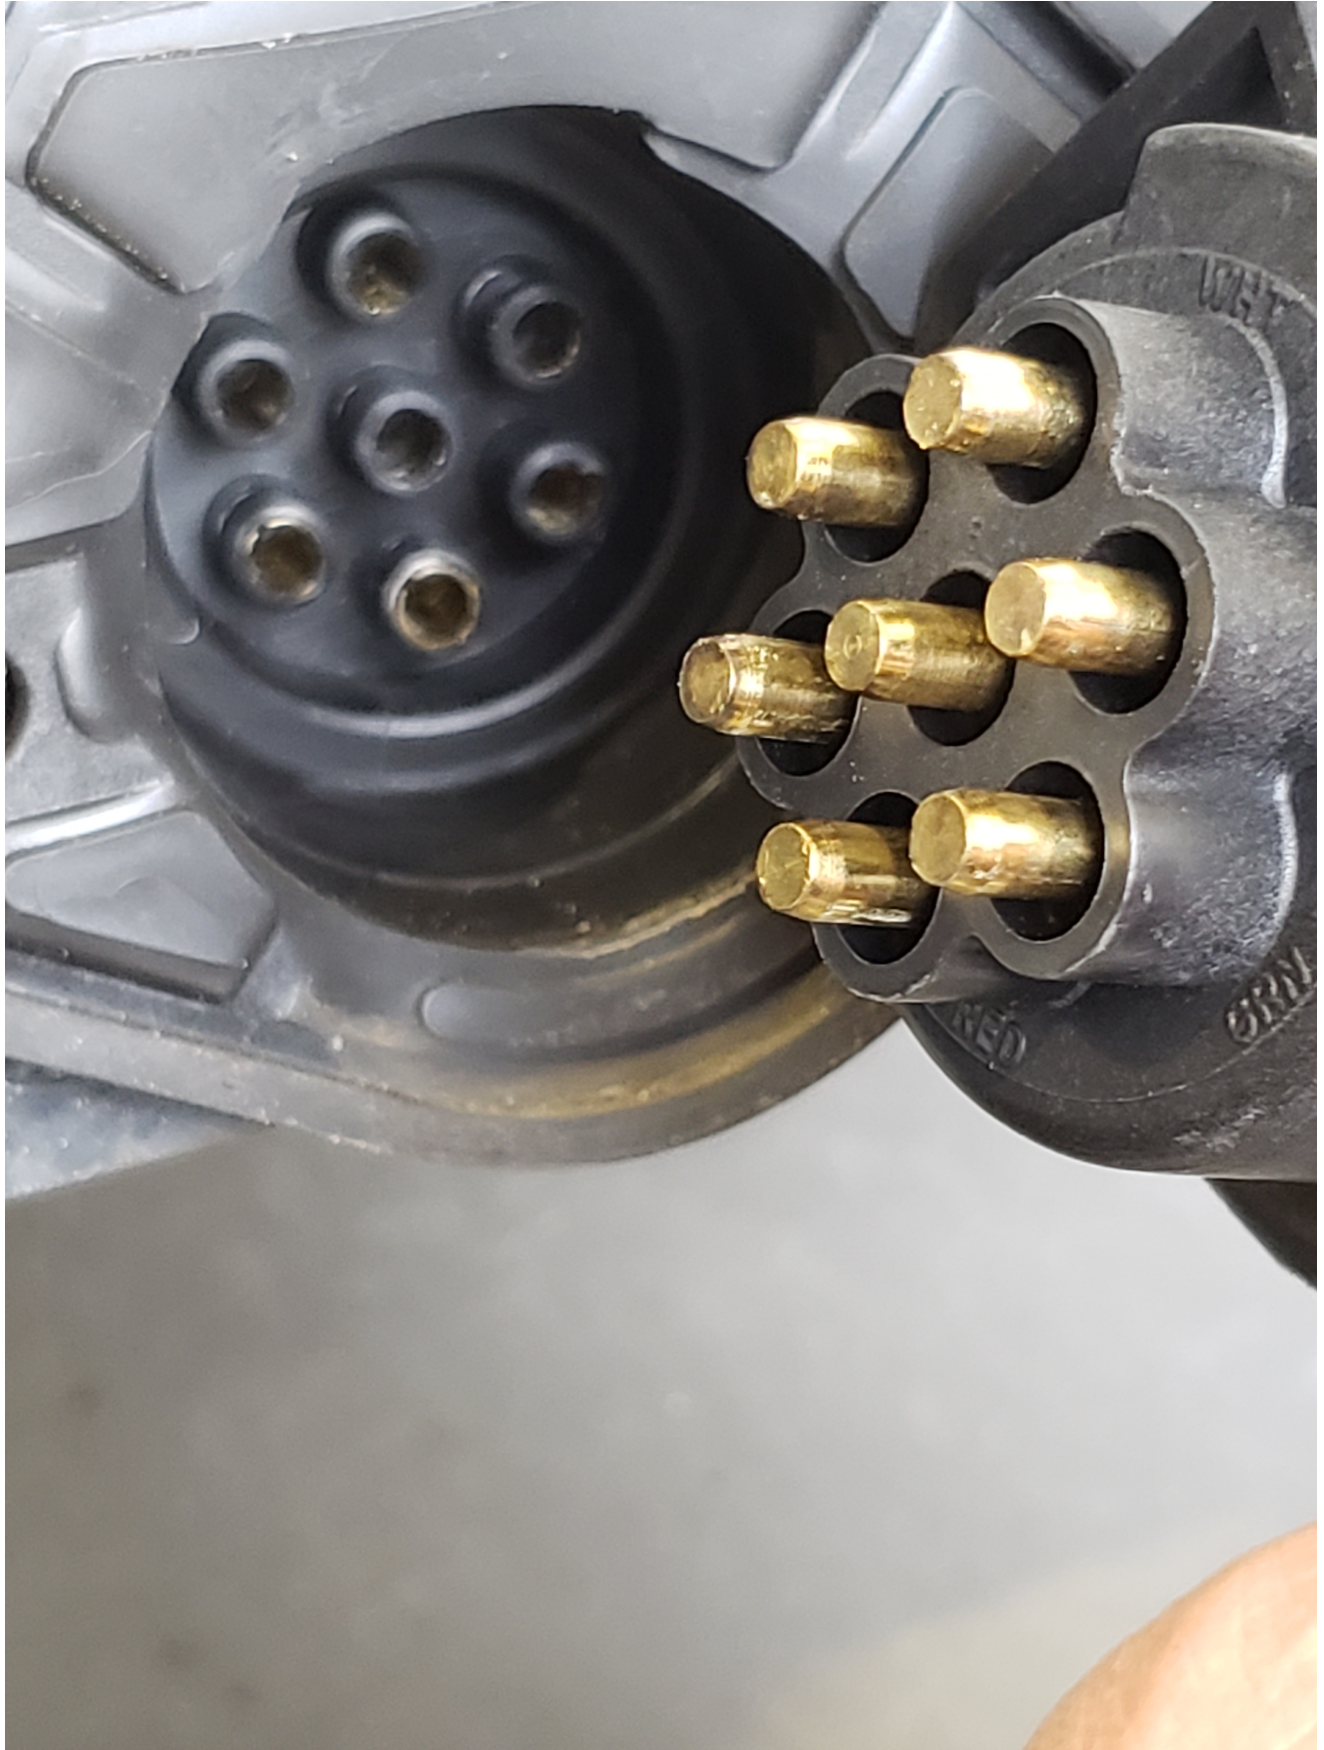
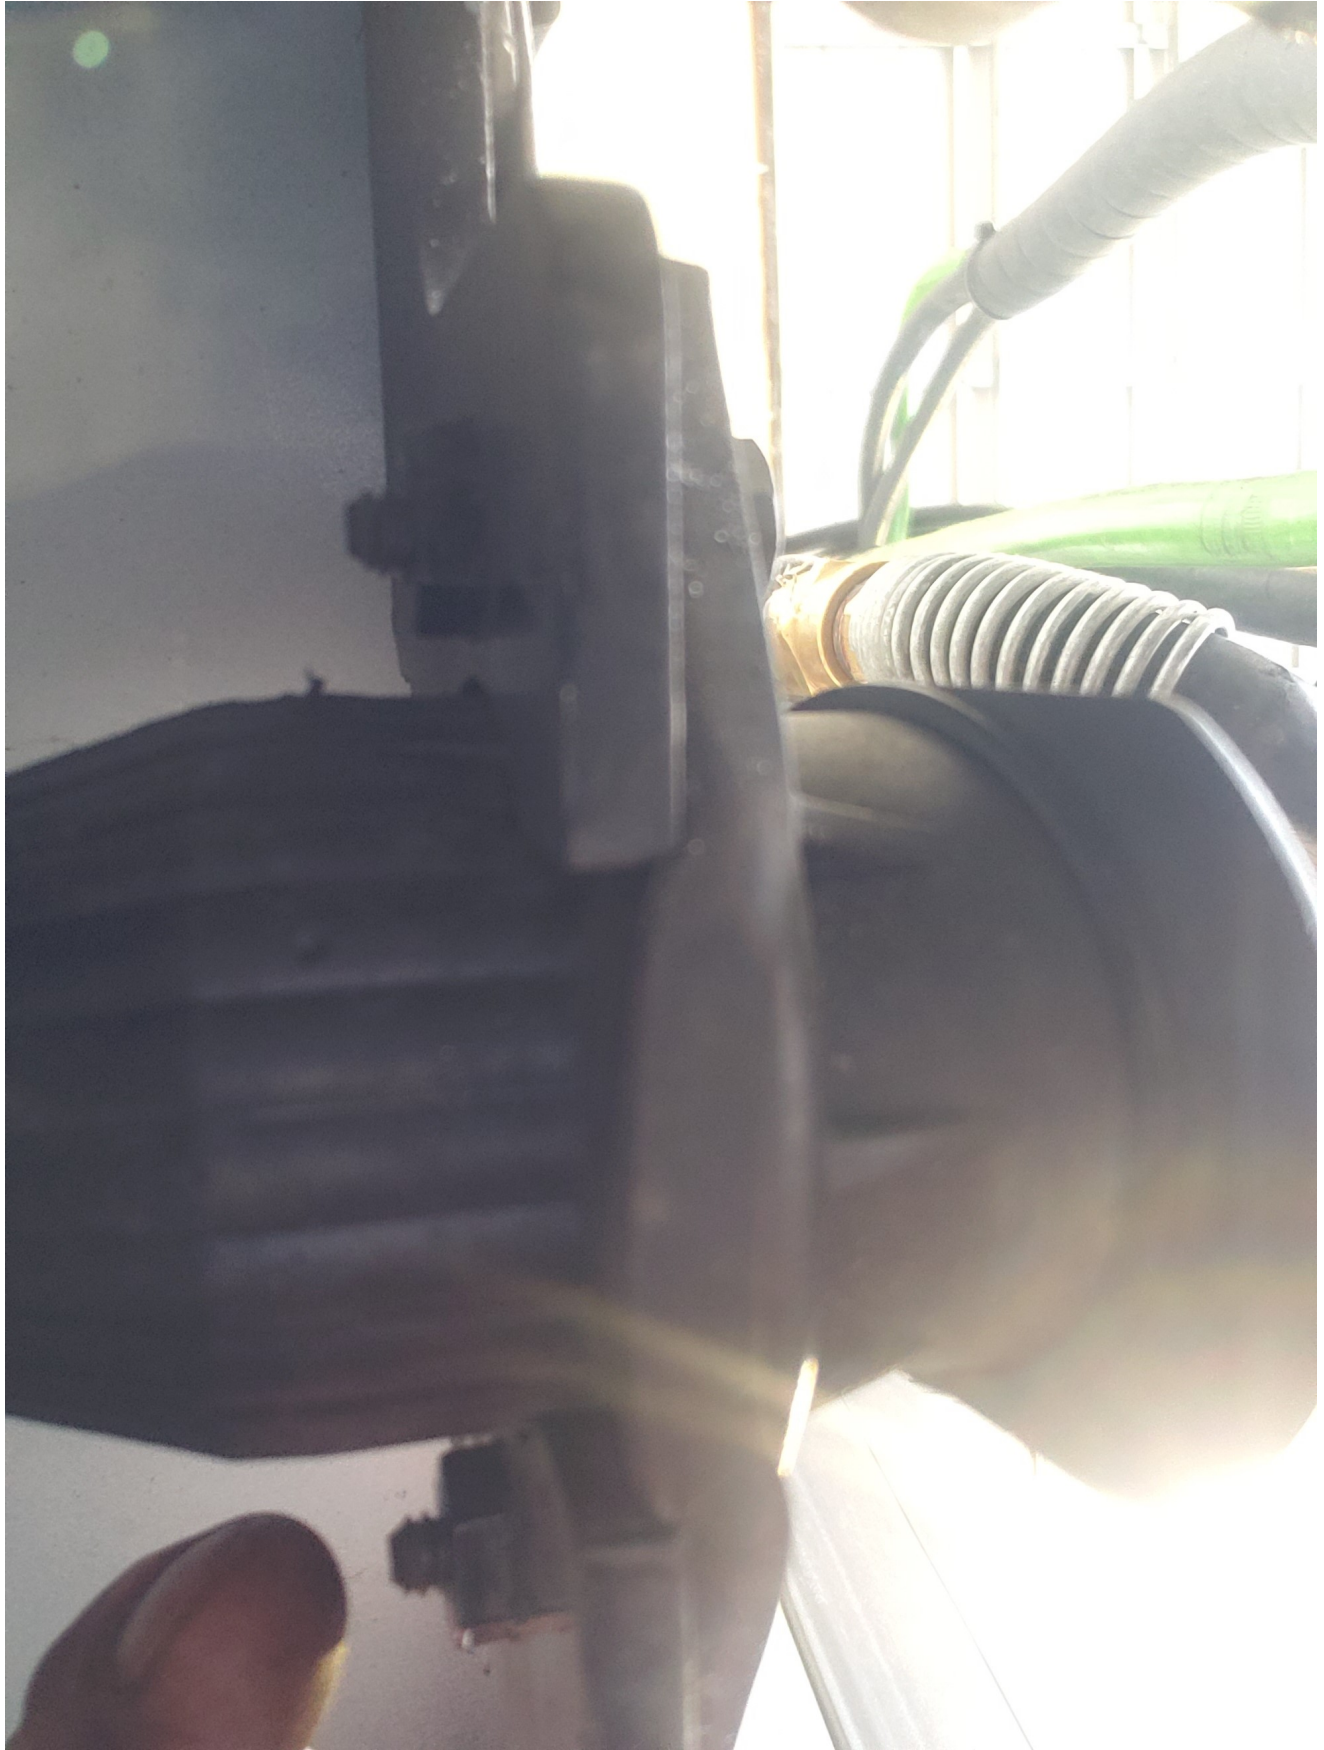
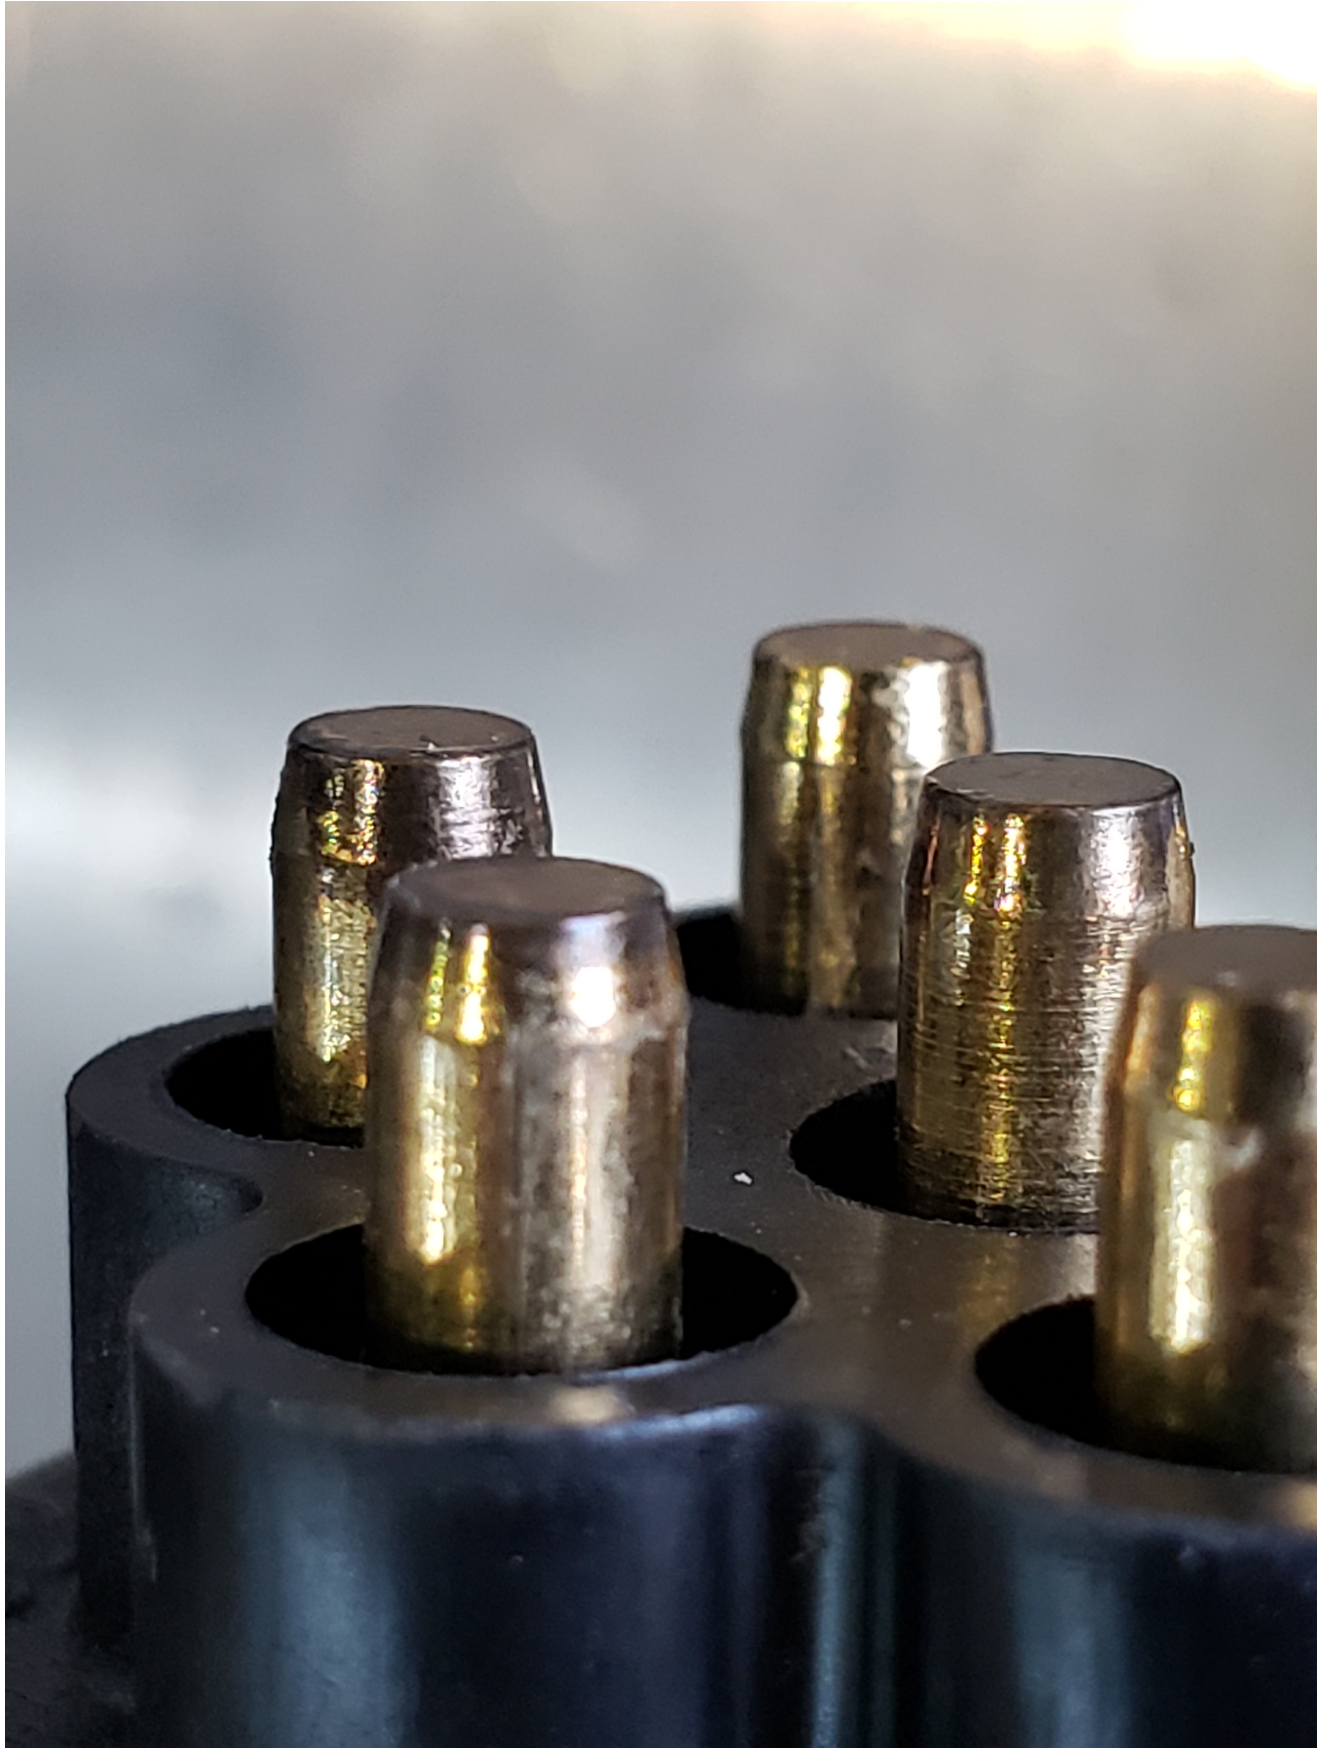
Has any body had a verified successful repair with this issue? I noticed something not mentioned in any of the talk aside from possibly a bad 7 way cable. I have seen this issue before when customer would replace the primary receptacle with the incorrect type and trailer lighting problems would occur. Is it possible we are overthinking this just because it is a P4? I took the primary receptacle off the back of the cab and now I am thinking it was not tight. When I first went to take it off, I felt on the inside of the plate to see if there were nuts on the other side or rivet nuts. I don't remember the bolt sticking through the back side of the bracket. When I inspect the primary receptacle and the trailer cord, it doesn't look like they are making full contact as seen by the wear patterns.

I can't say for certain as all ABS faults are inactive when it came in, and I was just checking things over. this is a local run truck, so I'm sure they will be back if this didn't correct the issue.

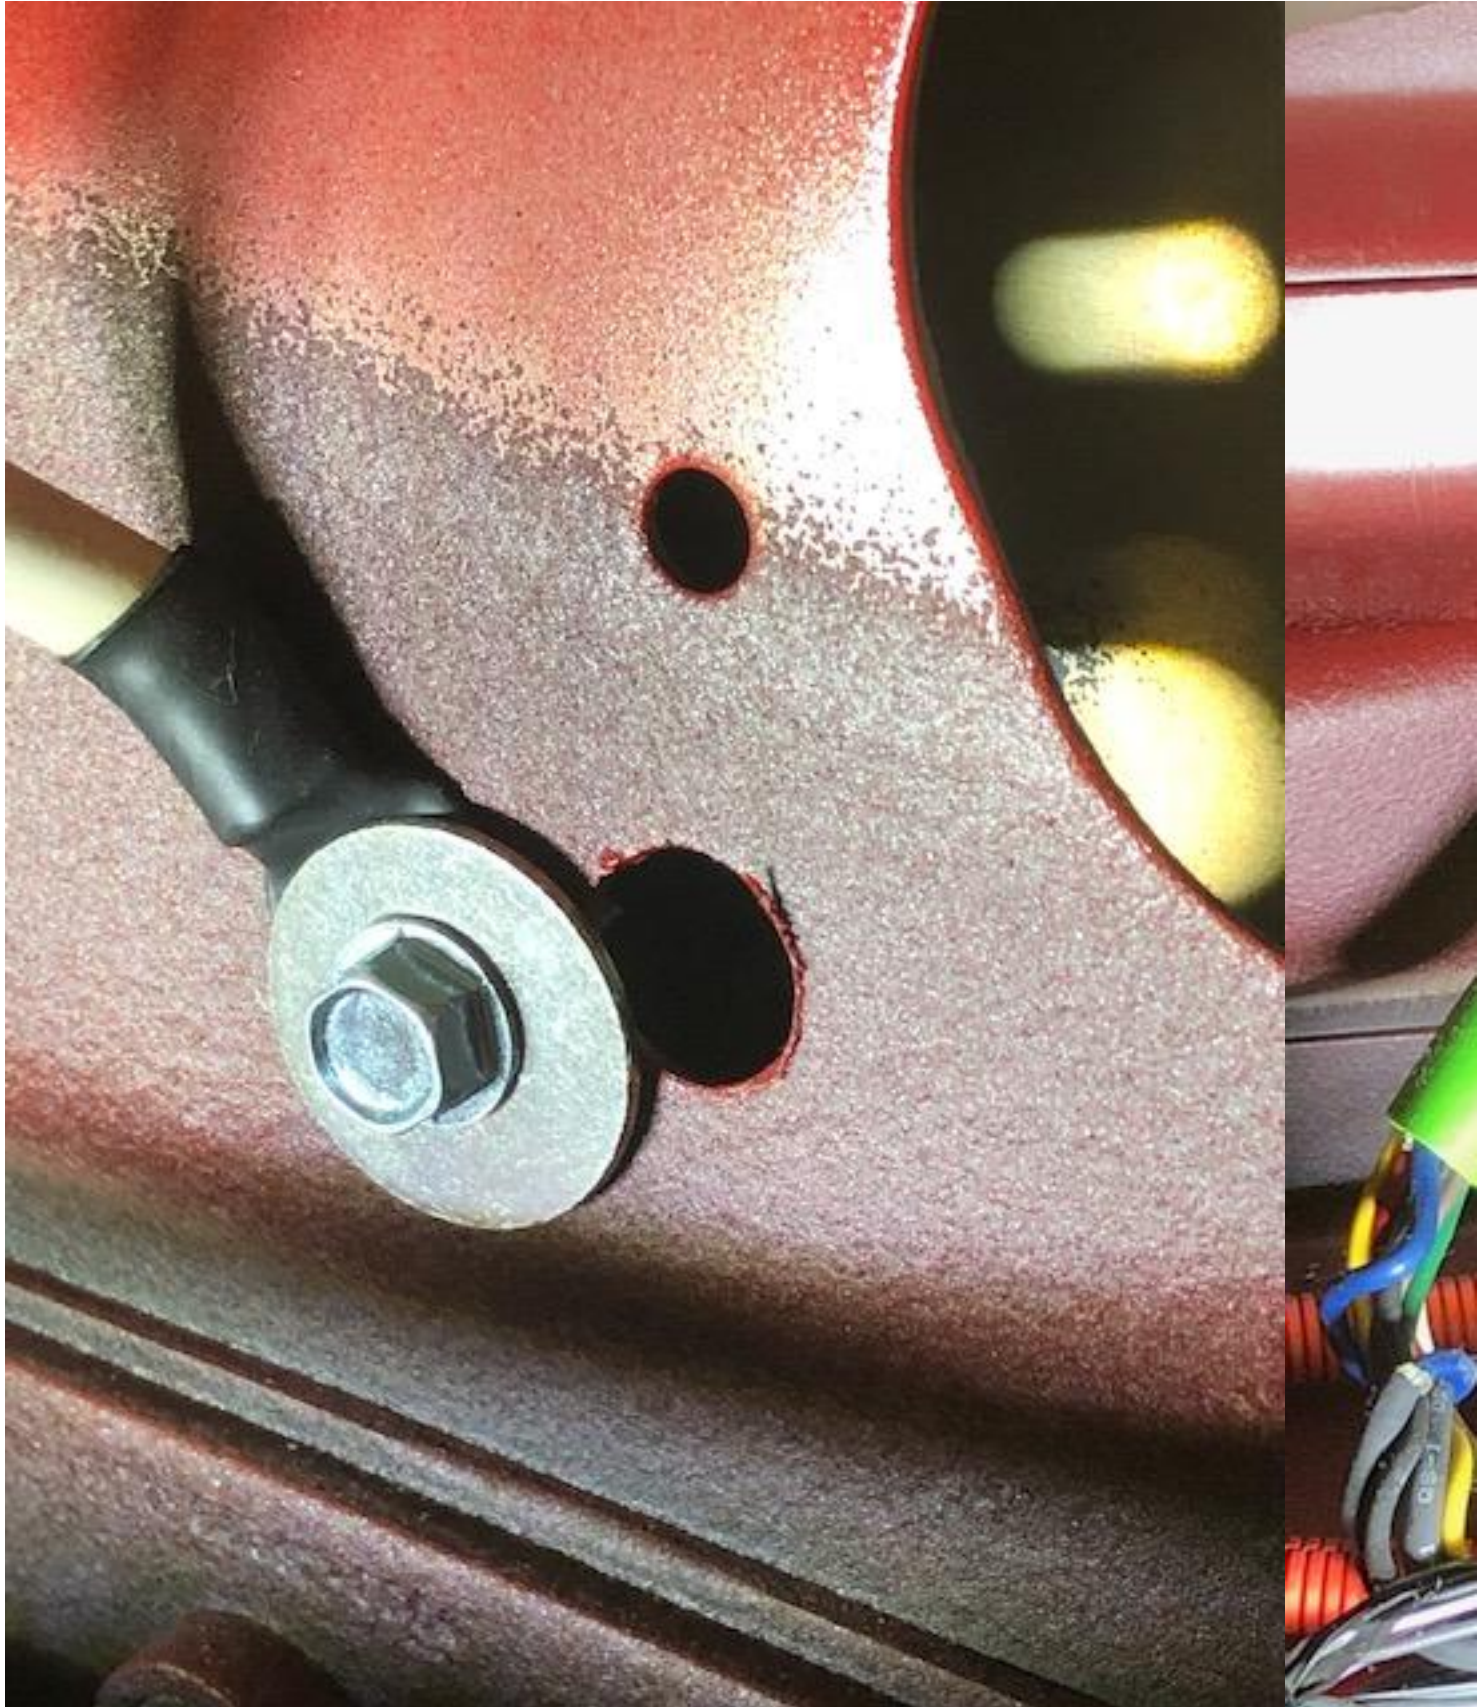
We have seen this a couple times and found the ground for the 7way on the rear wall to be the problem each time. Clean it up and re-attach properly.
