## Technical product information

| <b>Topic</b> | DTC U112100 evident within diagnostic address 0044 (Steering assistance control module) |
| <b>Brand</b> | Bentley |
| <b>Transaction No.</b> | 2061935/1 |

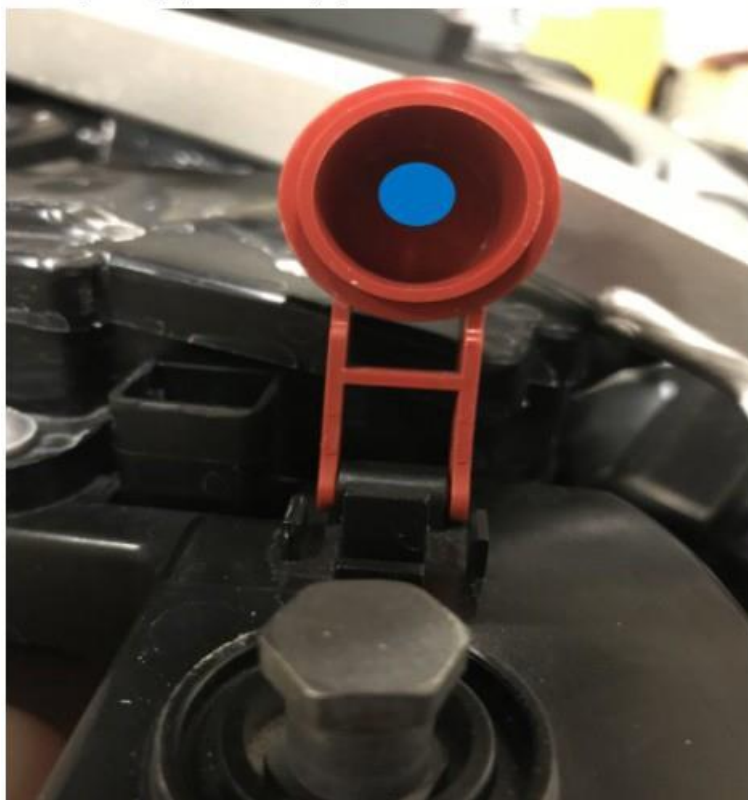
- Referring to Figure 1 - Conduct a visual check to the inside of the battery positive terminal cover to check/confirm the blue paint mark is evident

1) Confirm if (RE19/02) has been previously applied as follows:

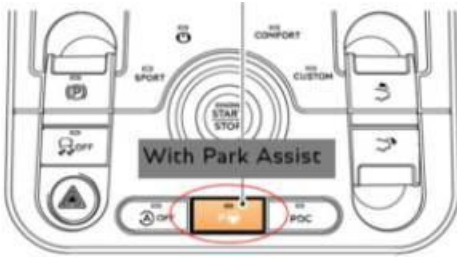
Figure 3

- If the vehicle DOES have Park Assist (Figure 3)

- The operative **MUST** raise a DISS query and await a response before conducting any further work, please ensure all supporting evidence is included within the DISS query including a current ODIS log.
