<b>Subject:</b> <b>SCRATCH ON SEAT BACK BAR GARNISH FROM CONTACT WITH CONVERTIBLE TOP</b>	<b>Bulletin No.:</b> 09-001/21
	<b>Last Issued:</b> 01/04/2021

2016-2021 MX-5

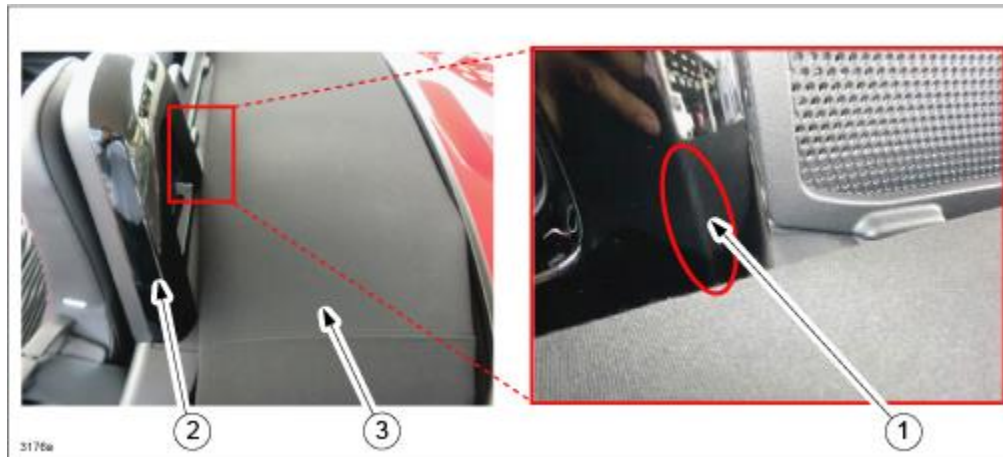
Some vehicles may exhibit scratches (1) on the rear of the seat back bar garnish (2) from contact with the convertible top (3).

Customers having this concern should have their vehicle repaired using the following repair procedure.
