Technical Service Bulletin

Subject: STAINS FOUND ON PAINT DURING PDI	Bulletin No.: 09-004/21
	Last Issued: 01/21/2021

2018-2021 CX-3
2018-2021 CX-5
2018-2021 CX-9
2020-2021 CX-30
2018-2021 Mazda3
2018-2021 Mazda6
2018-2021 MX-5

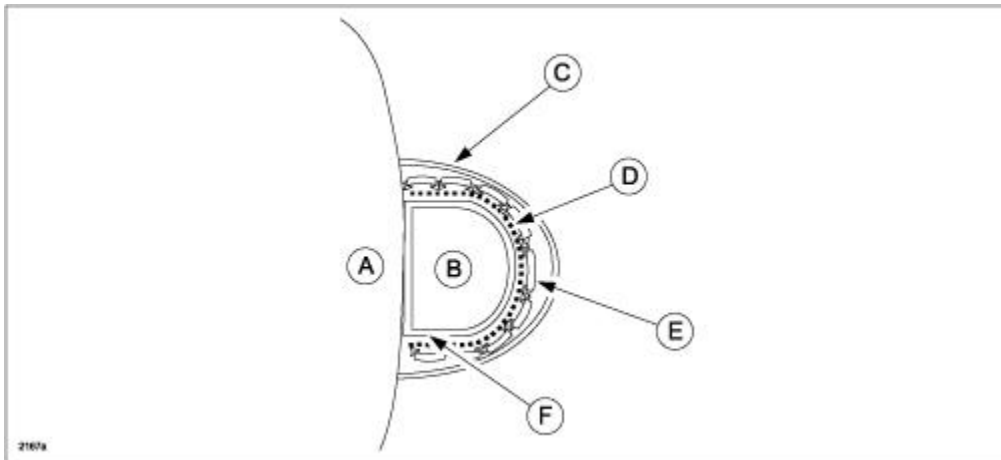
- Since this repair procedure requires the use of heat from a heat gun or infrared drier, be sure to insulate all rubber or plastic parts which are easily affected by heat from near the affected stain area.
- Use extreme care to ensure the top coat surface temperature stays below 284°F (140°C).
- To protect materials inside the cabin area (i.e. carpet, seats, etc.), also place insulation over the glass as necessary.

2. Insulate all plastic and rubber parts (as shown below) using heat insulation materials (C ~ F) prior to beginning the application of heat.

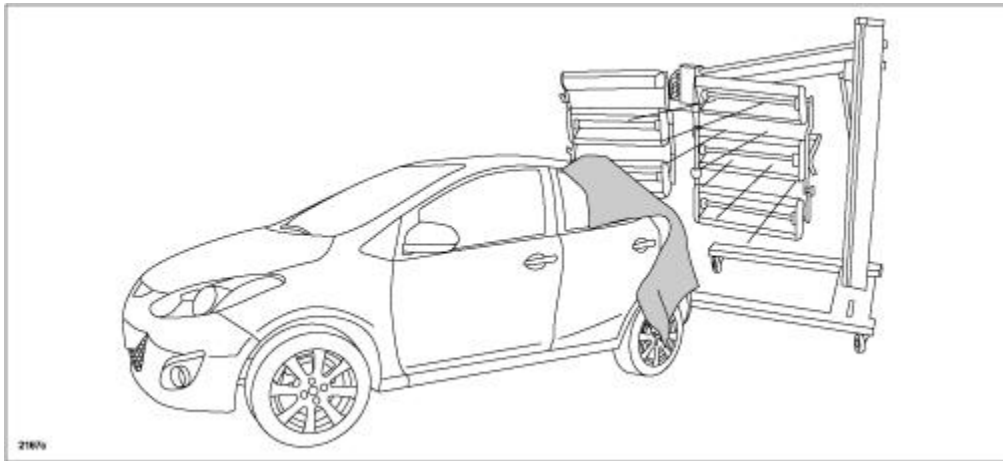
CAUTION: DO NOT apply heat for more than 60 minutes or damage to the body panel surface, plastic or rubber parts may occur.

6. Mount an infrared drier approx. 31.5 inches (80 cm) away from the surface of the stained area.

7. Set the temperature of the infrared drier to 140~158° F (60~70° C) and apply heat for a maximum of **60 minutes**.
