JLRTB02061NAS1

**TECHNICAL BULLETIN**

Amber 'Low Coolant' Warning Message Displayed On The Instrument Panel Cluster (IPC)

| MODEL: | MODEL YEAR: | VIN: | ASSEMBLY PLANT: |
|---|---|---|---|
| Defender (LE) | 2020 | 000584-021595 | Nitra (Slovakia) |

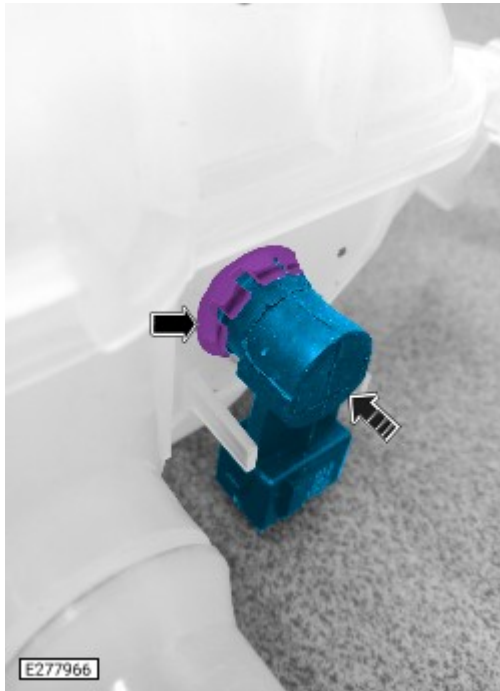
2.

Engine coolant level sensor loose.

Make sure the engine coolant level sensor is fully located in the engine coolant expansion tank.
