Rattle Noise From Floor Console

20MY RR Evoque
20MY Discovery Sport

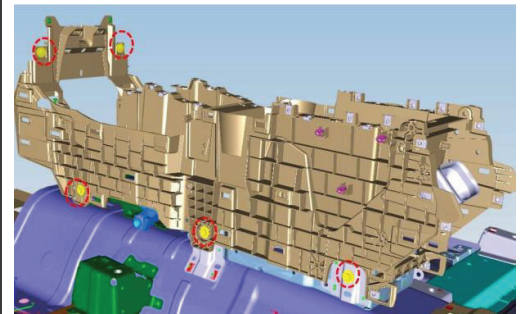
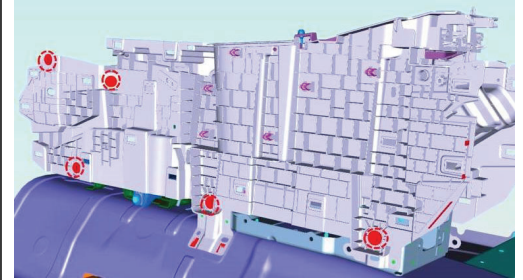
- A customer may report a rattle type noise from the floor console area between the front seats.

- The noise may be caused by the floor console mounting bolts to the vehicle body that are becoming loose.

- SSM75211 has been published to address this concern.
- Should a customer express a concern, refer to this SSM and apply Loctite 243 to the threads of the floor console mounting bolts.
