## Technical product information

<b>Topic</b>	DTC's P014800 and/or P008A00 - Rough running & potentially poor start up performance - MIL light on - Possible misfires
<b>Market area</b>	Russische Föderation (5RU),Australia E04 Bentley rest Asia and Australia (6E04),China 796 VW Import Comp. Ltd (Vico), Beijing (6796),Germany E02 Bentley rest Europe (6E02),Japan E03 Bentley Japan (6E03),Korea, (South) E08 Bentley South Korea (6E08),United Arab Emirates E06 Bentley Middle East and Africa (6E06),United Kingdom E01 Bentley UK (6E01),United States E05 Bentley USA and rest America (6E05)
<b>Brand</b>	Bentley
<b>Transaction No.</b>	2062016/1
<b>Level</b>	EH
<b>Status</b>	Approval
<b>Release date</b>

### New Continental GT/GTC and New Flying Spur - W12 TSI only

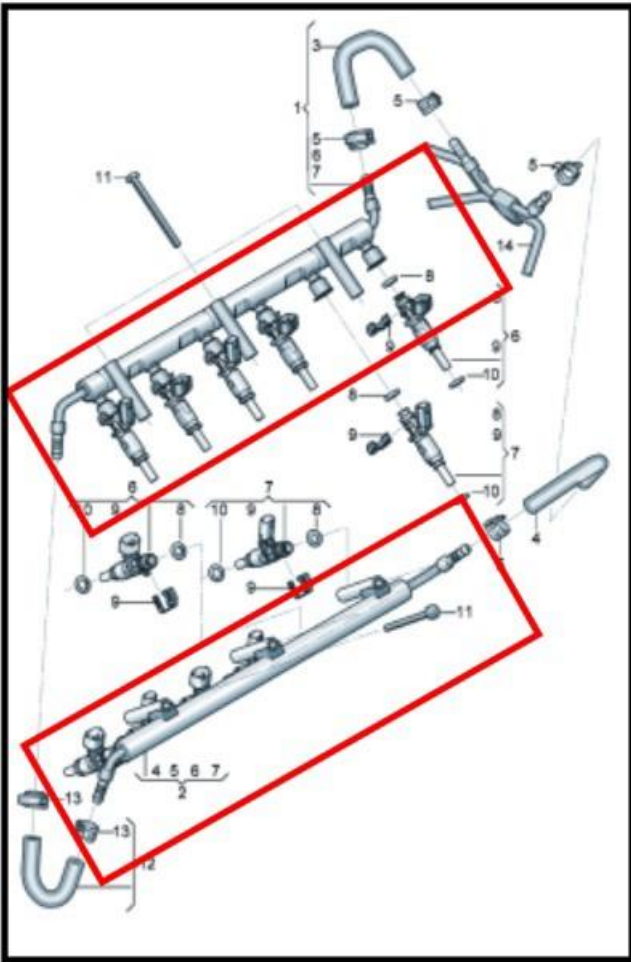
Figure 1

Debris in the fuel system can lead to a blockage in the low pressure fuel injectors, ultimately causing a cylinder misfire.

Replace both bank 1 and 2 low pressure fuel rails, the fuel rails come complete with injectors (Figure 1).
