Technical product information

Topic	Creaking noise from the upper C post trim panel
Market area	Bentley: worldwide (2WBE)
Brand	Bentley
Transaction No.	2061928/1
Level	EH
Status	Approval
Release date

New Flying Spur

Creaking noise from the upper C post trim panel

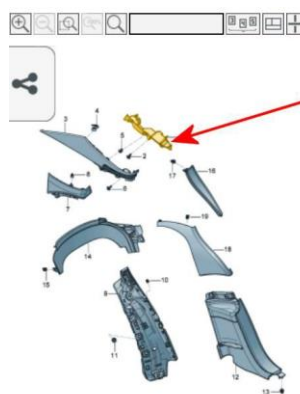
TIP: If the creaking noise occurs only when pressure is applied in this position, the concern is related to the tape specification which is fitted to the applicable upper C post bracket

2) Remove the applicable upper C post trim panel – Refer to Rep. Gr 70 to gain access to the Brackets shown in Figure 1
