Subject: PSB E264: PACCAR MX-13 EPA2017 Cylinder Head Bolt Tightening
EXPIRATION DATE: 02/01/2022

Technical Information Bulletin

E264

PACCAR MX-13 EPA17 Cylinder Head Bolt Tightening

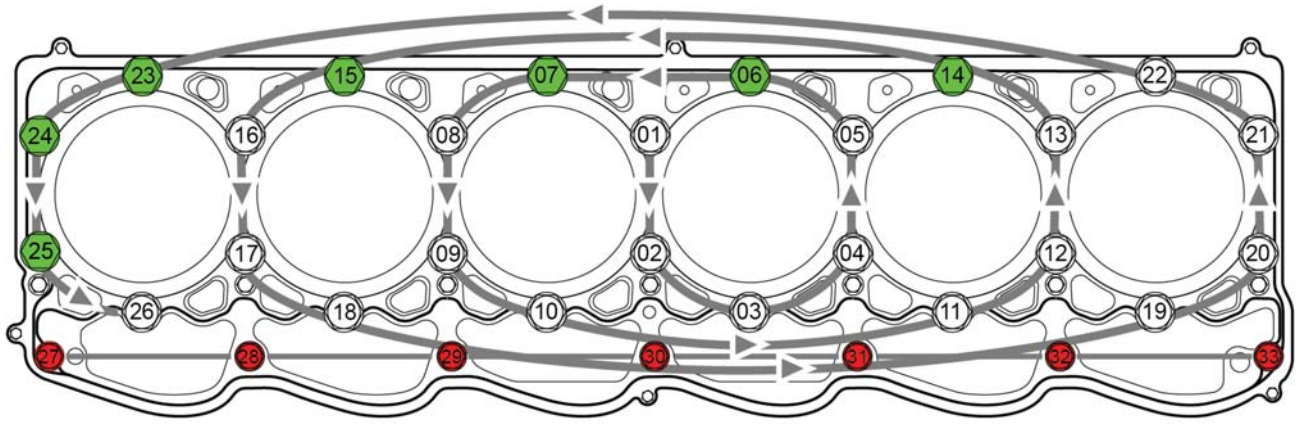
Figure 1 Head bolt locations

2. Confirm head bolt numbers 06, 07, 14, 15, 23, 24, 25—shown in **green** in Figure 1—**DO NOT** have a clean and visible index mark. If they have a clean index mark, **you MUST** confirm that this repair was not recently performed. Bolts 23 and 15 are easiest to see.

5. Turn head bolts 1-26 90°.
 - DO NOT RETORQUE BOLTS 27-33 shown in Figure 1 in red.
 - Use the torque adapter tool (p/n 2203481PE) on limited access bolts (head bolt numbers 06, 07, 14, 15, 23, 24, 25—indicated by green highlight in the image below). This tool allows for access under the EGR cooler.
