Technical Service Bulletin

SUBJECT:		No: TSB-21-51-001	
GAP BETWEEN FRONT WHEEL ARCH MOLDING AND FENDER		DATE: January 2021	
		MODEL: 2011-20 Outlander Sport	
CIRCULATE TO:	<input type="checkbox"/> GENERAL MANAGER	<input checked="" type="checkbox"/> PARTS MANAGER	<input checked="" type="checkbox"/> TECHNICIAN
<input checked="" type="checkbox"/> SERVICE ADVISOR	<input checked="" type="checkbox"/> SERVICE MANAGER	<input checked="" type="checkbox"/> WARRANTY PROCESSOR	<input type="checkbox"/> SALES MANAGER

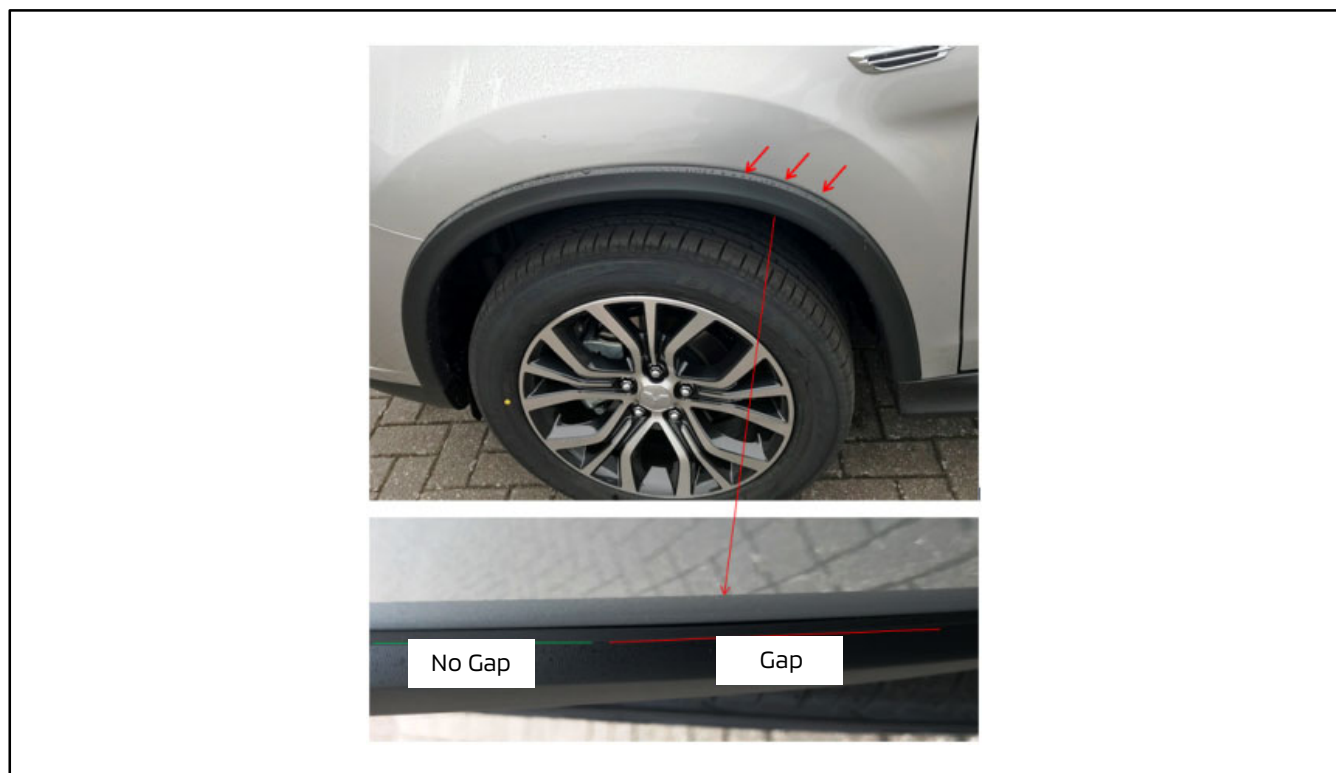
A customer may report a condition in vehicles equipped with a front wheel arch molding, where there is a gap between the front wheel arch molding and the fender. The front wheel arch molding is installed on the fender. When the position of the front wheel arch molding mounting hole is shifted, a gap may form over time.

This TSB instructs dealers to replace both sides of the wheel arch molding.
