| Subject: MRCC CANCELED WHILE DRIVING WITHOUT ANYTHING AHEAD TO BE DETECTED | Service Alert No.: SA-003/21 |
| | Last Issued: 01/15/2021 |

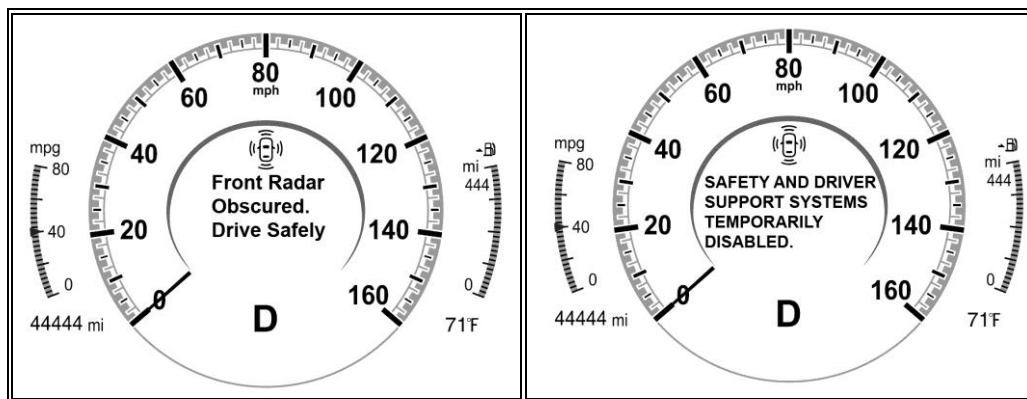
- While using Mazda Radar Cruise Control (MRCC), the MRCC cancels by itself.
- When MRCC is not in use, “Safety and Driver Support Systems Temporarily Disabled. Front Radar Obscured.” message appears in the instrument cluster / “Remove dirt on the front radar sensor” message appears in the center display and related i-ACTIVSENSE functions stop working.

This is caused by the front radar (under specific road conditions) detecting a false error as if the radar sensor is dirty, resulting in cancellation of the MRCC. (no metallic object reflects the radar wave such as a vehicle ahead, an oncoming vehicle, a road sign or a guard rail).

1. Verify customer concern.
2. Is the front radar sensor or forward sensing camera dirty?
 - Yes - Clean the front radar sensor and/or forward sensing camera.
 - No - Replace the front radar sensor.
3. Verify repairs.
