Service Alert

M-MDS (MDARS) SHOWS FRONT RADAR SENSOR DYNAMIC AIMING IS INCOMPLETE

Service Alert No.: SA-010/21

Last Issued: 01/29/2021

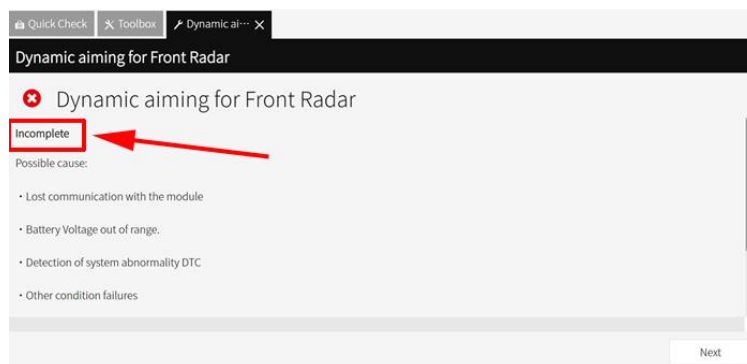
Some vehicles may experience M-MDS (MDARS) showing the front radar dynamic aiming is incomplete. This may be caused by:

- Faulty front radar sensor software logic (MDARS showing the front radar dynamic aiming is incomplete although the procedure is completed).
- Front radar sensor out of alignment due to vehicle accident.**

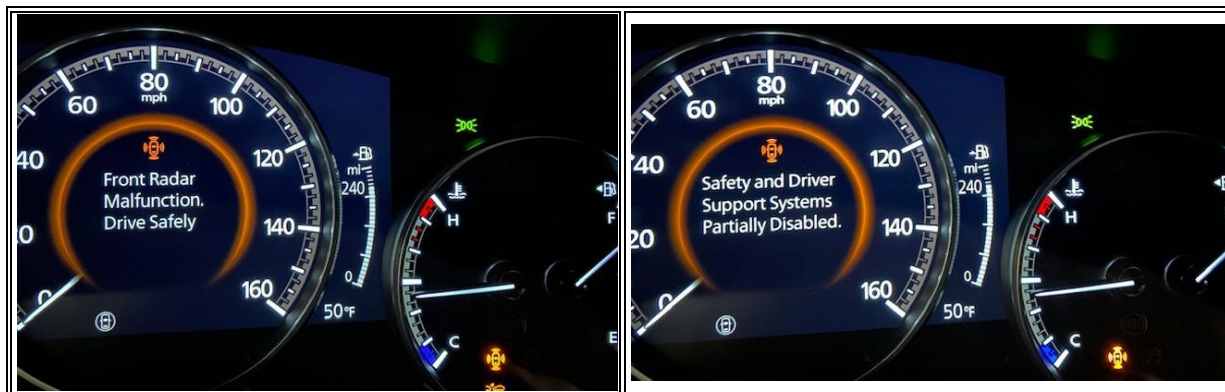
1. Check for a "Front Radar Malfunction. Drive Safely/Safety and Driver Support Systems Partially Disabled" warning message and warning light ON?

Is the warning message displayed and warning light ON?

- **Yes:** Go to step 3.
- **No:** Go to step 2.

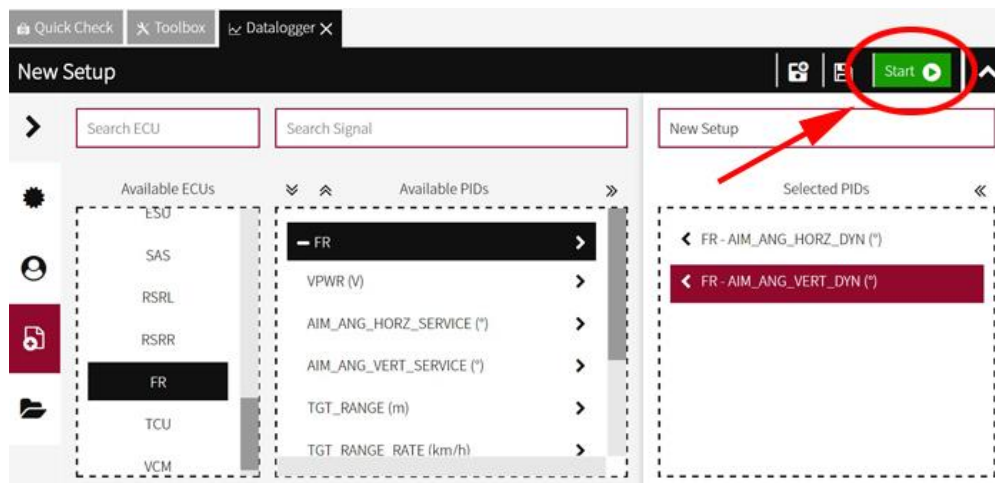
d. Select PIDs
Horizontal deviation: FR-AIM_ANG_HORZ_DYN
Vertical deviation: FR-AIM_ANG_VERT_DYN
e. Select Start

Horizontal and Vertical deviation specification: Lower than 4.2 degrees
NOTE: If either of the PIDs exceeds 4 deg, front radar sensor dynamic aiming will fail.

NOT Correct: Horizontal or Vertical deviation is out of specification

Go to next step.

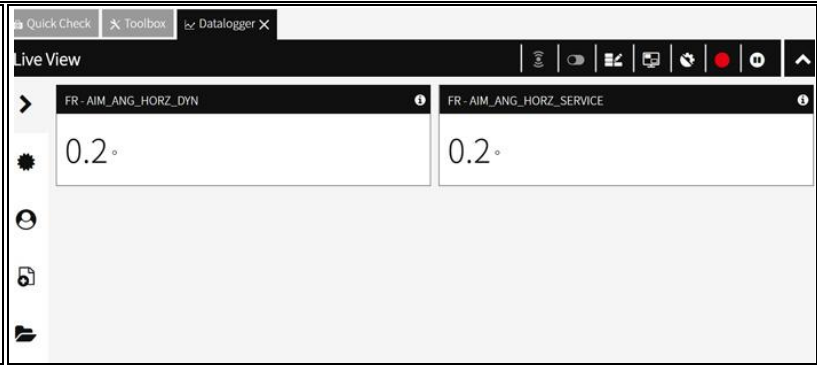
Correct: Horizontal and Vertical deviation is within specification

Repeat front radar sensor dynamic aiming

- Mazda3 - [FRONT RADAR SENSOR AIMING](#)
- CX-30 - [FRONT RADAR SENSOR AIMING](#)

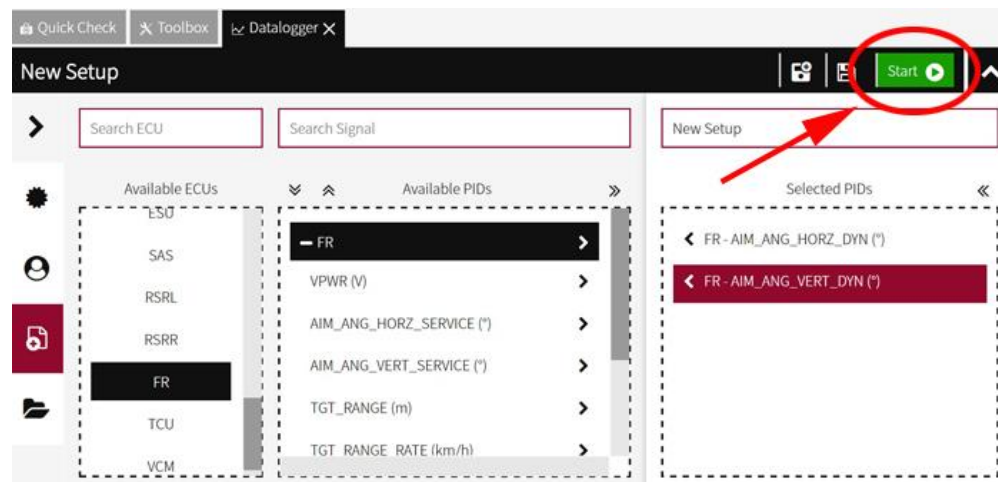
d. Select PIDs
Horizontal deviation: FR-AIM_ANG_HORZ_DYN
Vertical deviation: FR-AIM_ANG_VERT_DYN
Select Start

Horizontal and Vertical deviation specification: Lower than 4.2 degrees **NOTE:** If either of PIDs exceeds 4 deg, front radar sensor dynamic aiming will fail.

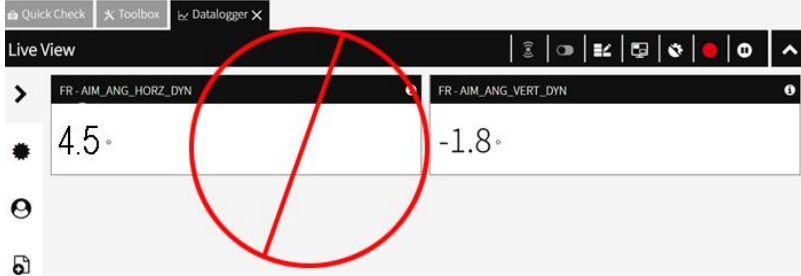
<p>NOT Correct: Horizontal or Vertical deviation is out of specification.</p> <p>Go to next step.</p>

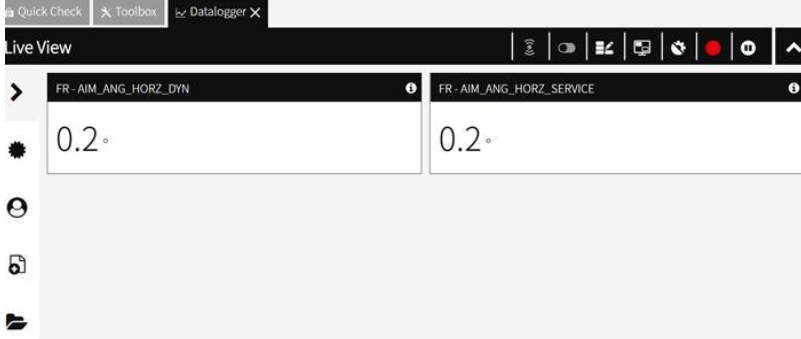
<p>Correct: Horizontal and Vertical deviation is within specification.</p> <p>Repeat front radar sensor dynamic aiming.</p> <ul style="list-style-type: none"> • Mazda3 - FRONT RADAR SENSOR AIMING • CX-30 - FRONT RADAR SENSOR AIMING
