HYUNDAI Technical Service Bulletin	GROUP CAMPAIGN	NUMBER 21-01-007H
	DATE JANUARY, 2021	MODEL(S) ELANTRA (CN7, CN7a) SONATA (DN8) SONATA HYBRID (DN8 HEV) PALISADE (LX2) VENUE (QX)
SUBJECT: WIRELESS CARPLAY SOFTWARE UPDATE (SERVICE CAMPAIGN T5T)

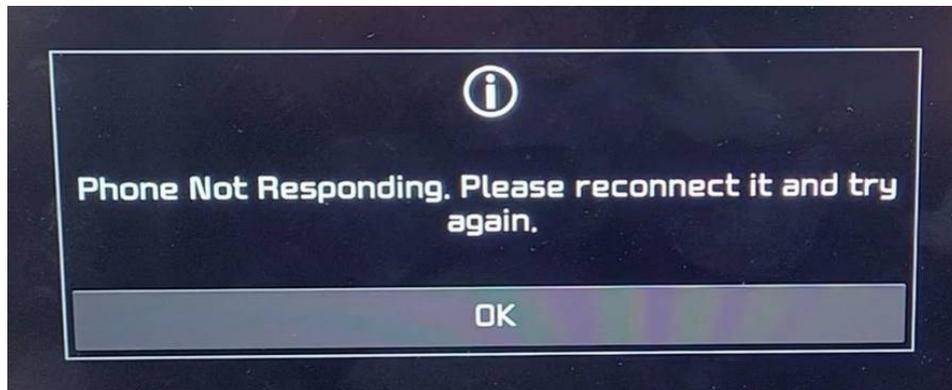
Description: When using Wireless CarPlay, the system may intermittently auto disconnect. When Wireless CarPlay is disconnected, a pop up message "Phone Not Responding. Please reconnect it and try again" will appear on the radio screen.

Note: The disconnection phenomenon is caused by the Apple IOS software. Apple IOS software intermittently pause the data transmission, causing the communication interruption between the radio and CarPlay. This software update helps reduce the disconnection occurrences, until Apple provides a software update to correct the condition.

This bulletin describes the procedure to update the radio software to help reduce the disconnection occurrences.
