SERVICE BULLETIN

Classification: BT14-023a	Reference: NTB14-105a	Date: January 7, 2021
------------------------------	--------------------------	--------------------------

2014-2020 ROGUE; CARPET WET FRONT FLOOR AREA

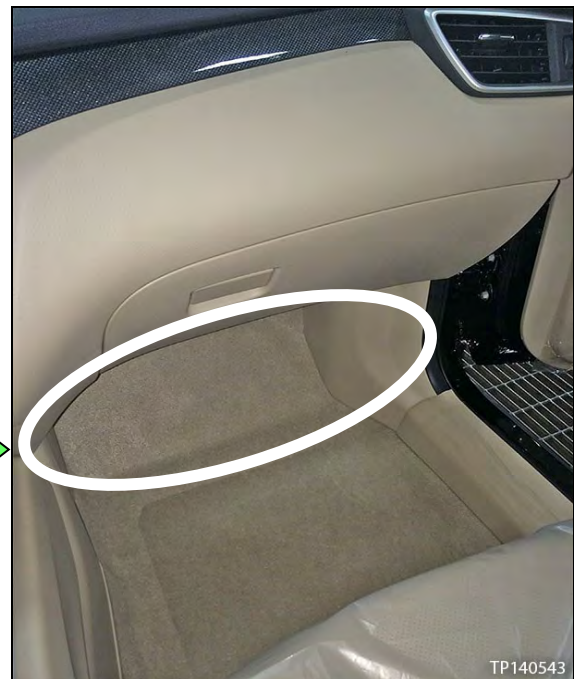
Figure 1

The carpet is wet on the driver and/or front passenger floor (see Figure 1).

1. Determine if the leak is from the kick panel and/or cowl end area.
2. If confirmed, apply body sealant to the incident areas as outlined in this bulletin.

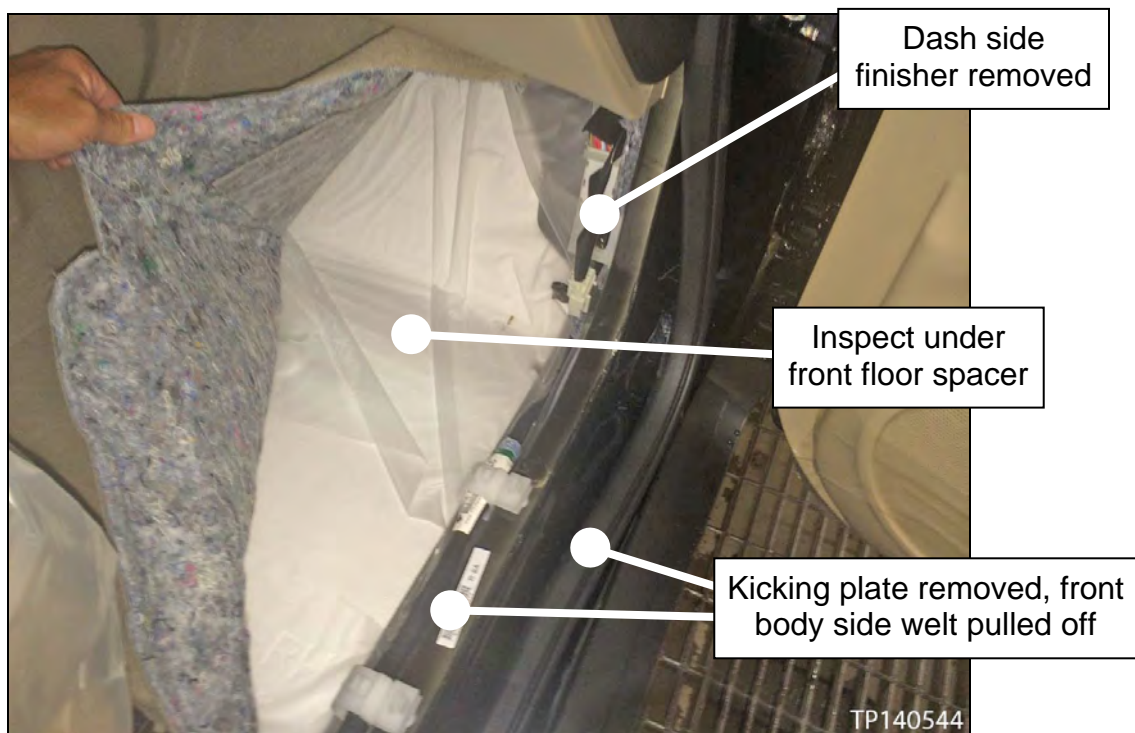
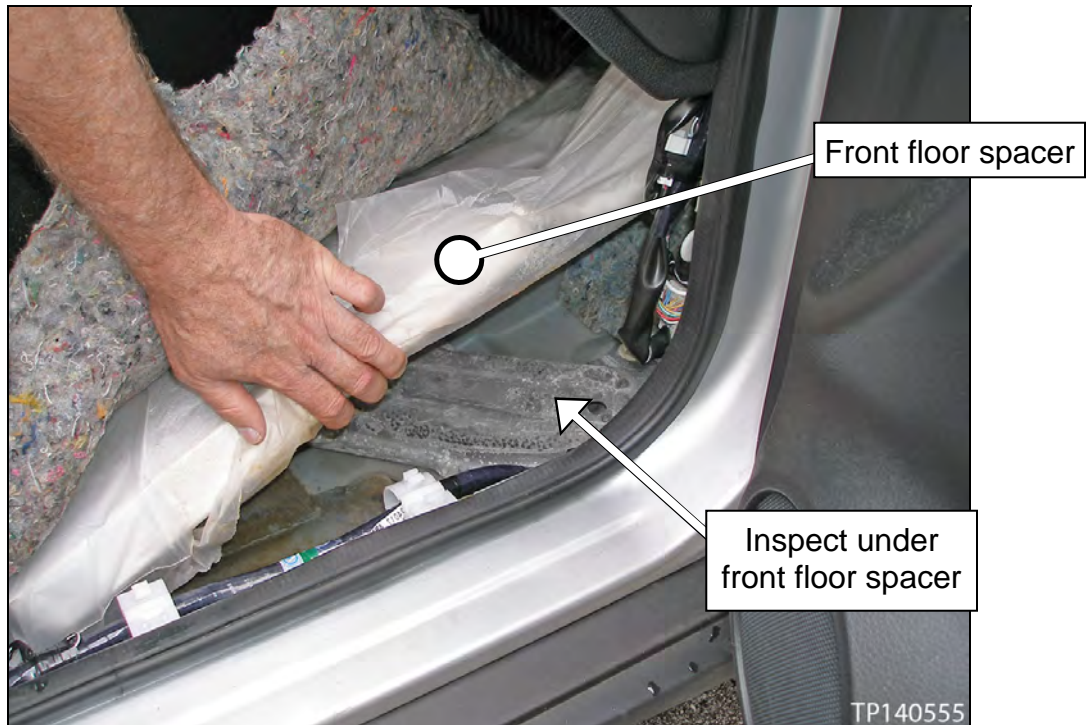
1. Pull back on the front floor trim (carpet) on both driver and front passenger floors, even if only one side is wet (see Figure 2, and 2a on the next page).
2. In order to pull back the carpet:
 - a. Remove the front kicking plates.
 - b. Pull off the front body side welts at the bottom.
 - c. Remove the dash side finishers.
 - Refer to the Electronic Service Manual (ESM), section **INT-Interior** or **BODY INTERIOR > INTERIOR > REMOVAL AND INSTALLATION > FLOOR TRIM**, for removal of the parts stated in step 2a - 2c.
3. Check for water under the front floor spacers (see Figure 2 and 2a).

4. If water is found under one or both front floor spacer(s):
 - a. Thoroughly dry the area(s).
 - b. Skip to **Body Sealing** on the next page.
5. If no water is found below either front floor spacer:
 - a. Leave the vehicle interior disassembled.
 - b. Perform a water leak test at the cowl and wheel well areas.
 - Run water down inside the cowl and spray water in the wheel well areas with a garden hose or similar water supply.
 - Do not use an excessive amount of water. Do not use a pressure sprayer.
 - c. Check again for water under both front floor spacers.
6. If there is still no water detected after water leak testing:
 - a. This bulletin does not apply. Refer to ASIST and the ESM for further diagnosis.
7. If water is found:
 - a. Leave the vehicle interior disassembled.
 - b. Go to **Body Sealing** on the next page.

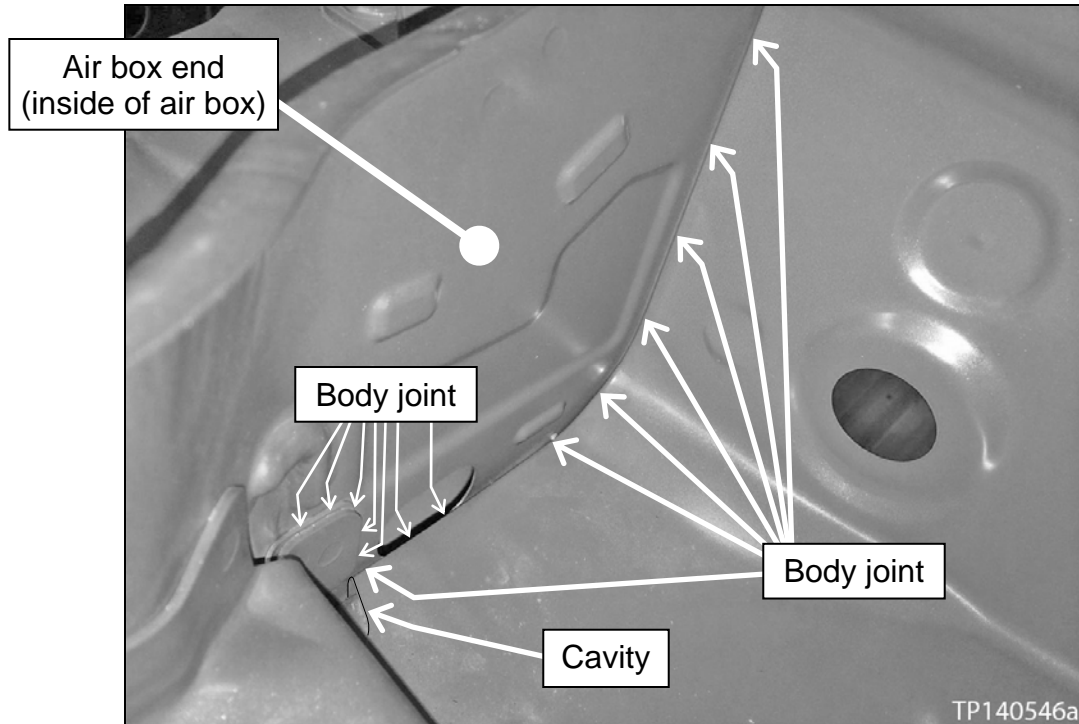
Figure 4: Body joint, passenger side. Driver side is similar.

2a. Inspect for body sealer on the side that leaks where shown in Figure 4 and 5.

- Apply body sealer with a suitable applicator to all areas where body sealer is not seen.
- If an area is questionable, add body sealer.
- Use one of the body sealers listed in the **PARTS INFORMATION** or equivalent.
- Follow the body sealer's directions for proper application.

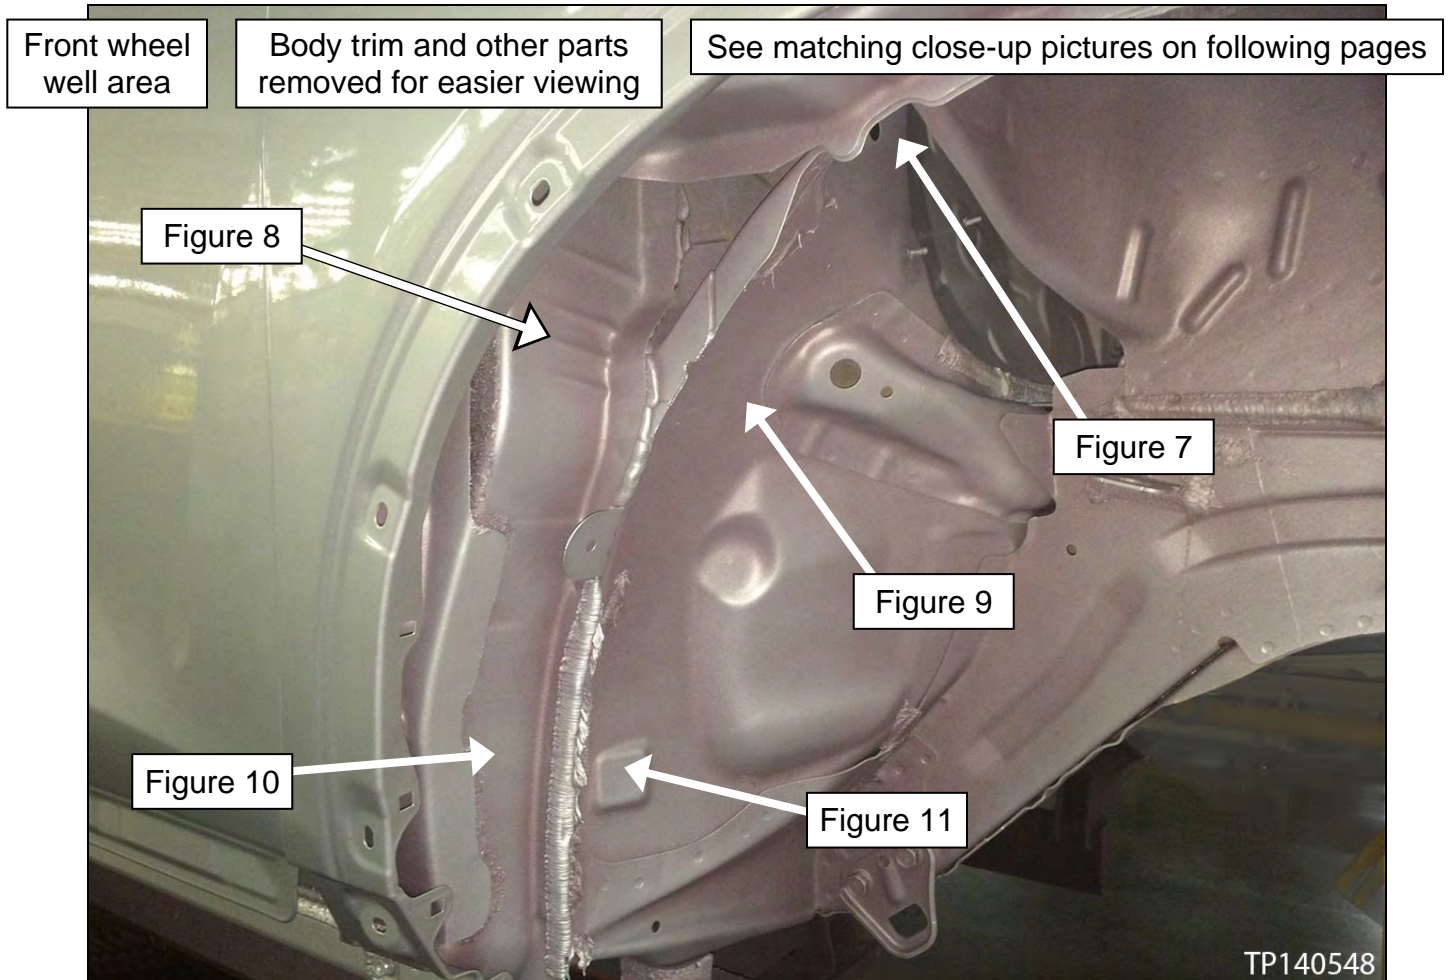
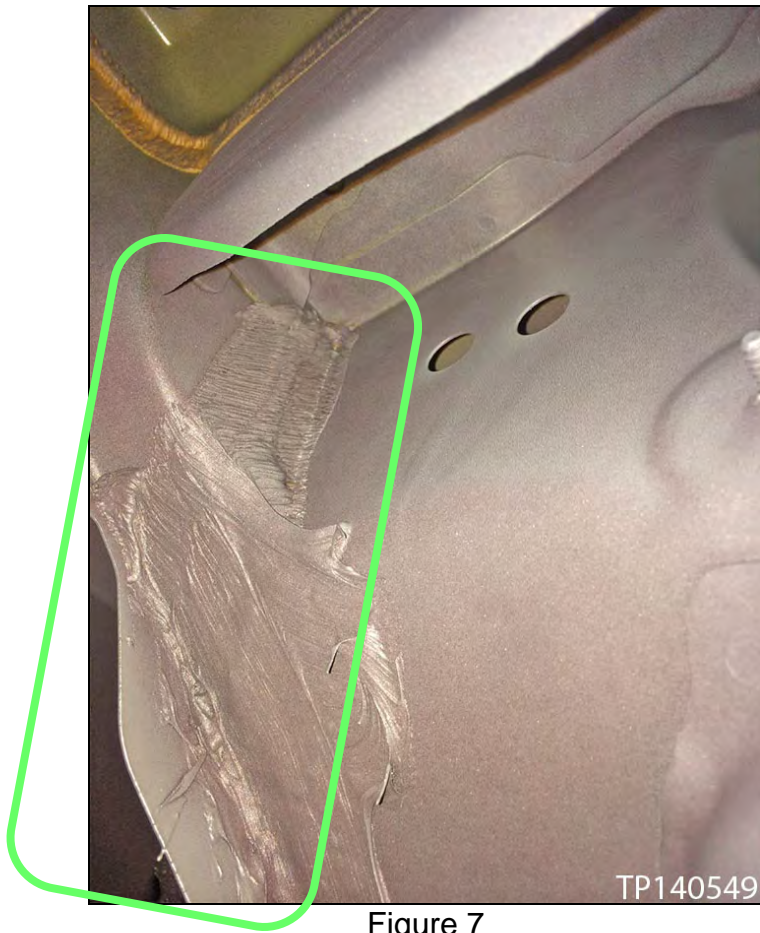
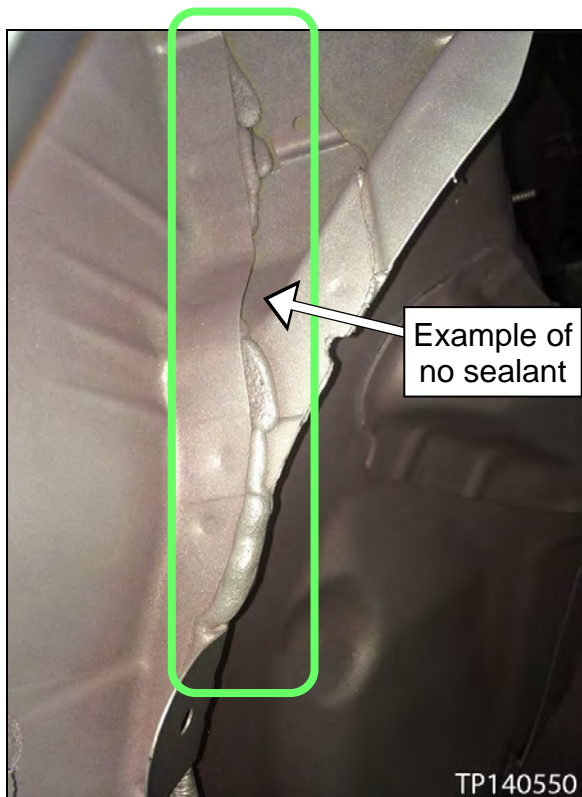
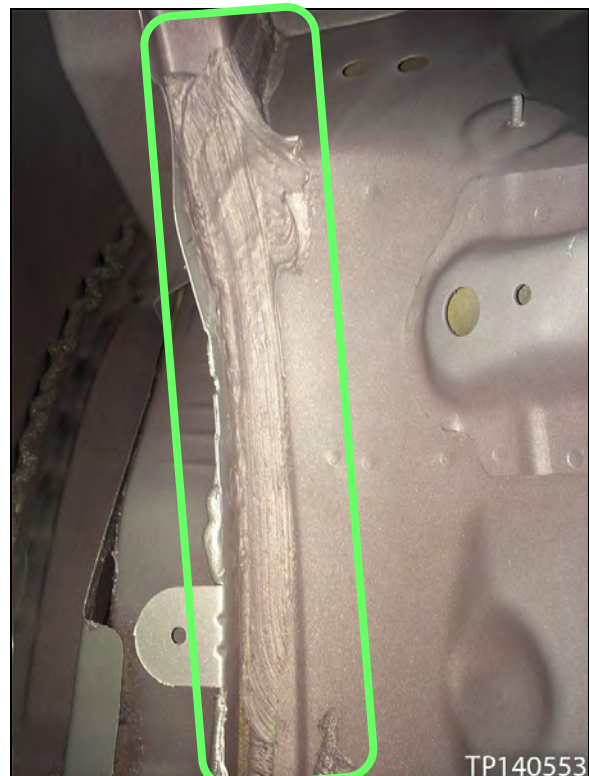
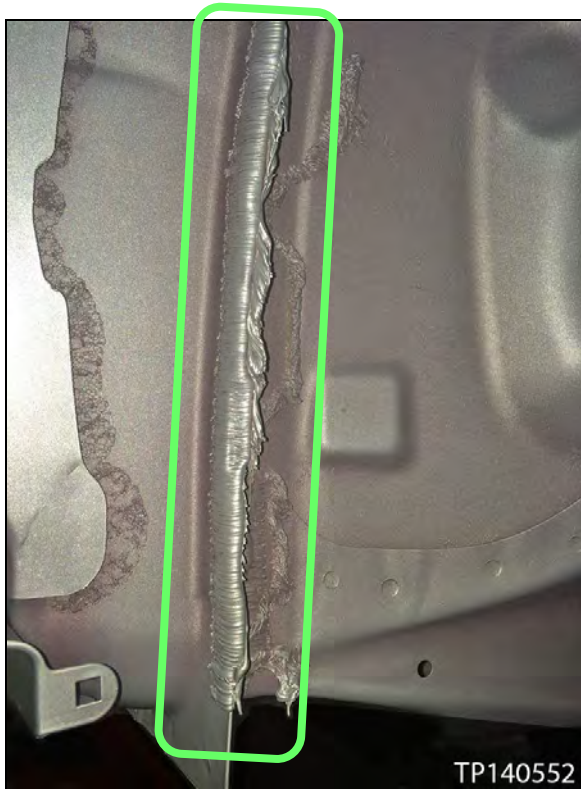
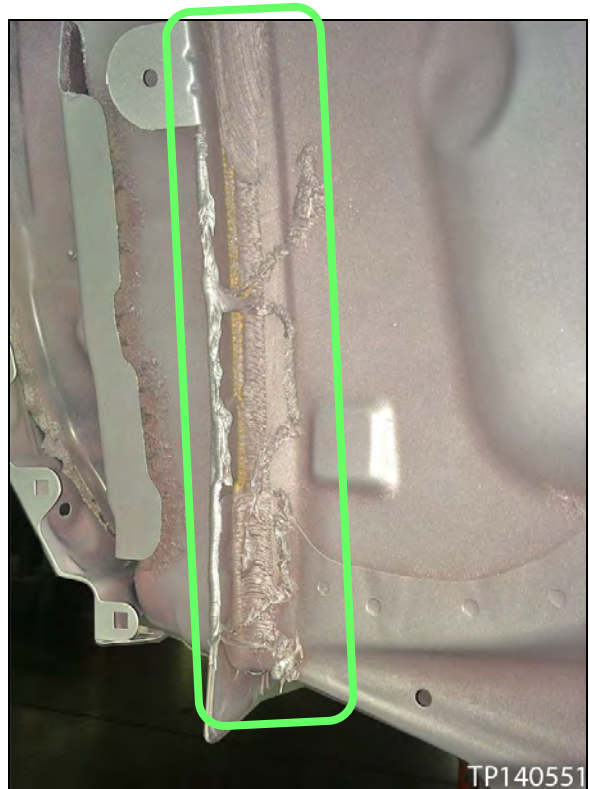
4. Inspect the areas shown in Figure 6 – 11 for body sealer or gaps in body sealer.
- Seal all areas where body sealer is not seen.
 - If an area is questionable, apply body sealer.

5. Once the sealer has sufficiently cured, perform another water leak test at the cowl and wheel well area(s).
 - First reassemble the fender protector(s) before testing the wheel well area(s).
 - Refer to the ESM, section **EXT-Exterior** or **BODY EXTERIOR, DOORS, ROOF & VEHICLE SECURITY > EXTERIOR > REMOVAL AND INSTALLATION > FENDER PROTECTOR > FENDER PROTECTOR**, for front fender protector installation procedure.
 - Run water throughout in the cowl/air box area and spray water in the wheel well area(s) from a garden hose or similar water supply.
 - Drench these areas for a while but do not use an excessive volume of water. Do not use a pressure sprayer.
