SERVICE BULLETIN

Classification: BT18-008b	Reference: NTB18-042b	Date: January 21, 2021
------------------------------	--------------------------	---------------------------

KICKS, LEAF, SENTRA AND VERSA; FRONT DOOR WILL NOT OPEN

APPLIED VEHICLES: 2018-2020 Kicks (P15)
2018-2021 LEAF (ZE1)
2020 Sentra (B18)
2020 Versa Sedan (N18)

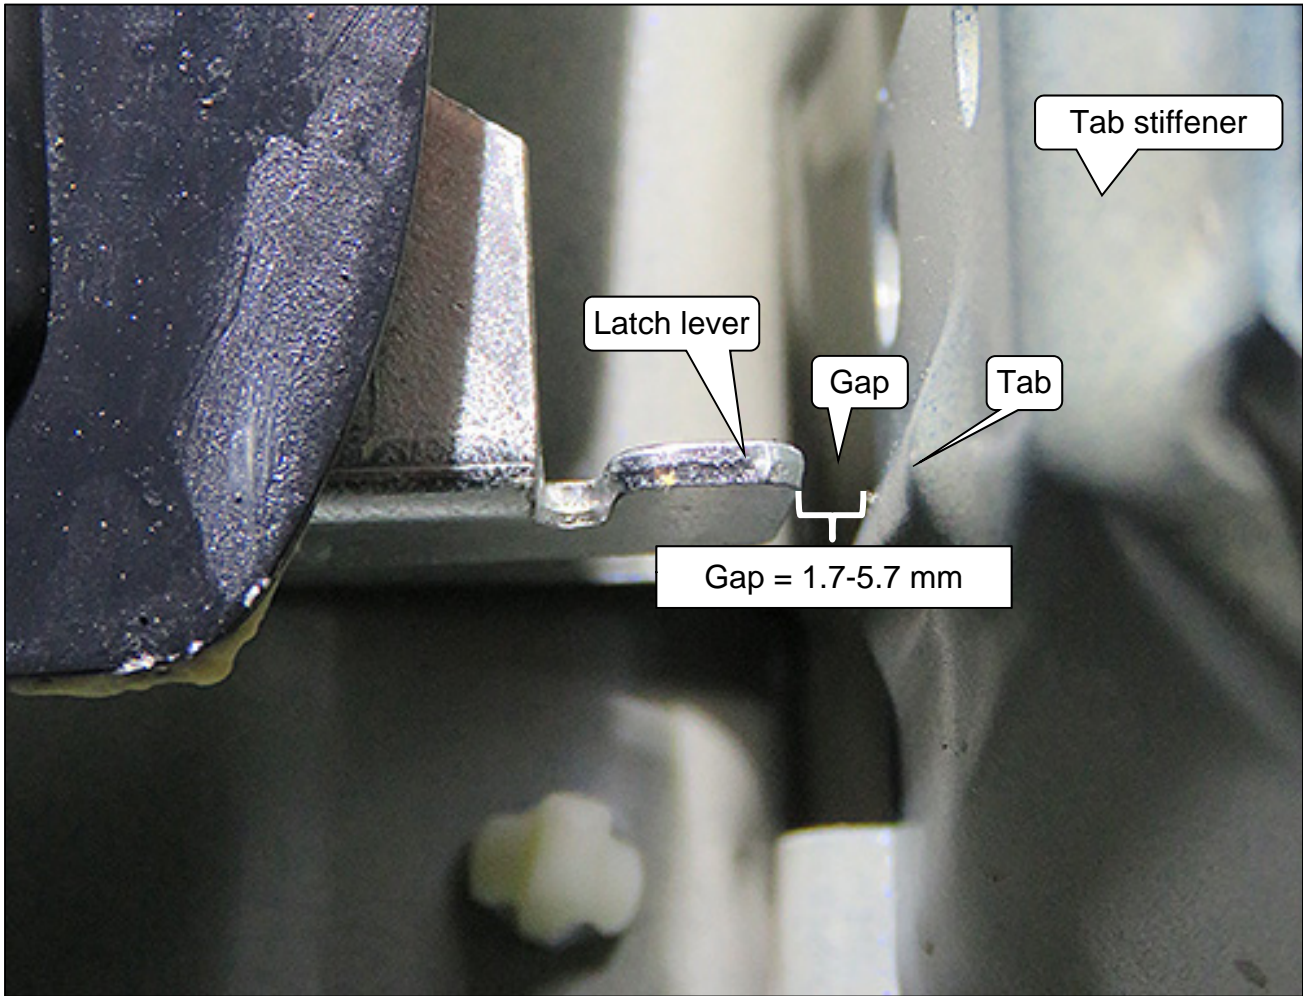
Figure 3

5. Move the latch lever on the door latch until it is level with the tab.
 - Move the latch lever by pulling the outside door handle outward.
6. With the latch lever and tab still level with each other (Figure 3), measure the gap between the latch lever and the tab.
 - The gap should be between a minimum of 1.7 mm (0.067 inch), and a maximum of 5.7 mm (0.224 inch).

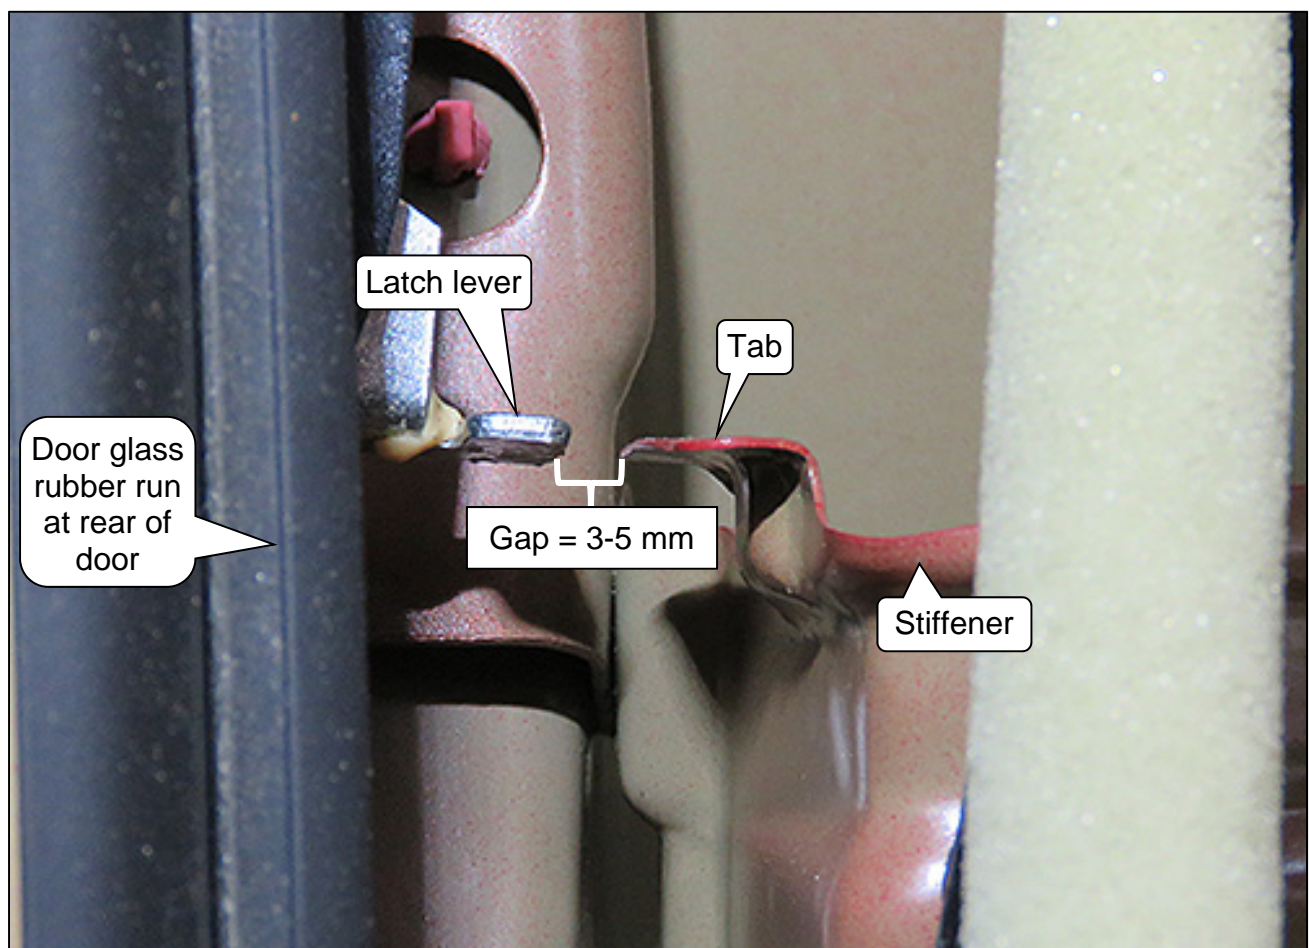
Figure 6

NOTE: The door latch is hidden behind the door glass rubber run.
13. With the latch lever and tab still level with each other (Figure 6), measure the gap between the latch lever and the tab.
 - The gap should be between a minimum of 3 mm (0.118 inch), and a maximum of 5 mm (0.197 inch).

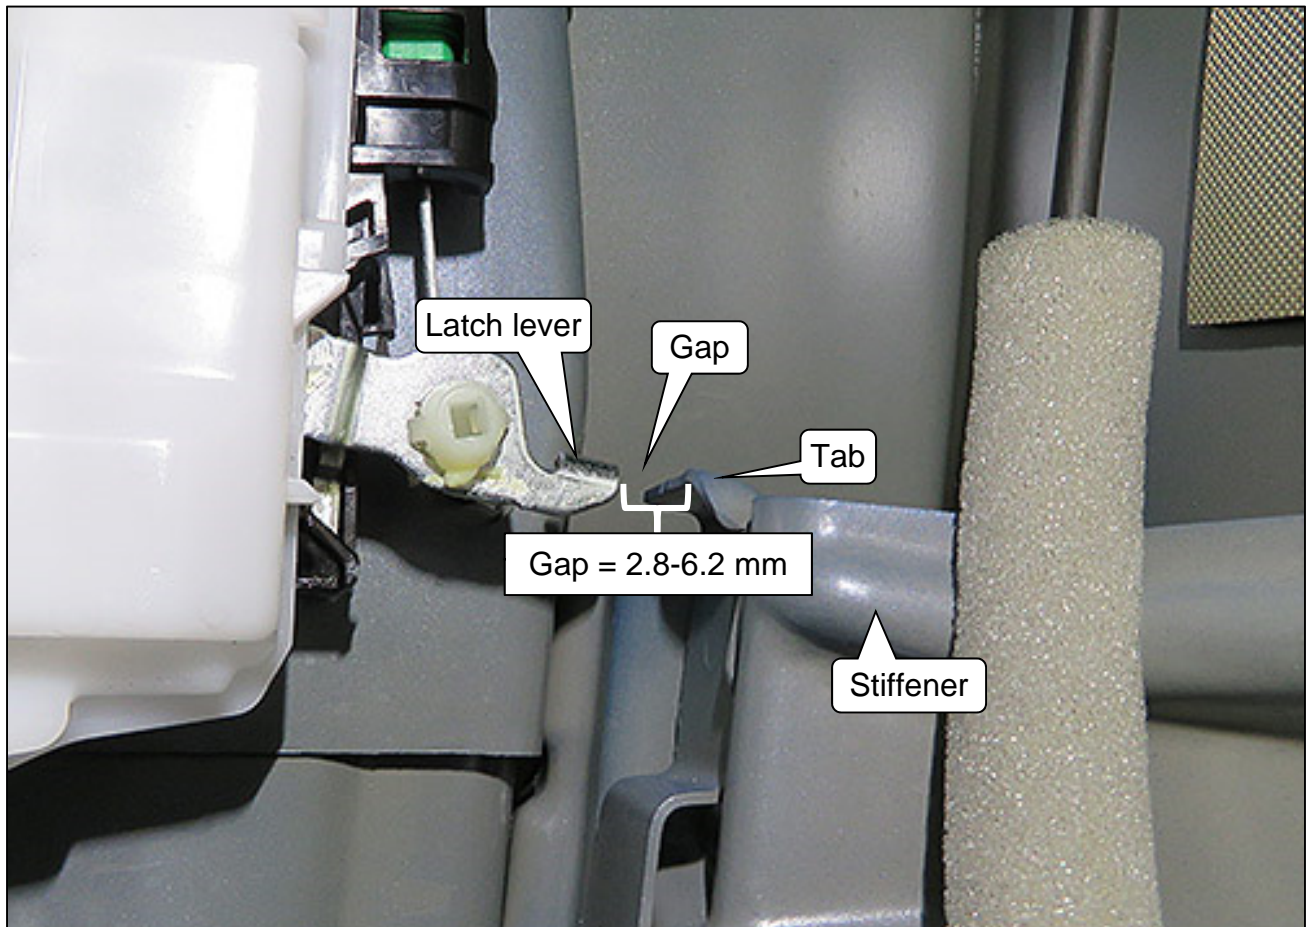
Figure 10

20. Move the latch lever on the door latch until it is level with the tab.
 - Move the latch lever by pulling the outside door handle outward.
21. With the latch lever and tab still level with each other (Figure 10), measure the gap between the latch lever and the tab.
 - The gap should be between a minimum of 2.8 mm (0.11 inch), and a maximum of 6.2 mm (0.224 inch).

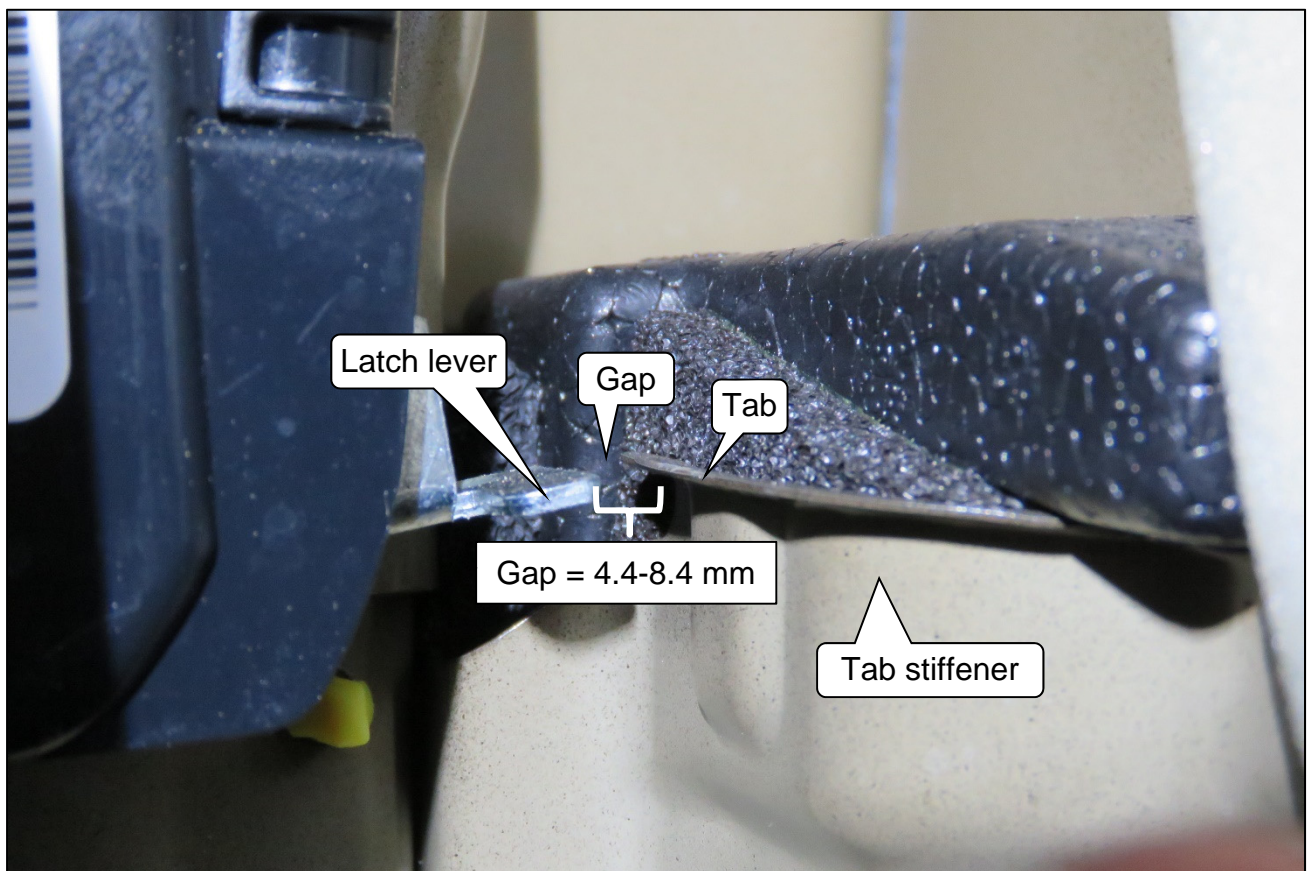
Figure 14

29. With the latch lever and tab still level with each other (Figure 14), measure the gap between the latch lever and the tab.
- The gap should be between a minimum of 4.4 mm (0.173 inch), and a maximum of 8.4 mm (0.331 inch).
