SERVICE BULLETIN

Classification: EL20-008c	Reference: NTB20-016c	Date: January 4, 2021
------------------------------	--------------------------	--------------------------

RADIO INTERMITTENTLY REBOOTS DURING AUDIO PLAYBACK VIA BLUETOOTH CONNECTED IPHONE

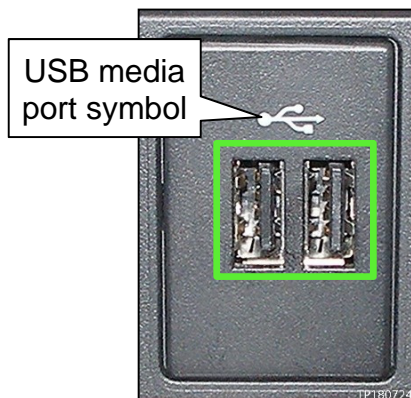
Figure 11

20. Turn OFF the audio system.
21. Insert the special tool USB drive J-52727 into the USB media port (Figure 11).

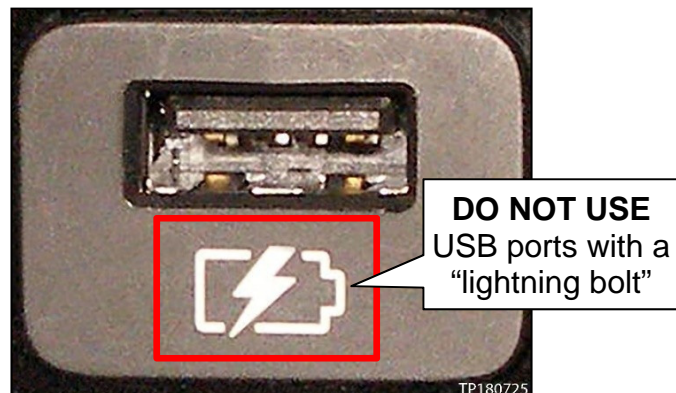
Figure 12

NOTICE Do not insert the USB drive into a charging port (Figure 12). If used, the update software and/or USB drive may become damaged. Only insert the USB drive in a USB media port.

HINT: Charging ports are marked in the vehicle with a “lightning bolt” symbol.

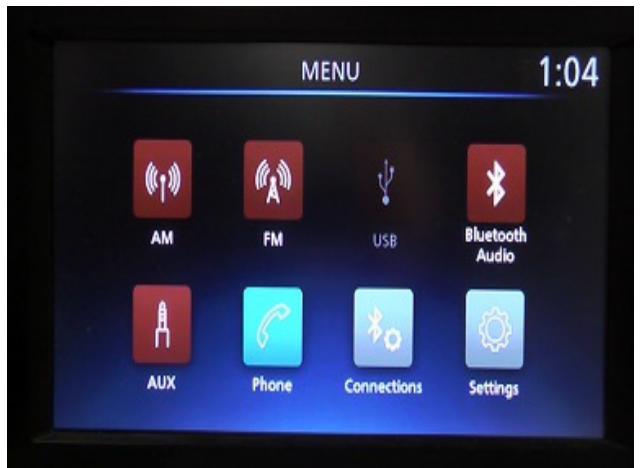
Figure 14

- Reprogramming is not complete until the audio unit reboots and returns to the main MENU screen (Figure 14).
- If the screen turns OFF (blank black screen), and remains OFF for longer than one (1) minute, press the volume knob (power button) or turn the screen back ON before proceeding to step 23.

NOTICE To prevent damage to the AV control unit, do NOT remove the USB drive unless the audio unit has rebooted and the main MENU screen, as shown in Figure 14, is displayed.
