SERVICE BULLETIN

EL20-008c

NTB20-016c

RADIO INTERMITTENTLY REBOOTS DURING AUDIO PLAYBACK VIA BLUETOOTH CONNECTED IPHONE

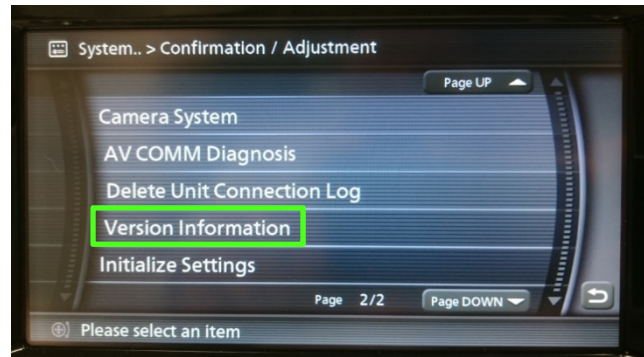
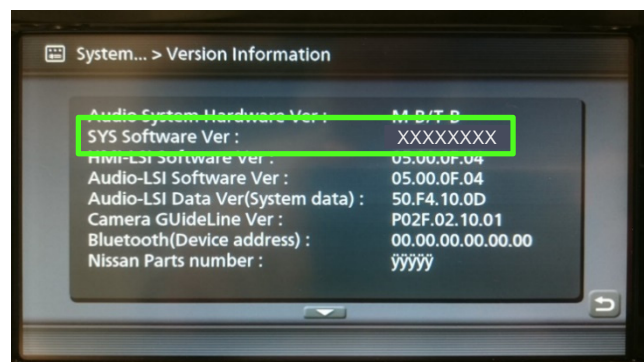
- If the **SYS Software Version #** is less than the numbers shown below, turn the ignition OFF and continue to step 7 on page 4.
- If the **SYS Software Version #** is equal to or greater than the numbers shown below, no software update is needed. Go to ASIST for further diagnostic and repair information.

- For 2018-2019 Sentra, Versa Note and Versa Sedan: 80856035
- For 2020 Versa Sedan and 2018-2020 Kicks: 80851035
- For 2018-2020 NV: 80856235
- For 2018-2020 Frontier: 80856135
