SERVICE BULLETIN

Classification: EC20-031	Reference: NTB21-001	Date: January 6, 2021
-----------------------------	-------------------------	--------------------------

2020-2021 TITAN/TITAN XD; TCM COMMUNICATION ERROR CAUSING A NO START CONDITION

APPLIED VEHICLES: 2020-2021 Titan/Titan XD (A61)

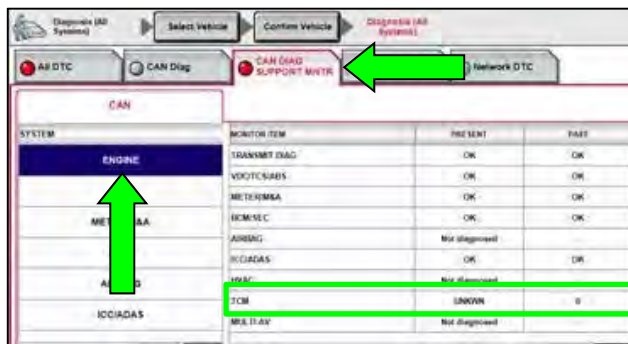
There is a U0101 DTC (Lost Comm TCM) in the Engine Control Unit (ECU) and/or the Shifter Control Unit (SCU). This DTC may be in a PAST or CURRENT status.

The TCM shows “UNKWN” in the **PRESENT** column or “0” in the **PAST** column under the **CAN DIAG SUPPORT MNTR** tab within the ECU (**ENGINE**) or the SCU (**SHIFT**) in CONSULT-III PLUS (C-III plus). See Figure 1 and Figure 2.
