SERVICE BULLETIN

EC20-032

NTB21-002

2020 FRONTIER; TCM COMMUNICATION ERROR CAUSING A NO START CONDITION

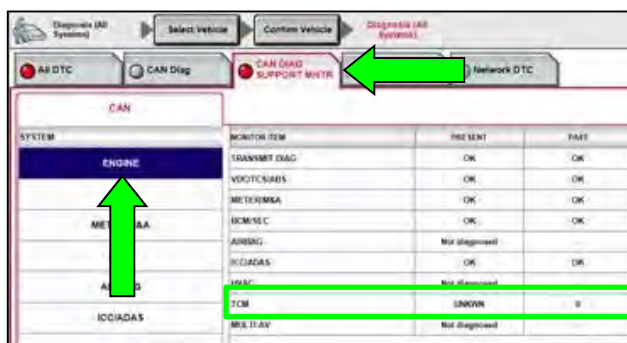
The TCM shows "UNKWN" in the **PRESENT** column or "0" in the **PAST** column under the **CAN DIAG SUPPORT MNTR** tab within the ECU (**ENGINE**) or the SCU (**SHIFT**) in CONSULT-III plus (C-III plus). See Figure 1 and Figure 2.

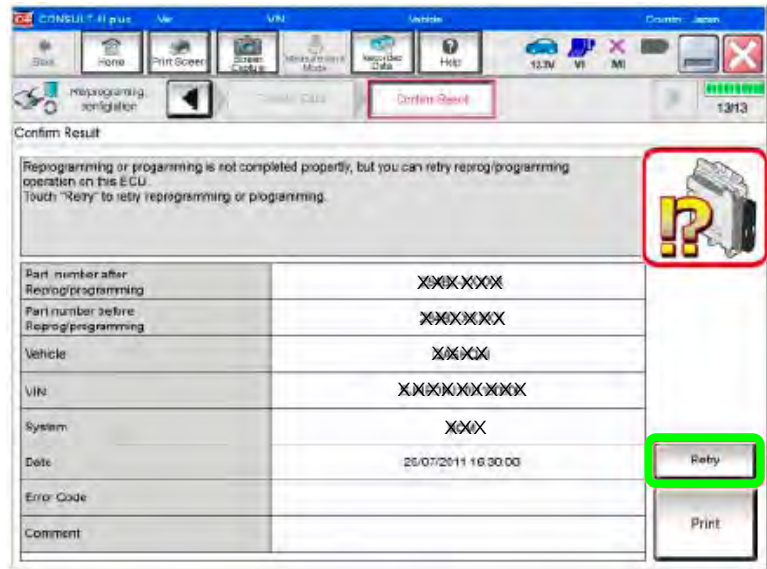
Figure 18

If reprogramming does not complete and the “!?” icon displays as shown in Figure 18:

- Check battery voltage (12.0 V – 15.5 V).
- Ignition is ON, engine is OFF.
- External Bluetooth® devices are OFF.
- All electrical loads are OFF.
- Select retry and follow the on screen instructions.
- “Retry” may not go through on first attempt and can be selected more than once.

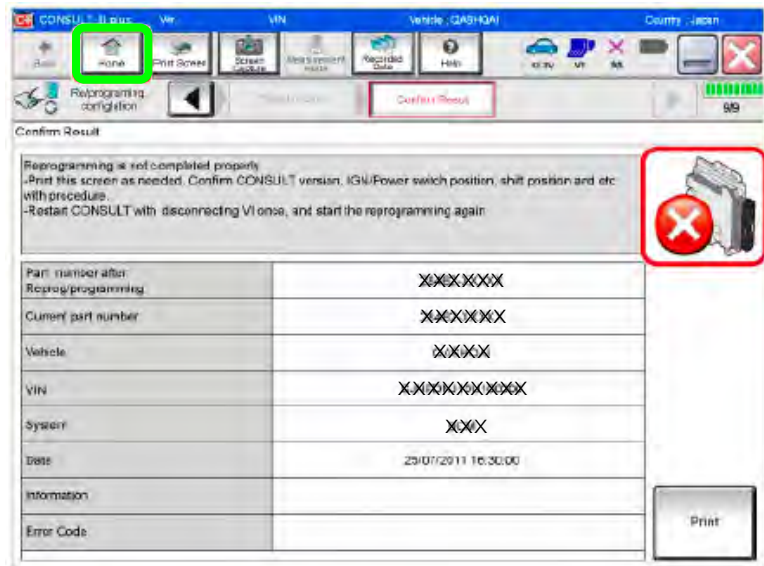
Figure 19

If reprogramming does not complete and the “X” icon displays as shown in Figure 19:

- Check battery voltage (12.0 V – 15.5 V).
- CONSULT A/C adapter is plugged in.
- Ignition is ON, engine is OFF.
- Transmission is in Park.
- All C-III plus / VI cables are securely connected.
- All C-III plus updates are installed.
- Select Home, and restart the reprogram procedure from the beginning.
