SERVICE BULLETIN

Classification: EC21-001	Reference: NTB21-006	Date: January 25, 2021
-----------------------------	-------------------------	---------------------------

MIL ON WITH DTC P0128 STORED

APPLIED VEHICLES: 2021 Versa (N18)
APPLIED TRANSMISSION: 5-speed M/T (RS5F91R)

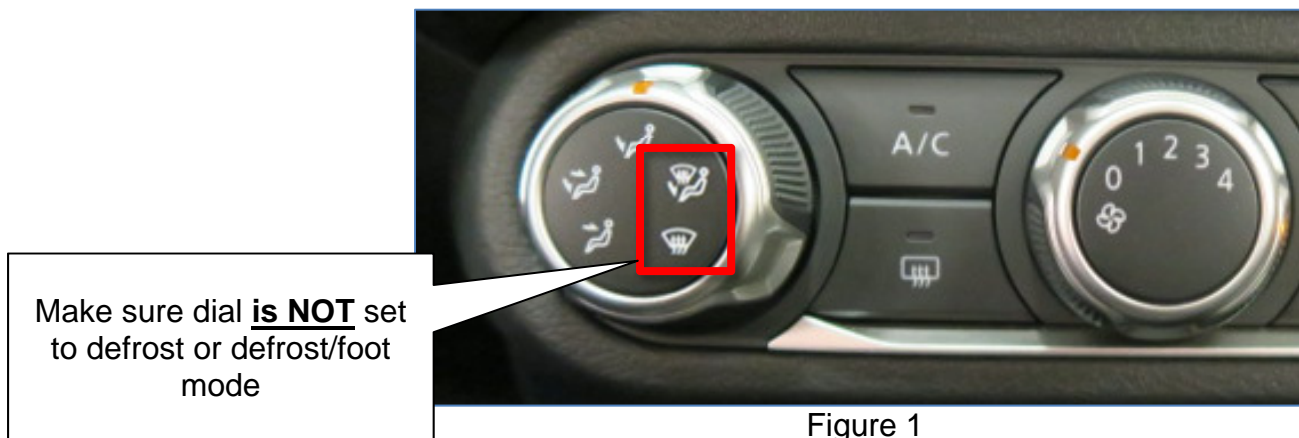
2. Confirm the HVAC air flow control dial **is NOT** set to defrost or defrost/foot mode.

NOTE: If unable to start the reprogram (the Start button is greyed out), refer to Figure 1 on page 2 and confirm the HVAC air flow control dial is NOT set to defrost or defrost/foot mode.
