Popping/Crackling from the Speakers; Display Blank

Supersedes 20-031, dated October 9, 2020, to revise the information highlighted in yellow.

Year	Model	Trim Level	VIN Range
2019-20	RDX	ALL	ALL

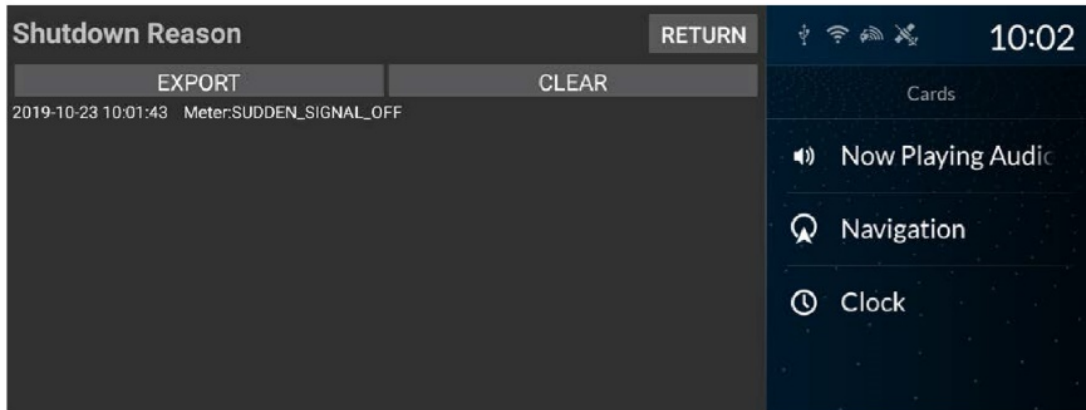
In this example, the cause of the failure can be identified as **Meter:SUDDEN_SIGNAL_OFF**.

5. Write down any failures as they will be collected on the warranty claim. Then, clear the data.
