Technical Service Bulletin

68 Noises from the dash panel around the MMI display

68 21 32 2056298/3 February 2, 2021. Supersedes Technical Service Bulletin Group 68 number 20-29 dated December 17, 2020 for reasons listed below.

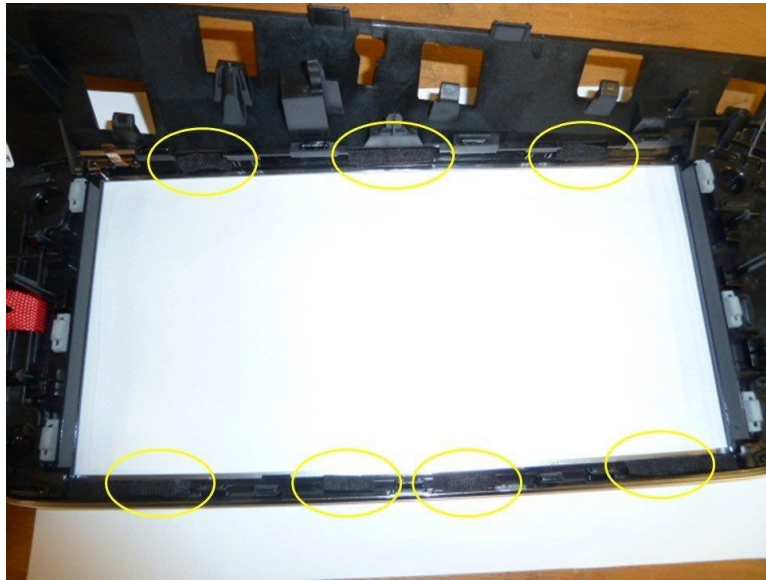
Figure 1. Apply felt strips to the circled areas.

- Felt strips 533867910A.
1. Remove the trim strip of the dash panel and stick the felt adhesive tape on the areas marked with yellow circles (Figure 1).

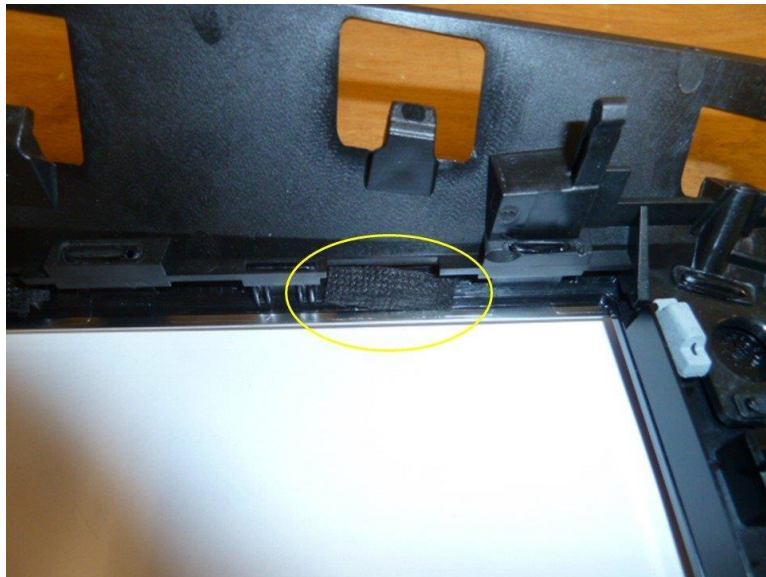
Figure 2. Close-up of Figure 1.

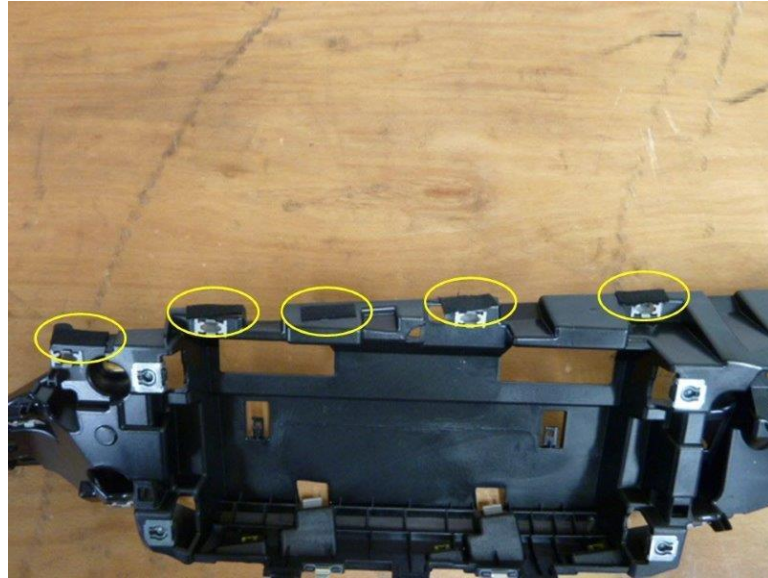
Figure 3. Apply felt strips to the circled areas.

2. The felt strips shown in Figure 1 and 2 must be stuck on and folded back behind the clip (Figures 3 -4).

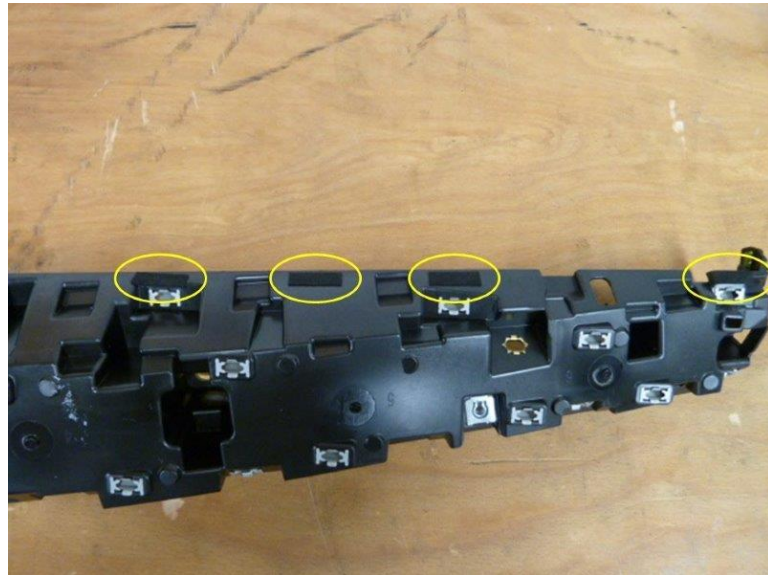
Figure 4. Apply felt strips to the circled areas.
