Technical Service Bulletin

46 Brake noise analysis and handling

46 21 24 2034181/18 February 10, 2021. Supersedes Technical Service Bulletin Group 46 number 19-08 dated March 18, 2019 for reasons listed below.

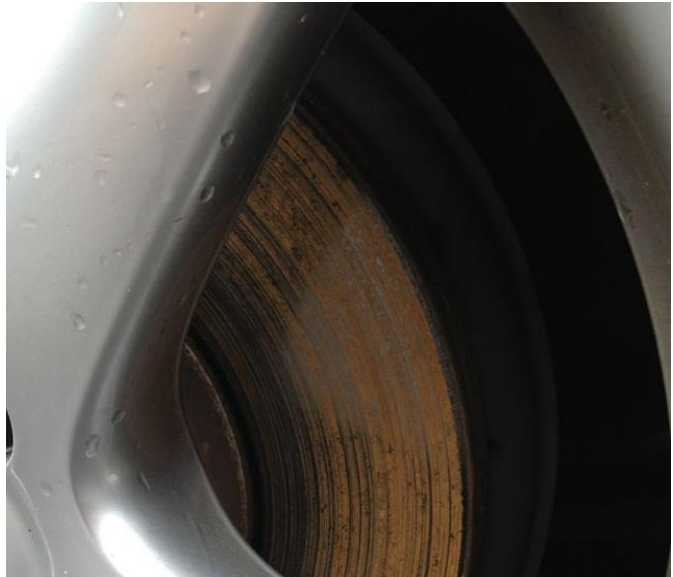
5. Discs are covered with rust. Rust can form when the vehicle has not been driven for a long period of time (Figure 1).

Figure 1. Disc covered with rust.

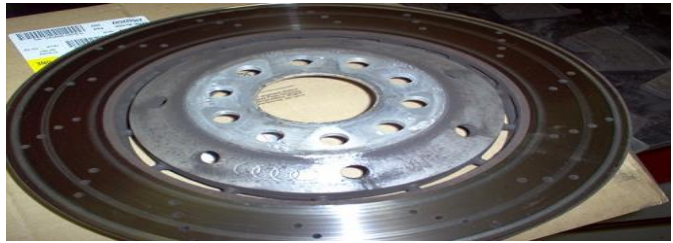
6. Discs are grooved (Figure 2).

Figure 2. Grooved disc.

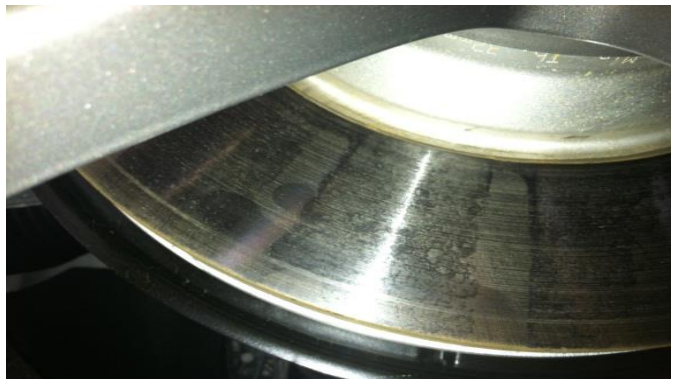
7. There is chemical contamination on the braking surface of the brake disc due to wheel or tire cleaner being sprayed directly onto the brake disc (Figure 3 and Figure 4).

Figure 3. Discoloration on the brake disc due to chemical contamination from the cleaner that was sprayed directly onto the disc.

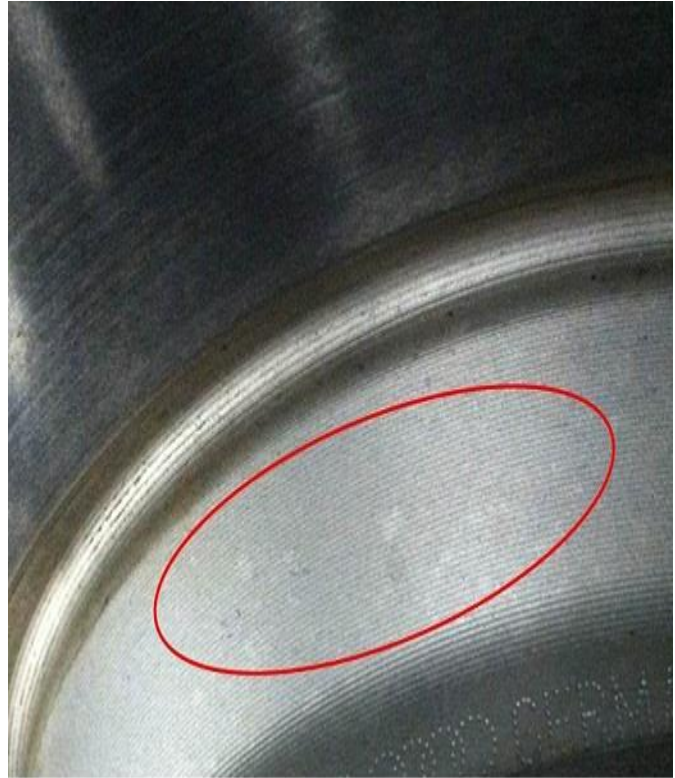
Figure 4. Small spots and discoloration due to chemical contamination from the cleaner that was sprayed directly onto the disc.

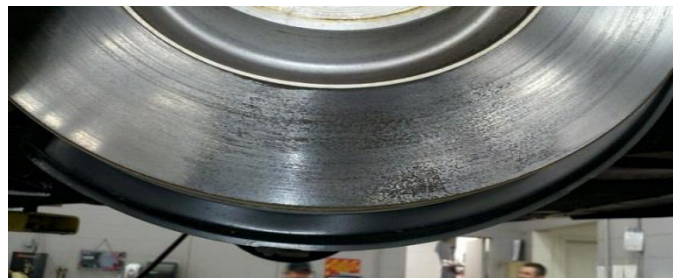
8. There are “pad marks” on the brake disc as a result of brake pad material transferring to the discs (Figure 5). Pad marks can occur when a vehicle has been parked for long periods of time in a wet or snowy environment.

Figure 5. Brake pad material has transferred to the discs.
