# Service Action

## Code: 37M9

<b>Subject</b>	Exhaust Bracket																			
<b>Release Date</b>	February 04, 2021																			
<b>Affected Vehicles</b>

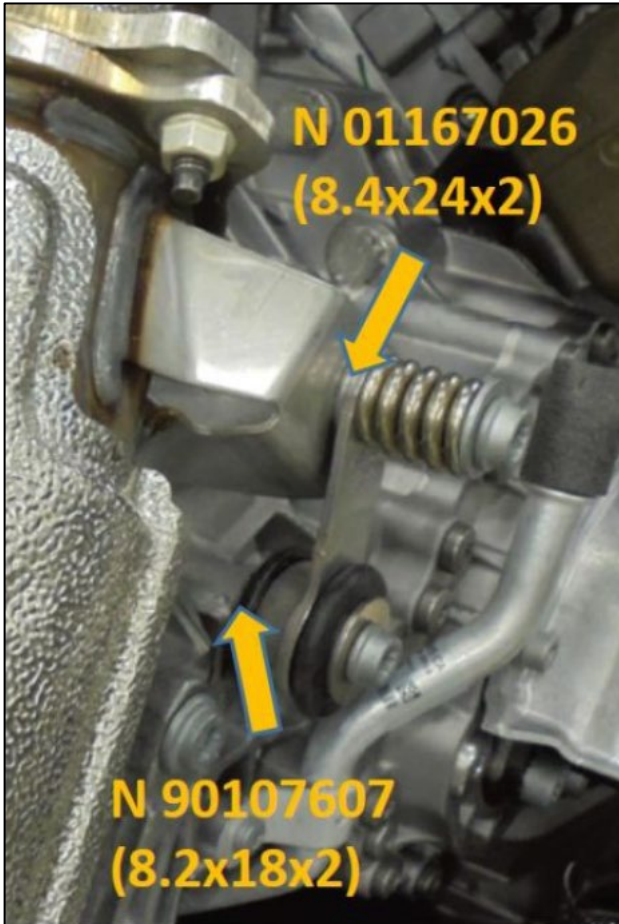
## Repair Overview

**What is the issue?** An irregularity in the transmission case casting may cause incorrect seating of the exhaust bracket connection. This can result in an uneven contact surface, and as a result the bolts for the exhaust system bracket can become loose.

- Install spacer washers to the exhaust bracket.
