STAR ONLINE PUBLICATION

Case Number: S2108000003

Symptom/Vehicle Issue: Cluster Displays Blind Spot Alert Off Incompatible Trailer Message, Left Steering Wheel Switches Do Not Allow Update Or Change

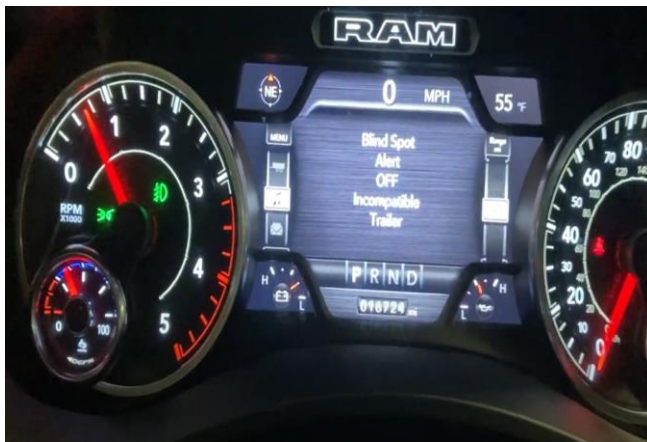
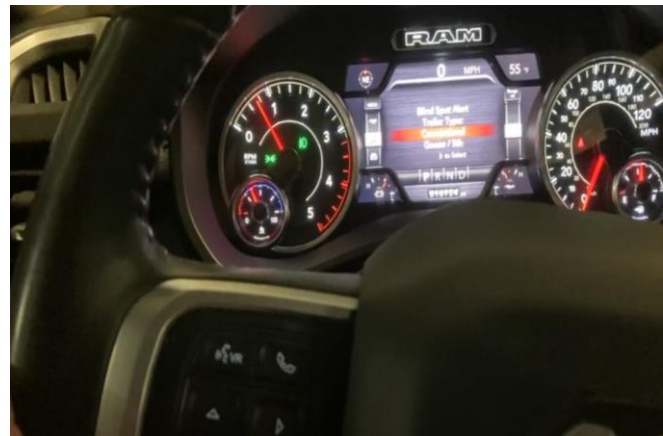
Repair Procedure: The Left and Right Blind spot sensors require trailer detection capabilities. Review a current scan report for the vehicle and ensure the sensors match the year of the vehicle they were intended for. Example below scan report 68358104AE is for 2019 vehicles and will not detect a trailer on a 2020 vehicle. Currently 2020 vehicles require 68442393AE. Replace the blind spot sensors to resolve.

LBSS	Left Blind Spot Sensor	CAN-I	68358104AE	Left and Right use the same part	68358104AE
RBSS	Right Blind Spot Sensor	CAN-I	68442393AC		68442393AC
