STAR ONLINE PUBLICATION

Case Number: S2108000018

Symptom/Vehicle Issue: Interior Camera Module, ICM1, Red On wiTECH Topology

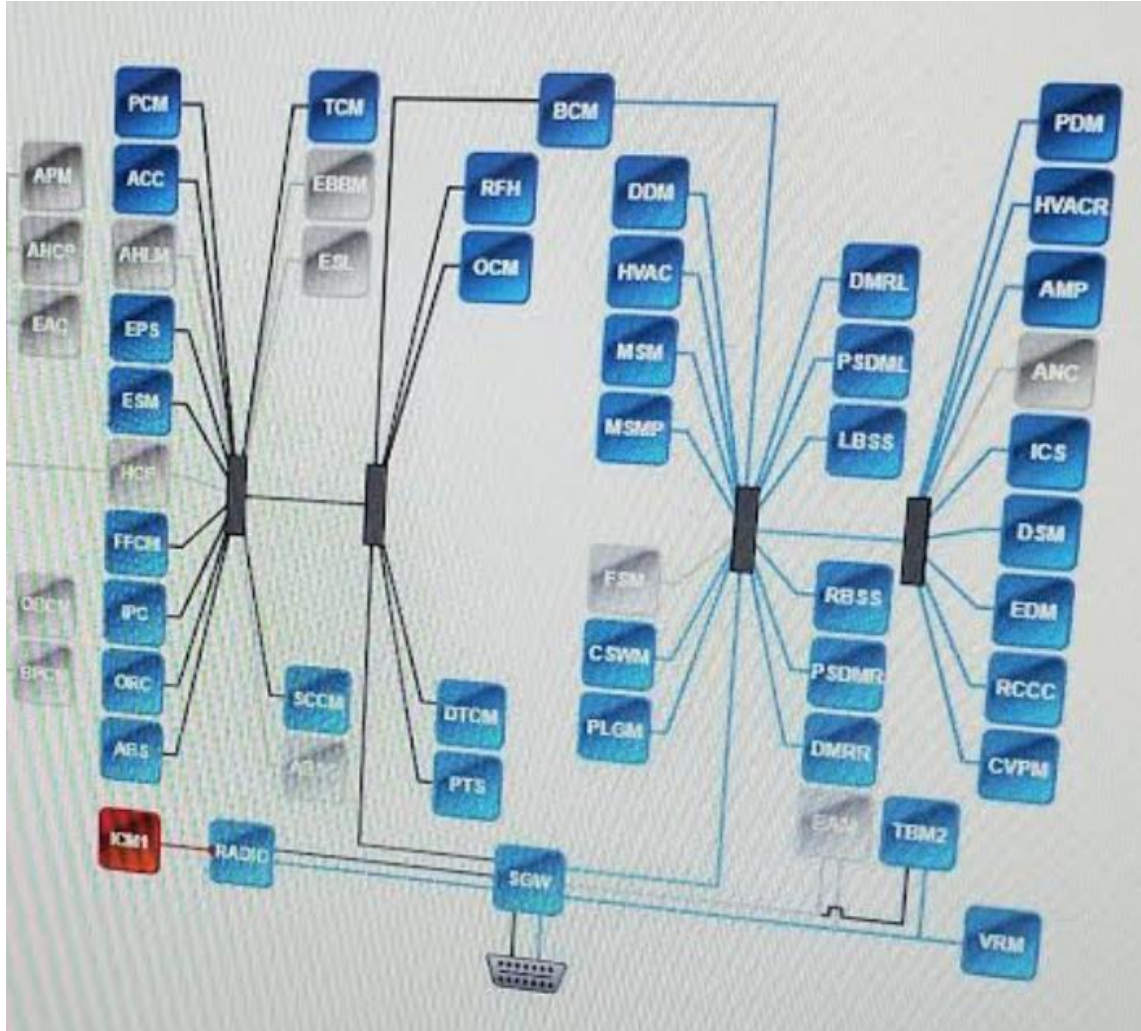
Fig 1

Discussion: Interior Camera Module (ICM1) or FamCam shows up RED on wiTECH Topology. Per Engineering, the red display for the ICM1 is expected, because the radio doesn't currently support reading diagnostic information for the ICM1.

Check the functionality of the Interior Camera. If camera is functioning, do not replace the camera or radio. Ignore the Red topology.

Do Not Replace The ICM1/Famcam or The Radio at This Time. A future software enhancement for the Radio and ICM1 will resolve concern. Tentatively 22 MY R18/S18 software.
