STAR ONLINE PUBLICATION

Case Number: S2123000006

Symptom/Vehicle Issue: Squeak Chirp Creak Noise From Left Quarter Panel Area

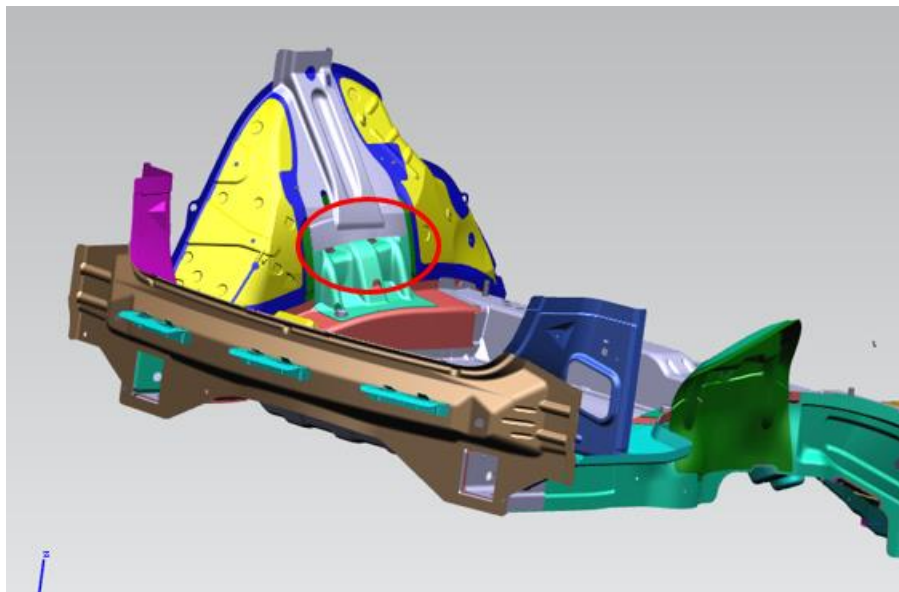
Fig 1

Tapping/rattling sound heard from the left rear of vehicle near the upper shock mount area. Remove the left inner quarter panel and test drive to determine if the noise is coming from a touch condition between the left rear wheelhouse reinforcement and the inner bracket (Fig 1).

If the noise originates from the circled area in Fig 1, separate the panels as shown below using a prybar (Fig 2). Once separated, inject a bead of RTV silicone between the 2 pieces to insulate them.

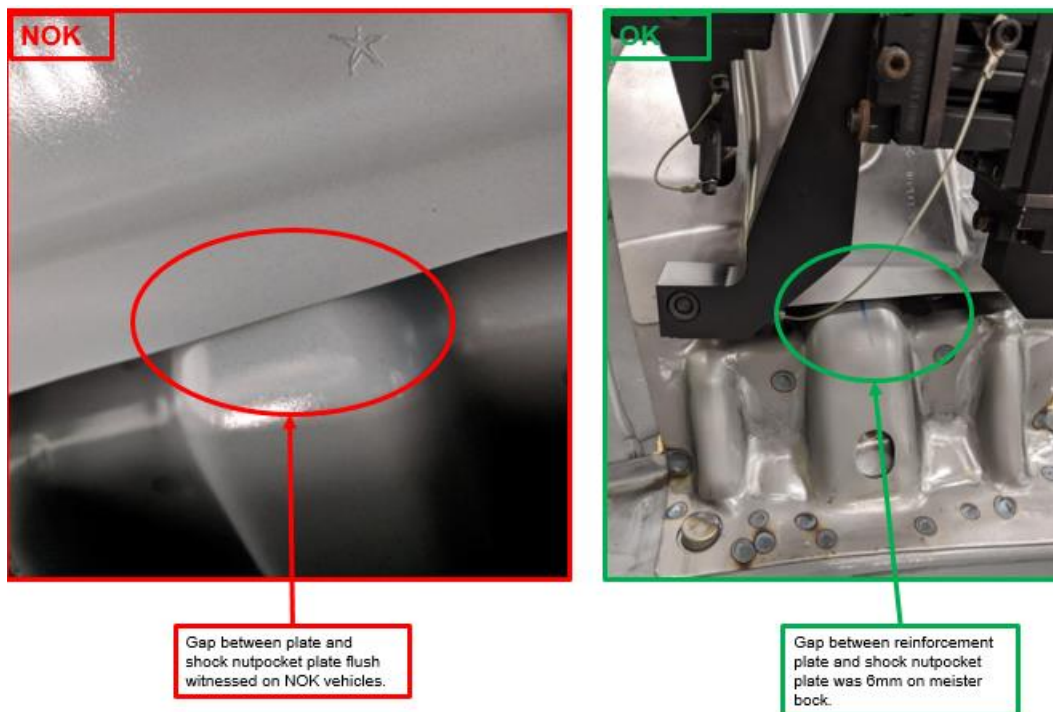
Fig 2
Left image shows no gap. Right shows correct gap
