## STAR ONLINE PUBLICATION

**Case Number:** S2123000007

**Symptom/Vehicle Issue:** Sliding Door Contacts Quarter Window Trim Molding

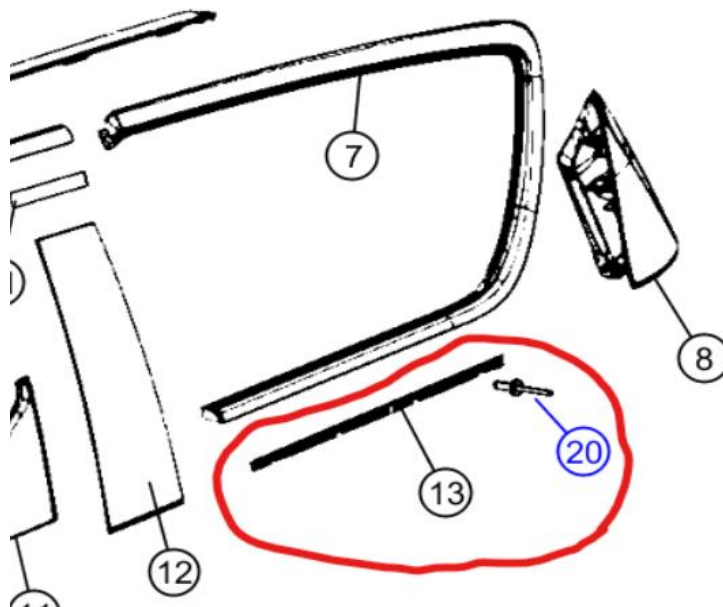
**Customer Complaint/Technician Observation:** Rub marks or customer complaint of the rear quarter window trim having scuffing from the sliding door contact.

**Discussion:** If there are signs of contact between the sliding door and the quarter window opening trim, replace the trim component with new rivets.

Rivet p/n: 06035073

Bracket p/n: 55112812ac
