GLOBAL SAFETY FIELD INVESTIGATIONS
DCS5636
URGENT - DISTRIBUTE IMMEDIATELY

Subject: N202320350 - Service Update
Lane Keep Assist Disable Harness Missing

Models: 2021 GMC Acadia
Equipped with Sensor Indicator – Forward Collision Alert (RPO UEU)

N202320350 Lane Keep Assist Disable Harness Missing

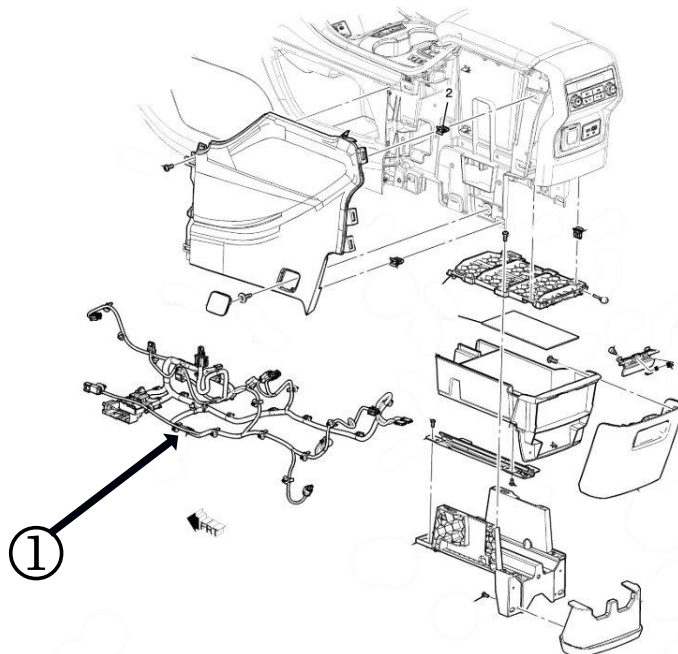
5682338

Condition	On certain 2021 model year GMC Acadia vehicles, the center consoles may have been assembled with harnesses missing two wires that connect the lane keep assist system to the disable switch. The lane keep assist will continue to be active and cannot be disabled.
Correction	Dealers are to inspect and if necessary, replace the front floor console wiring harness.

1. Verify the Lane Assist switch functions and can be turned off and on:
 - a. If the Lane Keep Assist switch functions correctly, no further action is required.
 - b. If the Lane Keep Assist switch does not turn the feature on and off, continue to step 2.
2. Replace the front floor console wiring harness (1). Refer to *Front Floor Console Removal and Installation* in SI.
