Subject: N202296840 - Service Update  
Upper Intermediate Steering Shaft

Models: 2020 Cadillac CT5

# Service Update

## N202296840 Upper Intermediate Steering Shaft

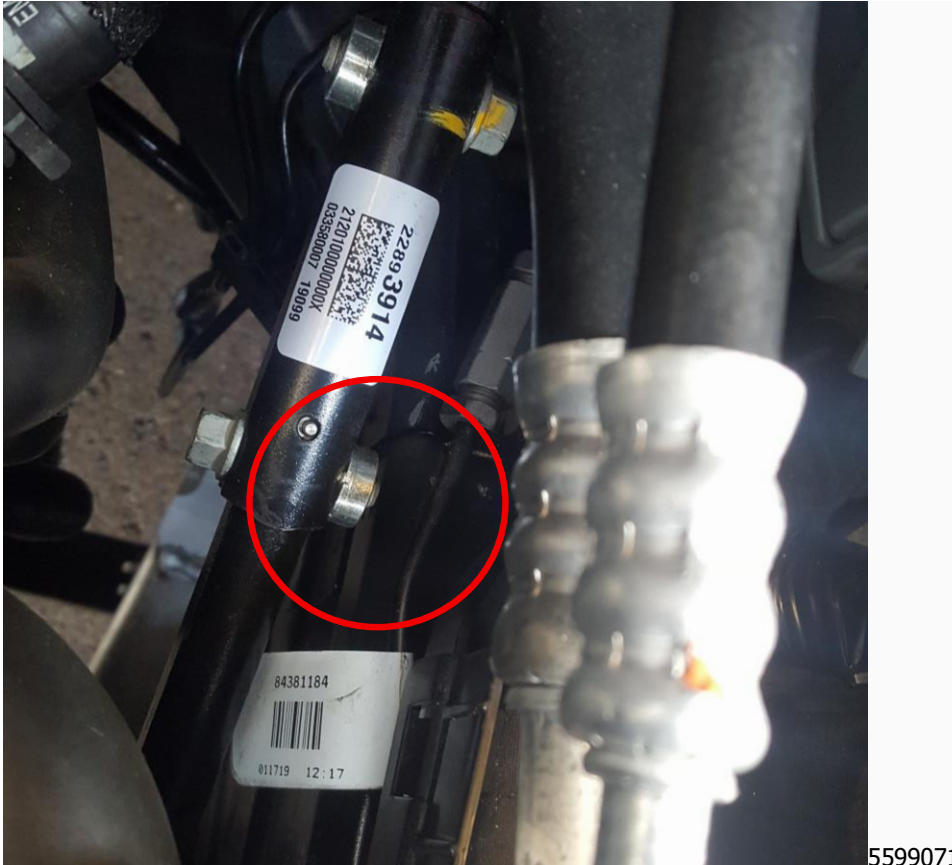
2. Inspect the area shown for approximately 0.55 inches (14mm) of clearance between the brake line and steering shaft bolt. Check with the threads of the bolt facing the brake line, as shown, and then rotate the steering wheel 180 degrees again and check again with the head of the bolt facing the brake line.

- If the brake line is NOT touching or has more than 0.55 inches (14mm) of clearance, no further action is required.
  - If the brake line is NOT touching, and has no signs of rubbing, but has LESS than 0.55 inches (14mm) of clearance to the steering intermediate shaft, gently bend the brake line away from the steering shaft until it has the specified amount of clearance, then skip to step 4.

- If the brake line IS touching, OR has signs of rubbing in the past, proceed to step 3.
3. Replace the damaged brake pipe sections. Refer to *Front Brake Pipe Replacement – Left Side* and *Brake Pressure Modulator Valve Pipe Replacement* in SI.
