GLOBAL SAFETY FIELD INVESTIGATIONS  
DCS5645  
URGENT - DISTRIBUTE IMMEDIATELY

Subject: N202319250 - Service Update  
Radio Unable to Receive OTA Updates

Models: 2021 Chevrolet Suburban,  
2021 Chevrolet Tahoe,  
2021 GMC Yukon,  
2021 GMC Yukon XL  
Equipped with Infotainment System (RPO IOT)

## N202319250 Radio Unable to Receive OTA Updates

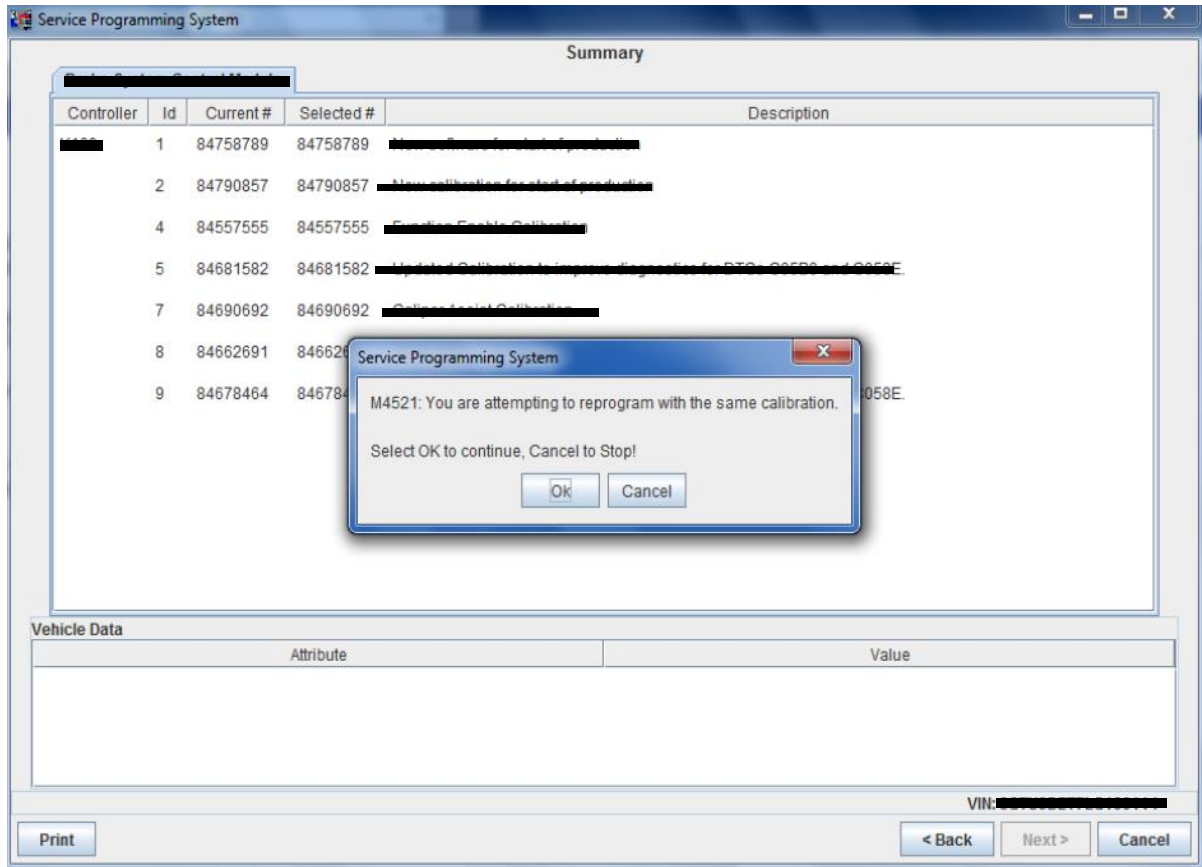
5431207

**Important:** If the same calibration/software warning is noted on the TLC or SPS Summary screen, select OK and follow screen instructions. After a successful programming event, the WCC is located in the Service Programming System dialogue box of the SPS Summary screen. No further action is required. Refer to the Warranty section of the bulletin.
