GLOBAL SAFETY FIELD INVESTIGATIONS  
DCS5661  
URGENT - DISTRIBUTE IMMEDIATELY

Subject: REVISION – N202302720 01 – Special Coverage  
On Track Performance Engine Overheating  
Revised Parts Section and Accepted Evidence Expanded

Models: 2015-2016 Chevrolet Corvette  
Equipped with Manual Transmission (RPO MEK)  
2015-2018 Chevrolet Corvette  
Equipped with Automatic Transmission (RPO M5U)

## N202302720 On Track Performance Engine Overheating

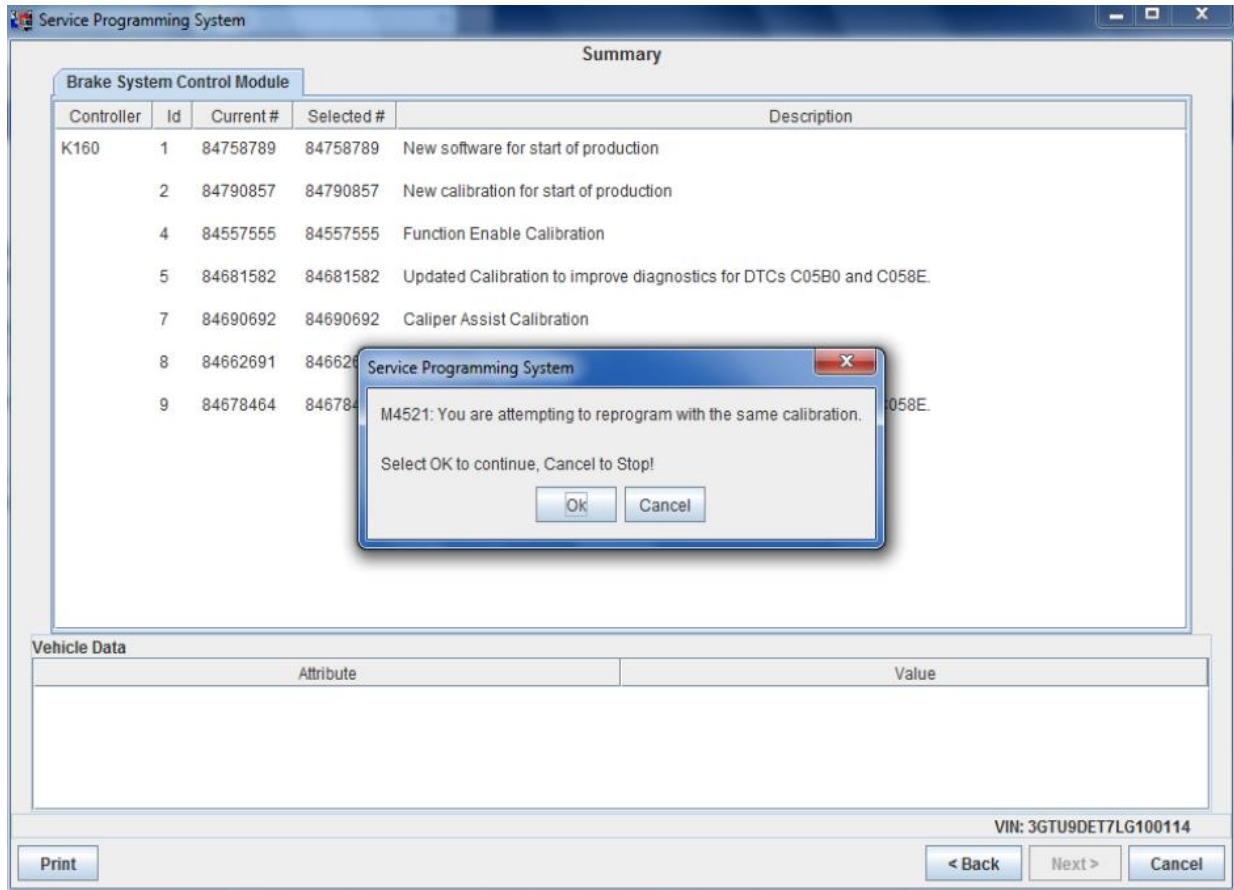
5431207

**Important:** TIS2WEB screen shown. Techline Connect screen is similar and will be included in the near future.

**Important:** If the same Calibration/Software Warning is noted on the SPS screen, select OK and follow screen instructions. After a successful programming event, the WCC is located in the Service Programming System dialogue box of the SPS Summary screen. No further action is required. Refer to the Warranty section of the bulletin.

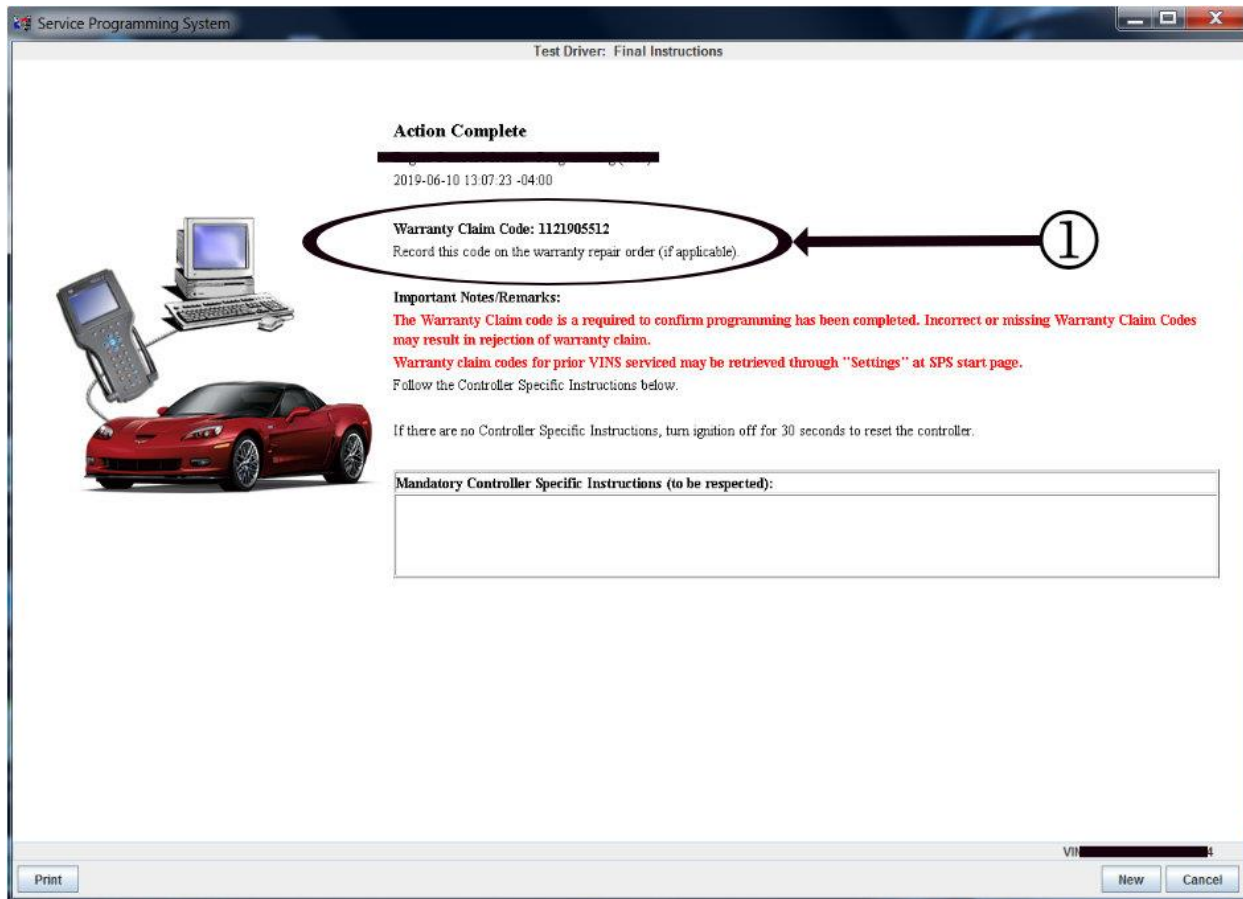
5431209

**Important:** TIS2WEB screen shown. Techline Connect screen is similar and will be included soon.

**Important:** To avoid warranty transaction rejections, you MUST record the warranty claim code provided on the SPS Warranty Claim Code (WCC) screen on the job card. Refer to callout 1 above for the location of the WCC on the SPS screen.

3. Record SPS Warranty Claim Code on job card for warranty transaction submission.
