Subject: REVISION – N202317390 01 - Customer Satisfaction Program
Brake System Control Module Internal Fault
Revised Service Procedure

Models: 2021 Cadillac Escalade, Escalade ESV
2021 Chevrolet Suburban, Tahoe
2021 GMC Yukon, Yukon XL

N202317390 Brake System Control Module Internal Fault

Condition	Certain 2021 model year Cadillac Escalade, Escalade ESV, Chevrolet Tahoe, Suburban, GMC Yukon and Yukon XL vehicles may have a condition in which the brake system control module (BSCM) may set and latch an internal fault in the module's on-board diagnostics (OBD) buffer. When the fault is present, no malfunction indicator lamp (MIL) is illuminated and there is no driver information center (DIC) message. If an over the air (OTA) software update is pushed to an OBD module and the customer accepts it through the Infotainment system, the update will fail because the presence of the active fault will block the OTA update. The customer may notice that the OTA update has failed with an error message on the DIC. This fault is not visible through dealer tools.
Correction	Dealers are to reprogram the BSCM.

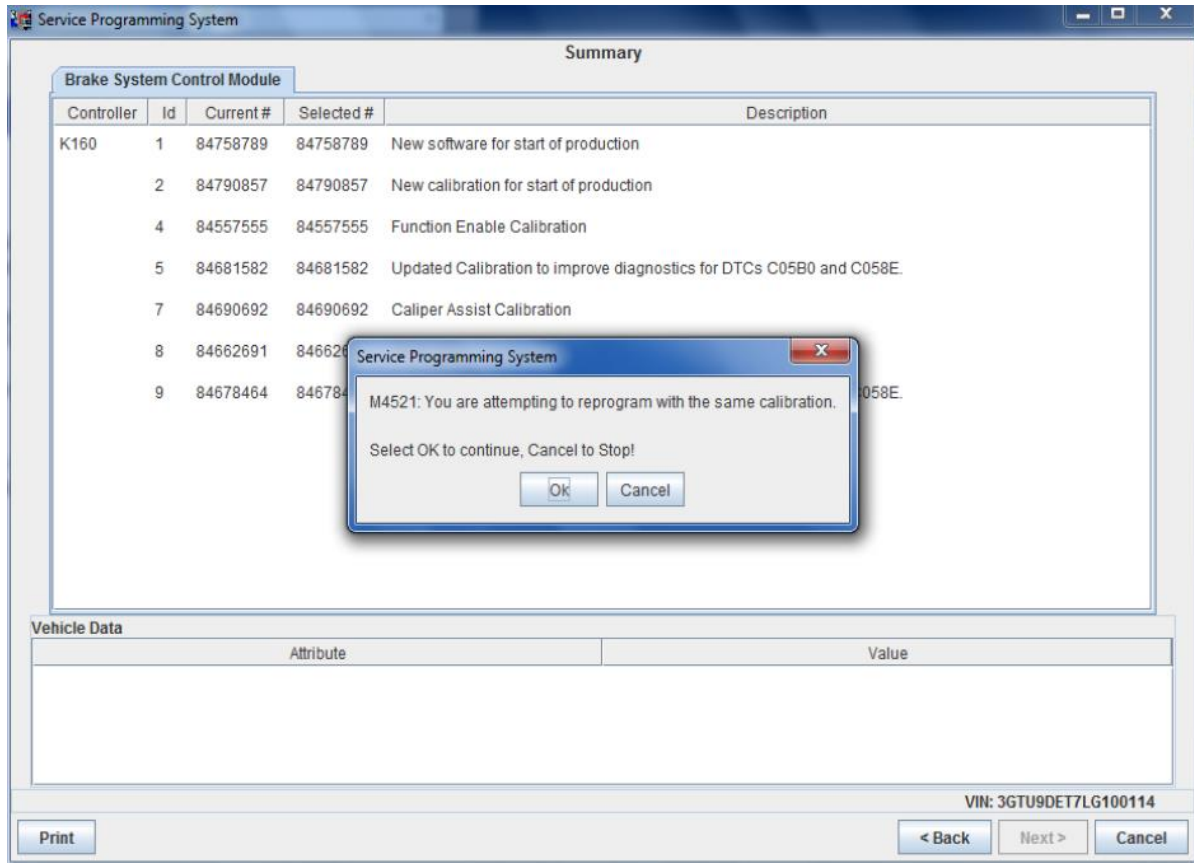
5431207

Important: Techline Connect and TIS2WEB screens shown above.

Important: If the same calibration/software warning is noted on the TLC or SPS Summary screen, select OK and follow screen instructions. After a successful programming event, the WCC is located in the Service Programming System dialogue box of the SPS Summary screen. No further action is required. Refer to the Warranty section of the bulletin.
